Profile/Photo Observation Report

Street:	Capitol	Flow Control:	Not Controlled
City:	Hobart, IN	Year Renewed:	
Location:	Yard	Tape/Media #:	
Purpose:	Maintenance Related	Dia/Height:	8"
Use:	Sanitary	Material:	PVC
Drain Area:	NA	Lining:	Cured in Place
Category:	NA		
Comment:	flow incorrect.

Location Details:		Direction of Survey:	Downstream
US MH:	M-906-004	DS MH:	M-906-009
		Total Length Surveyed (ft):	237.3

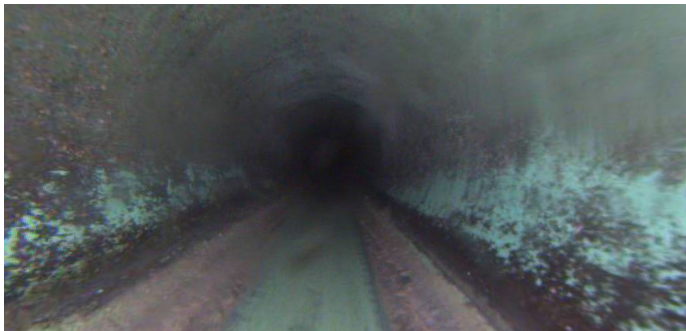
Code: **AMH**
Description: **Manhole**

Distance (ft): **.0**
Structural Grade: **0**
O&M Grade: **0**
Clock Start/From:
Clock To:
1st Value:
2nd Value:
Value Percent:
Continuous Index:
Within 8" of Joint: **NO**
Remarks: **M-906-004**

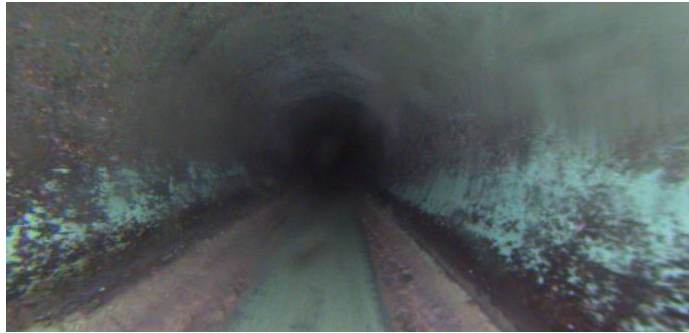
Code: **MWL**
Description: **Water Level**

Distance (ft): **.0**
Structural Grade: **0**
O&M Grade: **0**
Clock Start/From:
Clock To:
1st Value:
2nd Value:
Value Percent: **5.000**
Continuous Index:
Within 8" of Joint: **NO**
Remarks:

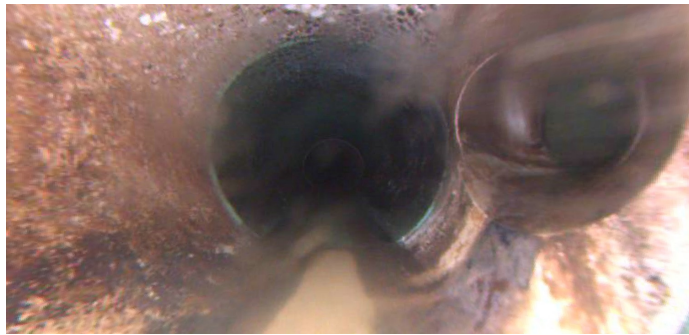
Code: **TF**
Description: **Tap Factory**

Distance (ft): **47.7**
Structural Grade: **0**
O&M Grade: **0**
Clock Start/From: **3**
Clock To:
1st Value: **4.000**
2nd Value:
Value Percent:
Continuous Index:
Within 8" of Joint:
Remarks:

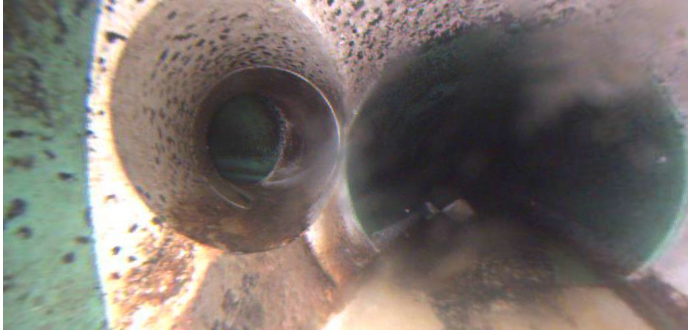
Code: **TF**
Description: **Tap Factory**

Distance (ft): **164.6**
Structural Grade: **0**
O&M Grade: **0**
Clock Start/From: **9**
Clock To:
1st Value: **4.000**
2nd Value:
Value Percent:
Continuous Index:
Within 8" of Joint:
Remarks:

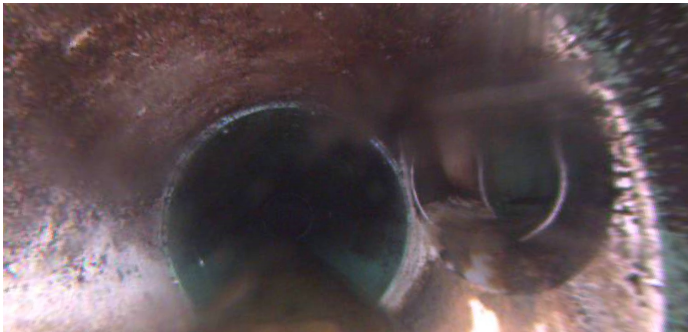
Code: **TF**
Description: **Tap Factory**

Distance (ft): **173.8**
Structural Grade: **0**
O&M Grade: **0**
Clock Start/From: **3**
Clock To:
1st Value: **4.000**
2nd Value:
Value Percent:
Continuous Index:
Within 8" of Joint:
Remarks:

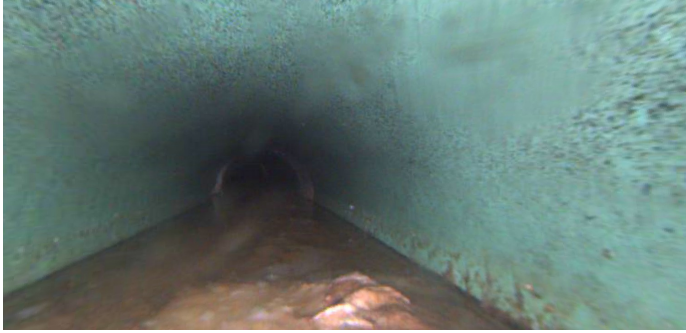
Code: **MWL**
Description: **Water Level**

Distance (ft): **213.9**
Structural Grade: **0**
O&M Grade: **0**
Clock Start/From:
Clock To:
1st Value:
2nd Value:
Value Percent: **30.000**
Continuous Index:
Within 8" of Joint: **NO**
Remarks:

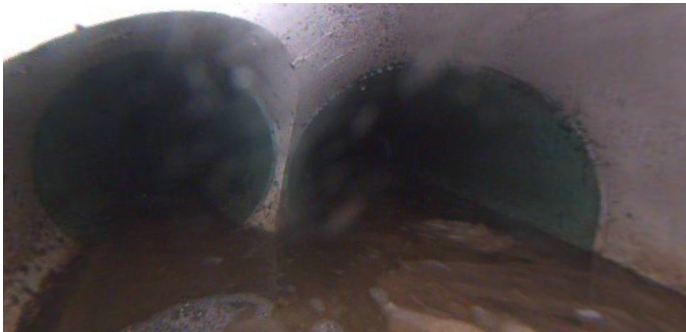
Code: **TFA**
Description: **Tap Factory Active**

Distance (ft): **216.5**
Structural Grade: **0**
O&M Grade: **0**
Clock Start/From: **9**
Clock To:
1st Value: **4.000**
2nd Value:
Value Percent:
Continuous Index:
Within 8" of Joint:
Remarks:

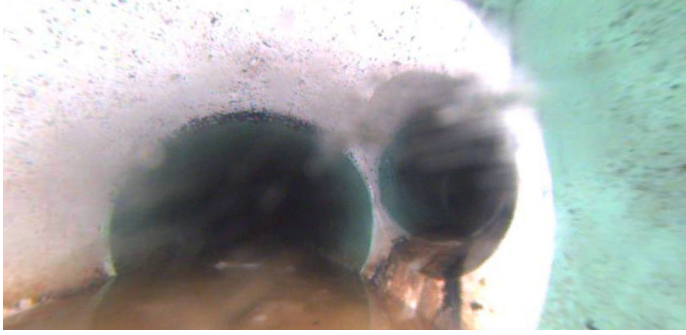
Code: **TF**
Description: **Tap Factory**

Distance (ft): **221.7**
Structural Grade: **0**
O&M Grade: **0**
Clock Start/From: **3**
Clock To:
1st Value: **4.000**
2nd Value:
Value Percent:
Continuous Index:
Within 8" of Joint:
Remarks:

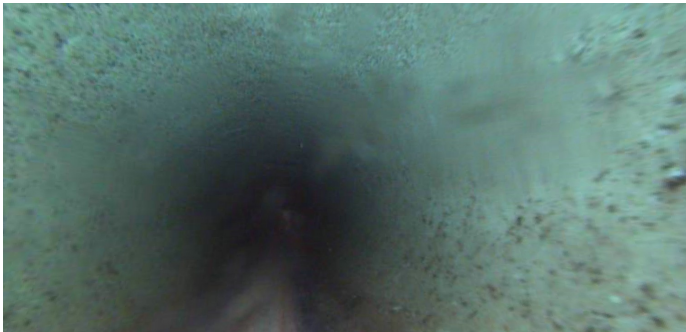
Code: **MWL**
Description: **Water Level**

Distance (ft): **230.9**
Structural Grade: **0**
O&M Grade: **0**
Clock Start/From:
Clock To:
1st Value:
2nd Value:
Value Percent: **5.000**
Continuous Index:
Within 8" of Joint: **NO**
Remarks:

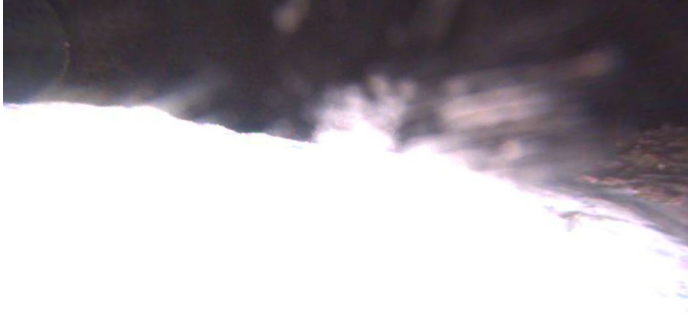
Code:	AMH
Description:	Manhole
Distance (ft):	237.3
Structural Grade:	0
O&M Grade:	0
Clock Start/From:	
Clock To:	
1st Value:	
2nd Value:	
Value Percent:	
Continuous Index:	
Within 8" of Joint:	NO
Remarks:	M-906-009
