Profile/Photo Observation Report

| Street: | E 9TH PL | Flow Control: | Not Controlled |
| City: | Hobart, IN | Year Renewed: | |

| US MH: | M-906-005 | DS MH: | M-906-004 |

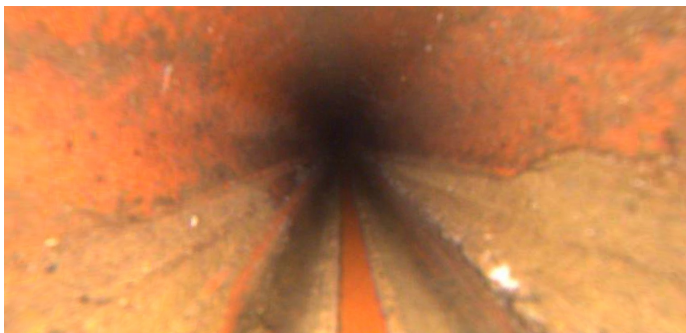
Code: **AMH**
Description: **Manhole**

Distance (ft): **.0**
Structural Grade: **0**
O&M Grade: **0**
Clock Start/From:
Clock To:
1st Value:
2nd Value:
Value Percent:
Continuous Index:
Within 8" of Joint: **NO**
Remarks: **M-906-005**

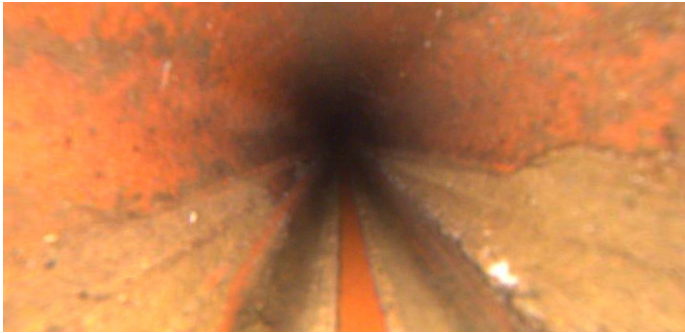
| Code: | MWL |

| Description: | Water Level |

| Distance (ft): | .0 |
| Value Percent: | 5.000 |

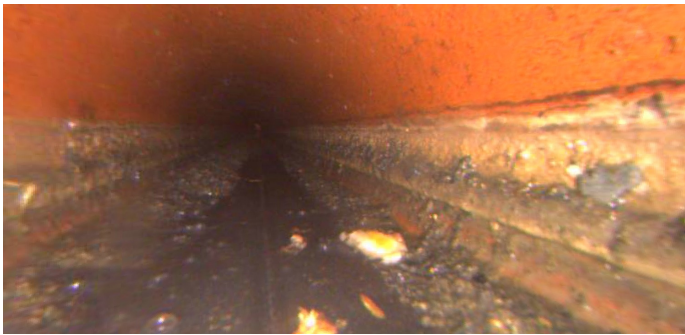
| Code: | DAGS |

| Description: | Deposits Attached Grease |

| Distance (ft): | 32.3 |
| O&M Grade: | 2 |
| Clock Start/From: | 8 |
| Clock To: | 4 |
| Value Percent: | 5.000 |

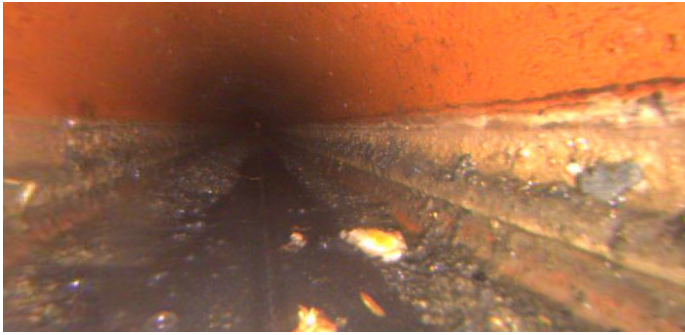
Code: **MGO**
Description: **General Observation**

Distance (ft): **32.3**
Structural Grade: **0**
O&M Grade: **0**
Clock Start/From:
Clock To:
1st Value:
2nd Value:
Value Percent:
Continuous Index:
Within 8" of Joint: **NO**
Remarks: **rear camera**

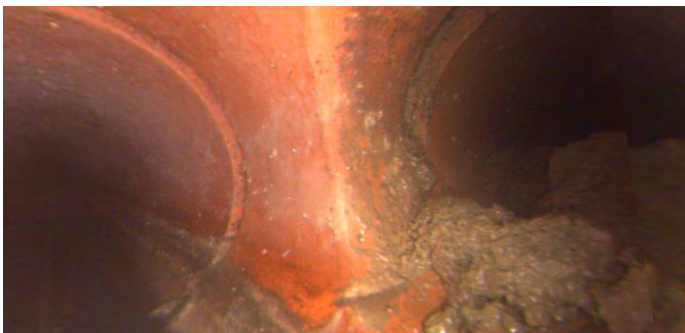
Code: **TF**
Description: **Tap Factory**

Distance (ft): **121.0**
Structural Grade: **0**
O&M Grade: **0**
Clock Start/From: **9**
Clock To:
1st Value: **4.000**
2nd Value:
Value Percent:
Continuous Index:
Within 8" of Joint:
Remarks:

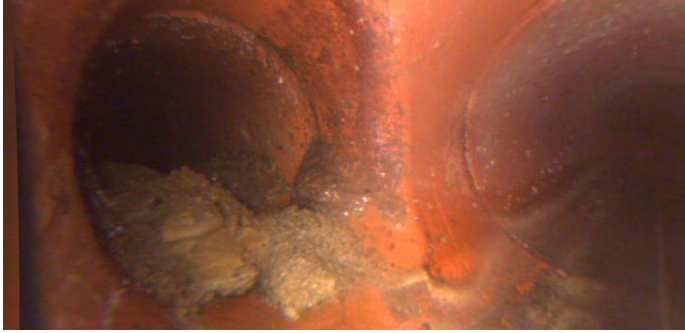
Code: **TF**
Description: **Tap Factory**

Distance (ft): **128.6**
Structural Grade: **0**
O&M Grade: **0**
Clock Start/From: **3**
Clock To:
1st Value: **4.000**
2nd Value:
Value Percent:
Continuous Index:
Within 8" of Joint:
Remarks:

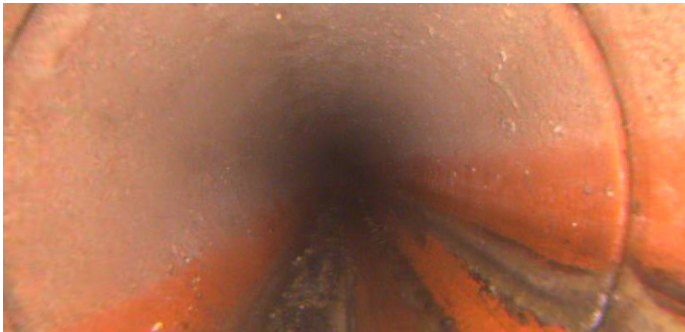
Code: **DSZ**
Description: **Deposits Settled Other**

Distance (ft): **146.7**
Structural Grade: **0**
O&M Grade: **2**
Clock Start/From: **5**
Clock To: **7**
1st Value:
2nd Value:
Value Percent: **10.000**
Continuous Index: **S02**
Within 8" of Joint: **NO**
Remarks: **soil**

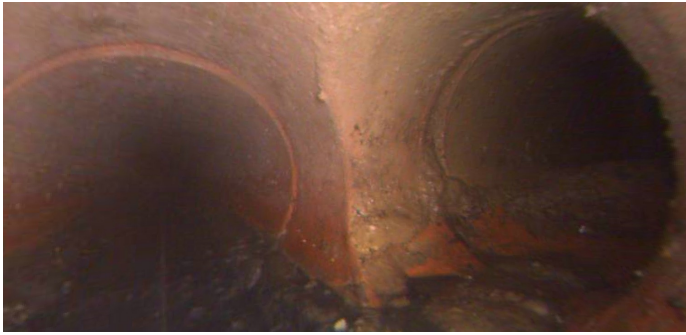
Code: **TFA**
Description: **Tap Factory Active**

Distance (ft): **234.9**
Structural Grade: **0**
O&M Grade: **0**
Clock Start/From: **9**
Clock To:
1st Value: **4.000**
2nd Value:
Value Percent:
Continuous Index:
Within 8" of Joint:
Remarks:

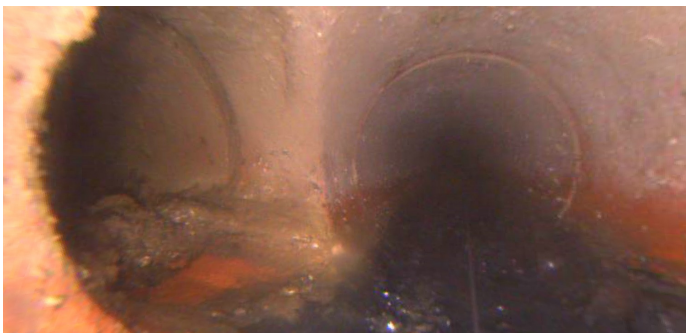
Code: **TFA**
Description: **Tap Factory Active**

Distance (ft): **242.6**
Structural Grade: **0**
O&M Grade: **0**
Clock Start/From: **3**
Clock To:
1st Value: **4.000**
2nd Value:
Value Percent:
Continuous Index:
Within 8" of Joint:
Remarks:

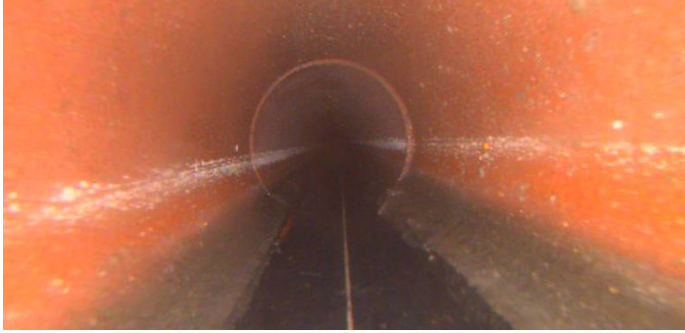
Code: **DSZ**
Description: **Deposits Settled Other**

Distance (ft): **321.7**
Structural Grade: **0**
O&M Grade: **2**
Clock Start/From: **5**
Clock To: **7**
1st Value:
2nd Value:
Value Percent: **10.000**
Continuous Index: **F02**
Within 8" of Joint: **NO**
Remarks: **soil**

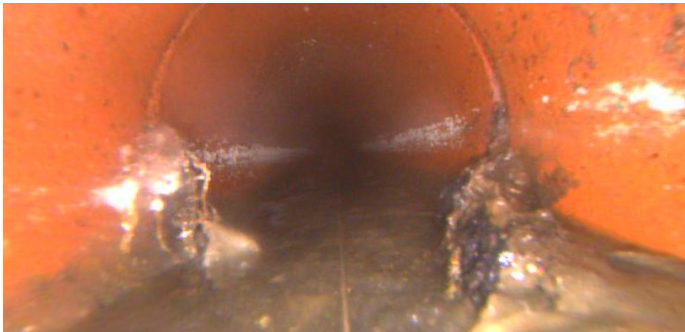
Code: **RMJ**
Description: **Roots Medium Joint**

Distance (ft): **348.7**
Structural Grade: **0**
O&M Grade: **3**
Clock Start/From: **8**
Clock To: **4**
1st Value:
2nd Value:
Value Percent: **10.000**
Continuous Index:
Within 8" of Joint: **YES**
Remarks:

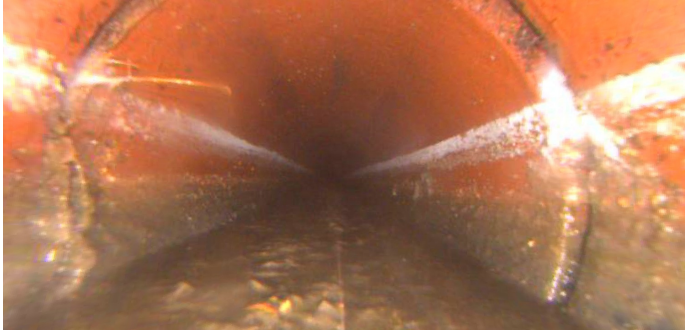
Code: **RFJ**
Description: **Roots Fine Joint**

Distance (ft): **370.7**
Structural Grade: **0**
O&M Grade: **1**
Clock Start/From: **2**
Clock To: **4**
1st Value:
2nd Value:
Value Percent:
Continuous Index:
Within 8" of Joint: **YES**
Remarks:

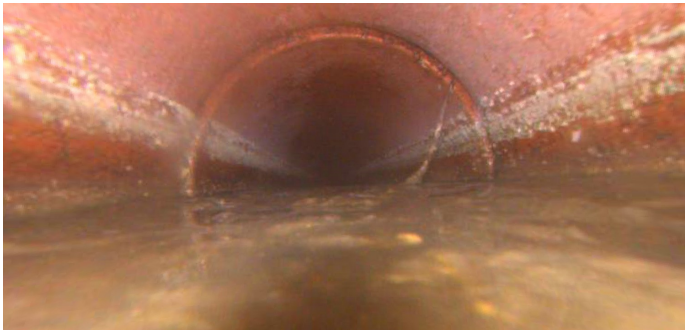
Code: **RFJ**
Description: **Roots Fine Joint**

Distance (ft): **382.2**
Structural Grade: **0**
O&M Grade: **1**
Clock Start/From: **10**
Clock To:
1st Value:
2nd Value:
Value Percent:
Continuous Index:
Within 8" of Joint: **YES**
Remarks:
