Profile/Photo Observation Report

Street:	Capitol	Flow Control:	Not Controlled
City:	Hobart, IN	Year Renewed:	
Location:	Yard	Tape/Media #:	
Purpose:	Maintenance Related	Dia/Height:	8"
Use:	Sanitary	Material:	VCP
Drain Area:	NA	Lining:	Cured in Place
Category:	NA		
Comment:

Location Details:		Direction of Survey:	Downstream
US MH:	M-906-005	DS MH:	M-906-004
		Total Length Surveyed (ft):	392.4

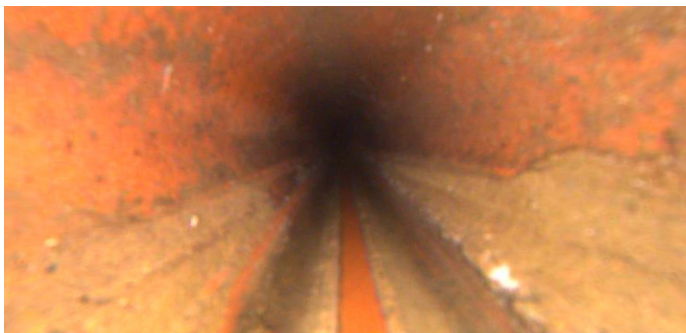
Code: **AMH**
Description: **Manhole**

Distance (ft): **.0**
Structural Grade: **0**
O&M Grade: **0**
Clock Start/From:
Clock To:
1st Value:
2nd Value:
Value Percent:
Continuous Index:
Within 8" of Joint: **NO**
Remarks: **M-906-005**

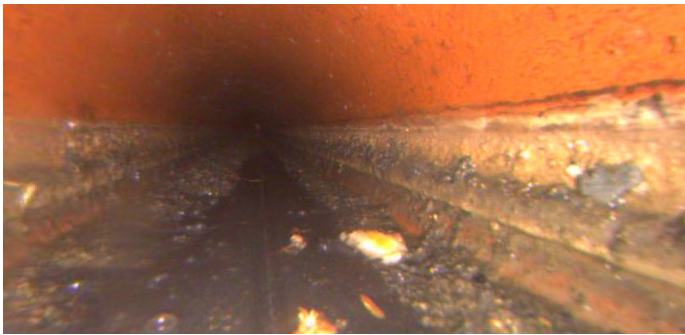
Code:	DAGS
Description:	Deposits Attached Grease

Distance (ft):	32.3
Structural Grade:	0
O&M Grade:	2
Clock Start/From:	8
Clock To:	4
1st Value:	
2nd Value:	
Value Percent:	5.000
Continuous Index:	S01
Within 8" of Joint:	NO
Remarks:

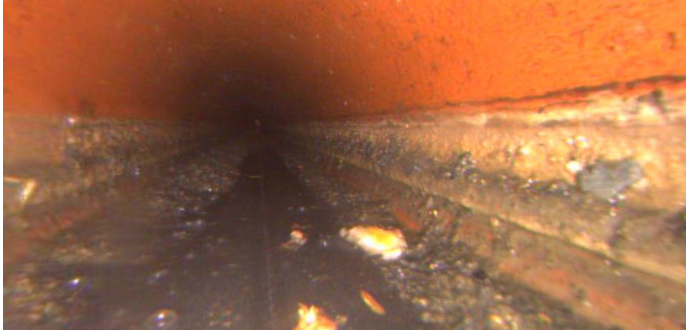
Code: **MGO**
Description: **General Observation**

Distance (ft): **32.3**
Structural Grade: **0**
O&M Grade: **0**
Clock Start/From:
Clock To:
1st Value:
2nd Value:
Value Percent:
Continuous Index:
Within 8" of Joint: **NO**
Remarks: **rear camera**

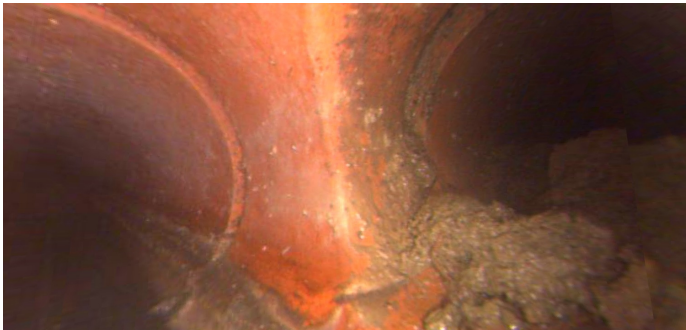
Code: **TF**
Description: **Tap Factory**

Distance (ft): **121.0**
Structural Grade: **0**
O&M Grade: **0**
Clock Start/From: **9**
Clock To:
1st Value: **4.000**
2nd Value:
Value Percent:
Continuous Index:
Within 8" of Joint:
Remarks:

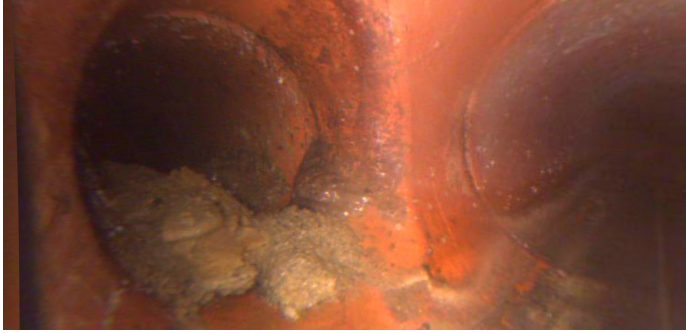
Code: **TF**
Description: **Tap Factory**

Distance (ft): **128.6**
Structural Grade: **0**
O&M Grade: **0**
Clock Start/From: **3**
Clock To:
1st Value: **4.000**
2nd Value:
Value Percent:
Continuous Index:
Within 8" of Joint:
Remarks:

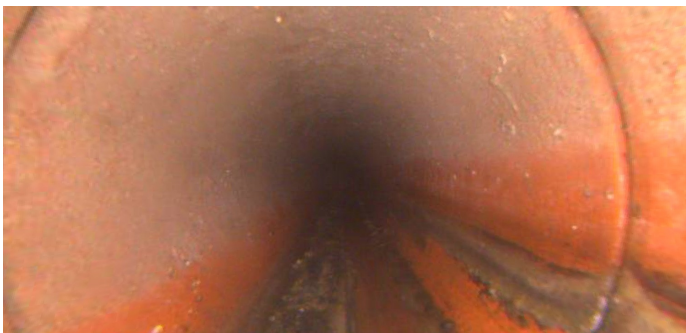
Code: **DSZ**
Description: **Deposits Settled Other**

Distance (ft): **146.7**
Structural Grade: **0**
O&M Grade: **2**
Clock Start/From: **5**
Clock To: **7**
1st Value:
2nd Value:
Value Percent: **10.000**
Continuous Index: **S02**
Within 8" of Joint: **NO**
Remarks: **soil**

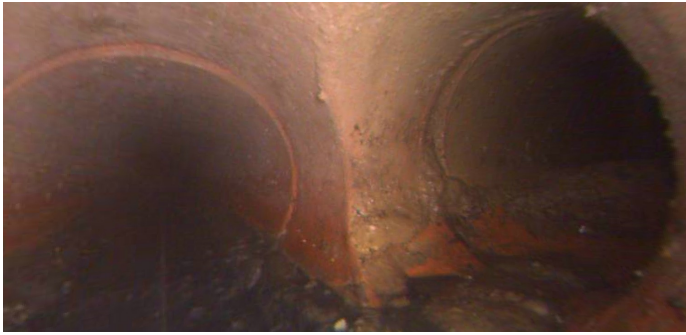
Code: **TFA**
Description: **Tap Factory Active**

Distance (ft): **234.9**
Structural Grade: **0**
O&M Grade: **0**
Clock Start/From: **9**
Clock To:
1st Value: **4.000**
2nd Value:
Value Percent:
Continuous Index:
Within 8" of Joint:
Remarks:
