## Profile/Photo Observation Report

Street:	<b>E 9TH PL</b>	Flow Control:	<b>Not Controlled</b>
City:	<b>Hobart, IN</b>	Year Renewed:	
Location:	<b>Yard</b>	Tape/Media #:	
Purpose:	<b>Maintenance Related</b>	Dia/Height:	<b>8"</b>
Use:	<b>Sanitary</b>	Material:	<b>PVC</b>
Drain Area:	<b>NA</b>	Lining:	<b>Cured in Place</b>
Category:	<b>NA</b>		
Comment:	<b>heavy black silt at 225'.-flow incorrect.</b>		
Location Details:		Direction of Survey:	<b>Downstream</b>
US MH:	<b>M-906-008</b>	DS MH:	<b>M-906-004</b>
		Total Length Surveyed (ft):	<b>226.7</b>

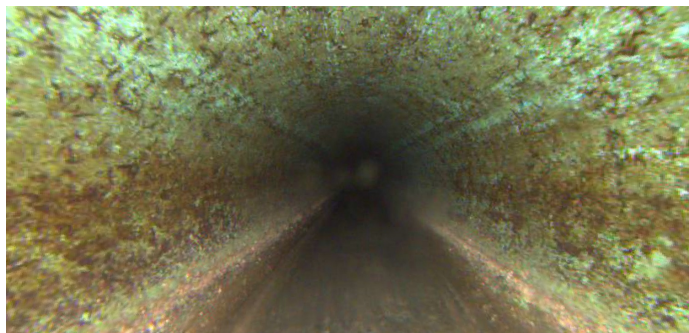
Code: **AMH**  
Description: **Manhole**

Distance (ft): **.0**  
Structural Grade: **0**  
O&M Grade: **0**  
Clock Start/From:  
Clock To:  
1st Value:  
2nd Value:  
Value Percent:  
Continuous Index:  
Within 8" of Joint: **NO**  
Remarks: **M-906-008**

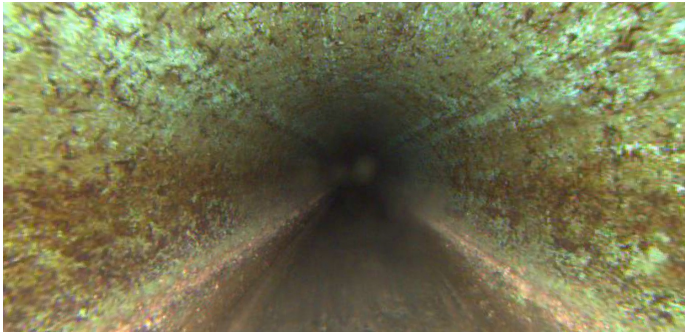
Code:	<b>MWL</b>
Description:	<b>Water Level</b>

Distance (ft):	<b>.0</b>
Structural Grade:	<b>0</b>
O&M Grade:	<b>0</b>
Clock Start/From:	
Clock To:	
1st Value:	
2nd Value:	
Value Percent:	<b>5.000</b>
Continuous Index:	
Within 8" of Joint:	<b>NO</b>
Remarks:

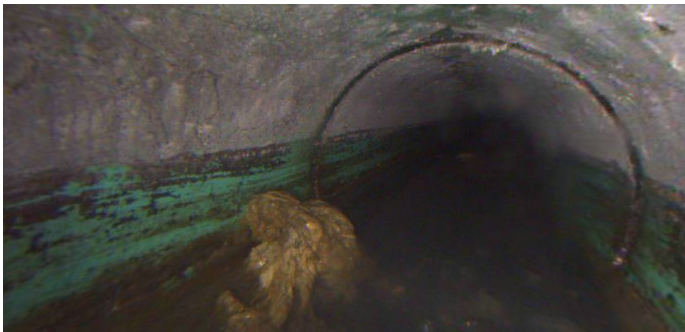
Code:	<b>DAGS</b>
Description:	<b>Deposits Attached Grease</b>

Distance (ft):	<b>208.6</b>
Structural Grade:	<b>0</b>
O&M Grade:	<b>2</b>
Clock Start/From:	<b>8</b>
Clock To:	<b>9</b>
1st Value:	
2nd Value:	
Value Percent:	<b>10.000</b>
Continuous Index:	
Within 8" of Joint:	<b>YES</b>
Remarks:

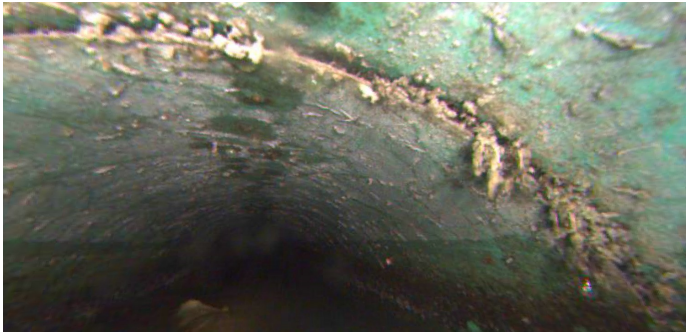
Code: **RFJ**  
Description: **Roots Fine Joint**

Distance (ft): **222.2**  
Structural Grade: **0**  
O&M Grade: **1**  
Clock Start/From: **8**  
Clock To: **4**  
1st Value:  
2nd Value:  
Value Percent:  
Continuous Index:  
Within 8" of Joint: **YES**  
Remarks:

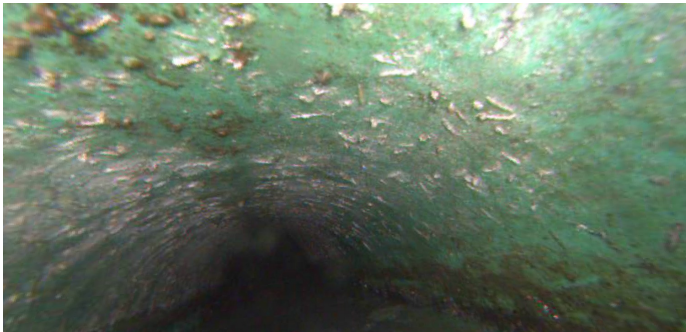
Code: **MSA**  
Description: **Abandoned Survey**

Distance (ft): **226.7**  
Structural Grade: **0**  
O&M Grade: **0**  
Clock Start/From:  
Clock To:  
1st Value:  
2nd Value:  
Value Percent:  
Continuous Index:  
Within 8" of Joint: **NO**  
Remarks: **DEBRIS UNDER WATER**
