Profile/Photo Observation Report

Date:	04/13/2018	Weather:		Coding:	PACP 6.0
Pipe Length (ft):	390.1	Owner:	NA	Pre Clean:	Not Known
P.O.#:		Surveyor:	Jen Costello	PSR:	P-906-010-001
Customer:		Clean Date:	01/01/1900	Shape:	C

Street:	E 10TH ST & DUCK CREEK CT	Flow Control:	Not Controlled
City:	Hobart, IN	Year Renewed:	
Location:	Sidewalk	Tape/Media #:	
Purpose:	Maintenance Related	Dia/Height:	8"
Use:	Sanitary	Material:	PVC
Drain Area:	NA	Lining:	Cured in Place
Category:	NA		
Comment:

Location Details:		Direction of Survey:	Upstream
US MH:	M-906-010	DS MH:	M-906-001
		Total Length Surveyed (ft):	378.6

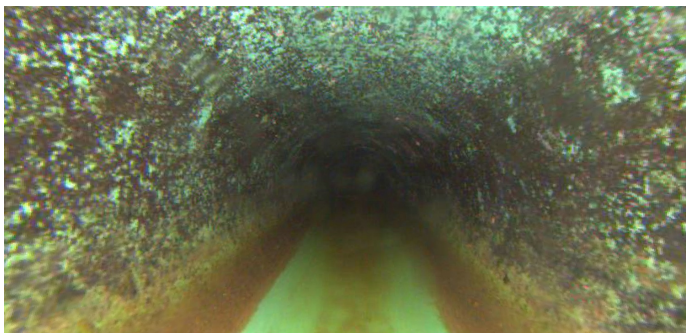
Code: **AMH**
Description: **Manhole**

Distance (ft): **.0**
Structural Grade: **0**
O&M Grade: **0**
Clock Start/From:
Clock To:
1st Value:
2nd Value:
Value Percent:
Continuous Index:
Within 8" of Joint: **NO**
Remarks: **M-906-001**

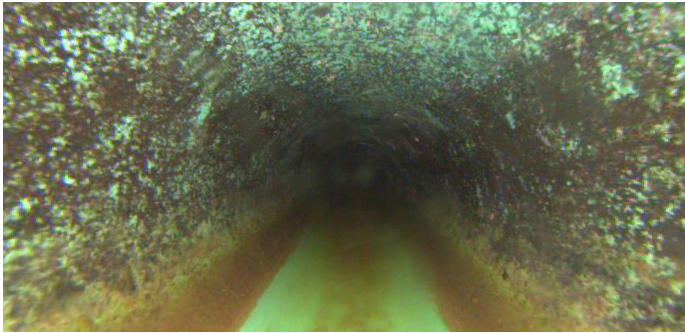
Code:	MWL
Description:	Water Level

Distance (ft):	.0
Structural Grade:	0
O&M Grade:	0
Clock Start/From:	
Clock To:	
1st Value:	
2nd Value:	
Value Percent:	5.000
Continuous Index:	
Within 8" of Joint:	NO
Remarks:

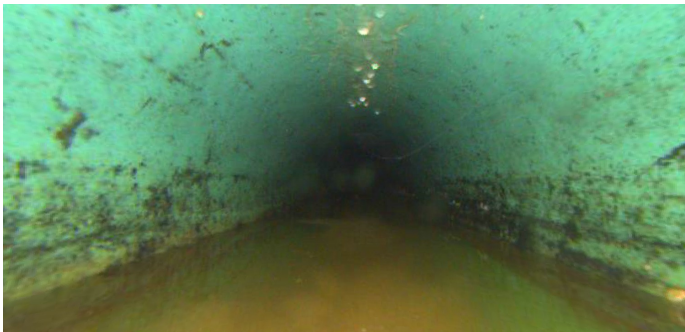
Code:	MWL
Description:	Water Level

Distance (ft):	8.8
Structural Grade:	0
O&M Grade:	0
Clock Start/From:	
Clock To:	
1st Value:	
2nd Value:	
Value Percent:	40.000
Continuous Index:	
Within 8" of Joint:	NO
Remarks:

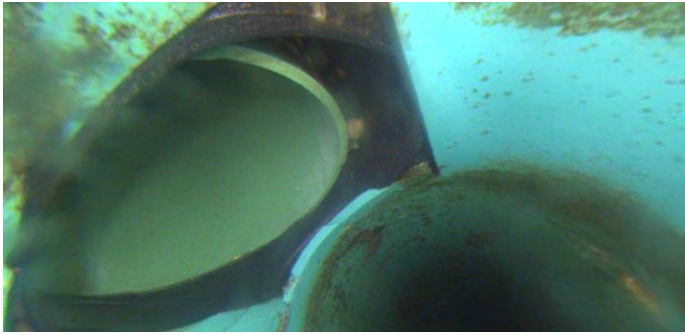
Code: **TB**
Description: **Tap Break-in**

Distance (ft): **35.8**
Structural Grade: **0**
O&M Grade: **0**
Clock Start/From: **2**
Clock To:
1st Value: **4.000**
2nd Value:
Value Percent:
Continuous Index:
Within 8" of Joint:
Remarks:

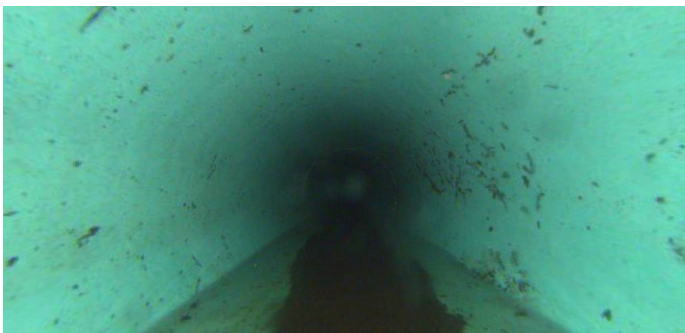
Code: **MWL**
Description: **Water Level**

Distance (ft): **89.5**
Structural Grade: **0**
O&M Grade: **0**
Clock Start/From:
Clock To:
1st Value:
2nd Value:
Value Percent: **10.000**
Continuous Index:
Within 8" of Joint: **NO**
Remarks:

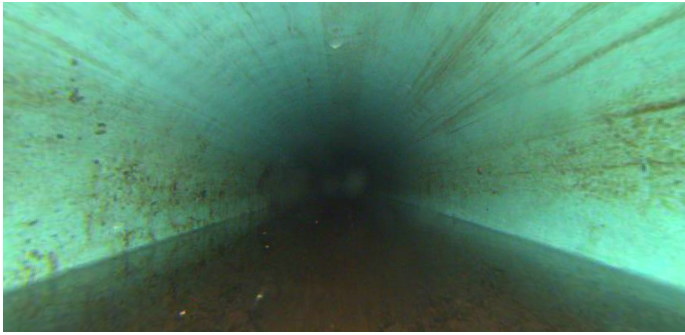
Code: **MWL**
Description: **Water Level**

Distance (ft): **171.4**
Structural Grade: **0**
O&M Grade: **0**
Clock Start/From:
Clock To:
1st Value:
2nd Value:
Value Percent: **30.000**
Continuous Index:
Within 8" of Joint: **NO**
Remarks:

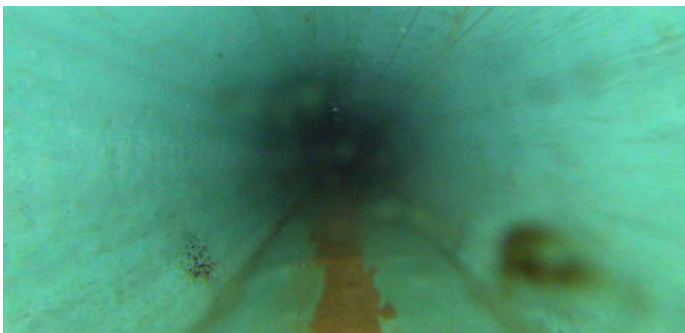
Code: **MWL**
Description: **Water Level**

Distance (ft): **224.4**
Structural Grade: **0**
O&M Grade: **0**
Clock Start/From:
Clock To:
1st Value:
2nd Value:
Value Percent: **5.000**
Continuous Index:
Within 8" of Joint: **NO**
Remarks:

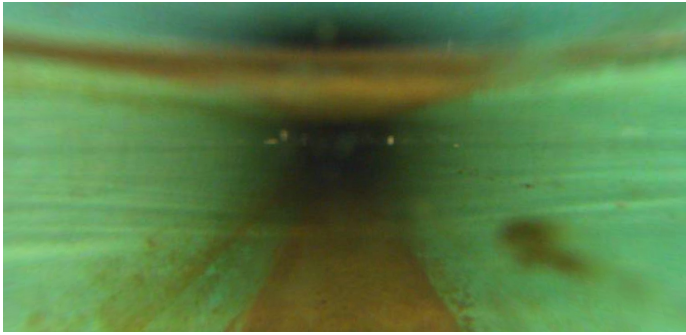
Code: **MCU**
Description: **Camera Underwater**

Distance (ft): **258.1**
Structural Grade: **0**
O&M Grade: **4**
Clock Start/From:
Clock To:
1st Value:
2nd Value:
Value Percent:
Continuous Index: **S01**
Within 8" of Joint: **NO**
Remarks:

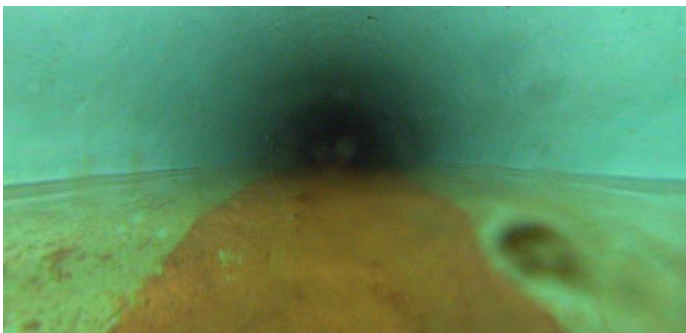
Code: **MCU**
Description: **Camera Underwater**

Distance (ft): **273.7**
Structural Grade: **0**
O&M Grade: **4**
Clock Start/From:
Clock To:
1st Value:
2nd Value:
Value Percent:
Continuous Index: **F01**
Within 8" of Joint: **NO**
Remarks:

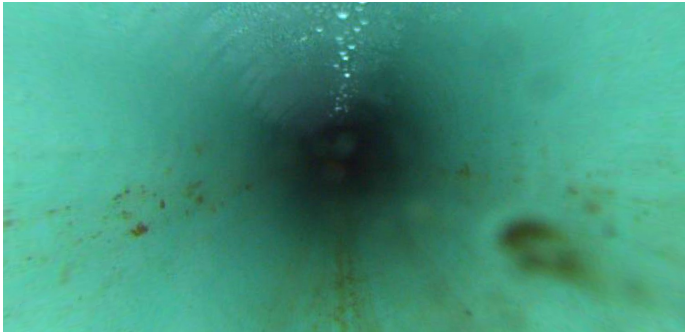
Code: **MWL**
Description: **Water Level**

Distance (ft): **284.5**
Structural Grade: **0**
O&M Grade: **0**
Clock Start/From:
Clock To:
1st Value:
2nd Value:
Value Percent: **0.000**
Continuous Index:
Within 8" of Joint: **NO**
Remarks:

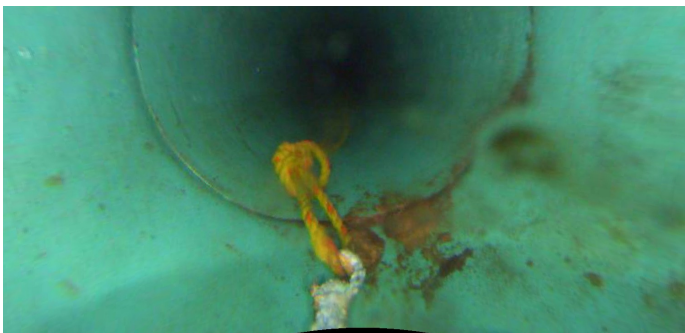
Code: **OBZ**
Description: **Obstacle Other**

Distance (ft): **287.7**
Structural Grade: **0**
O&M Grade: **2**
Clock Start/From: **6**
Clock To:
1st Value:
2nd Value:
Value Percent: **5.000**
Continuous Index:
Within 8" of Joint: **NO**
Remarks: **rope**

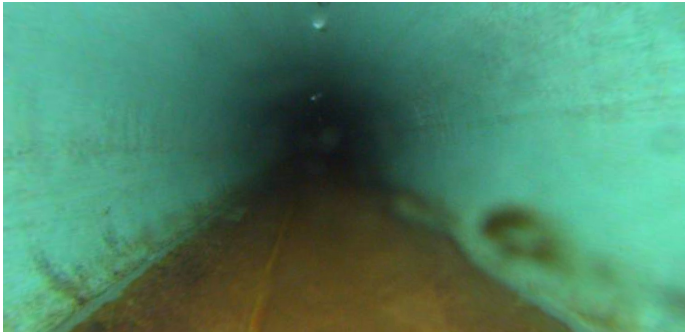
Code: **MWL**
Description: **Water Level**

Distance (ft): **345.1**
Structural Grade: **0**
O&M Grade: **0**
Clock Start/From:
Clock To:
1st Value:
2nd Value:
Value Percent: **10.000**
Continuous Index:
Within 8" of Joint: **NO**
Remarks:

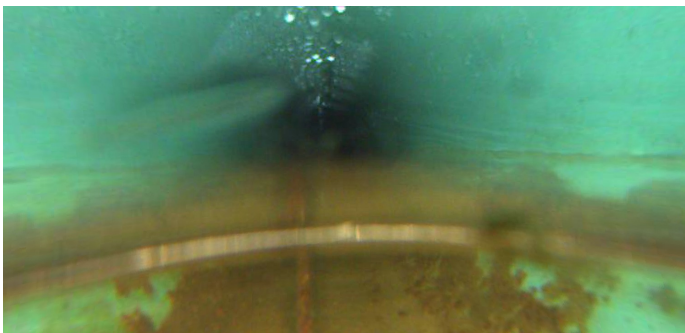
Code: **MWL**
Description: **Water Level**

Distance (ft): **357.2**
Structural Grade: **0**
O&M Grade: **0**
Clock Start/From:
Clock To:
1st Value:
2nd Value:
Value Percent: **40.000**
Continuous Index:
Within 8" of Joint: **NO**
Remarks:

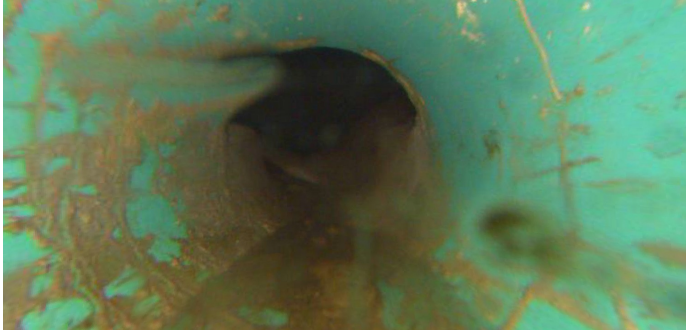
Code: **MWL**
Description: **Water Level**

Distance (ft): **375.8**
Structural Grade: **0**
O&M Grade: **0**
Clock Start/From:
Clock To:
1st Value:
2nd Value:
Value Percent: **5.000**
Continuous Index:
Within 8" of Joint: **NO**
Remarks:

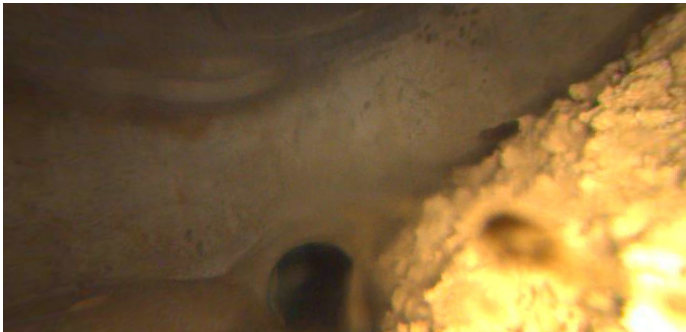
Code: **AMH**
Description: **Manhole**

Distance (ft): **378.6**
Structural Grade: **0**
O&M Grade: **0**
Clock Start/From:
Clock To:
1st Value:
2nd Value:
Value Percent:
Continuous Index:
Within 8" of Joint: **NO**
Remarks: **M-906-010**
