Profile/Photo Observation Report

Street:	E 10TH ST	Flow Control:	Not Controlled
City:	Hobart, IN	Year Renewed:	
Location:	Sidewalk	Tape/Media #:	
Purpose:	Maintenance Related	Dia/Height:	8"
Use:	Sanitary	Material:	PVC
Drain Area:	NA	Lining:	Cured in Place
Category:	NA		
Comment:

Location Details:		Direction of Survey:	Downstream
US MH:	M-906-011	DS MH:	M-906-010
		Total Length Surveyed (ft):	399.0

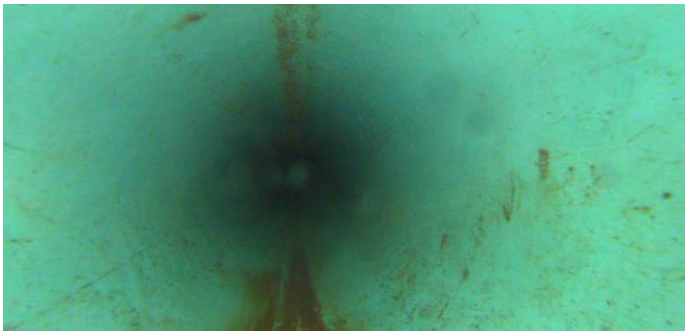
Code: **AMH**
Description: **Manhole**

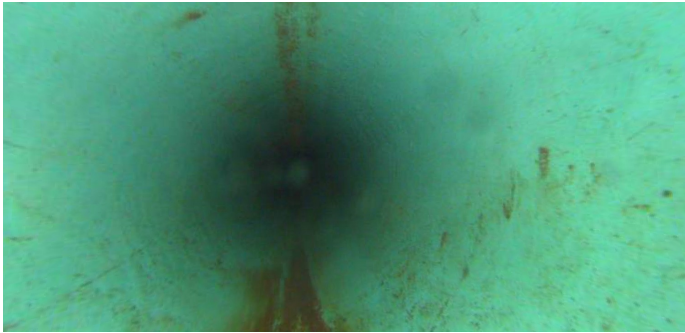
Code:	MWL
Description:	Water Level

Distance (ft):	.0
Structural Grade:	0
O&M Grade:	0
Clock Start/From:	
Clock To:	
1st Value:	
2nd Value:	
Value Percent:	5.000
Continuous Index:	
Within 8" of Joint:	NO
Remarks:

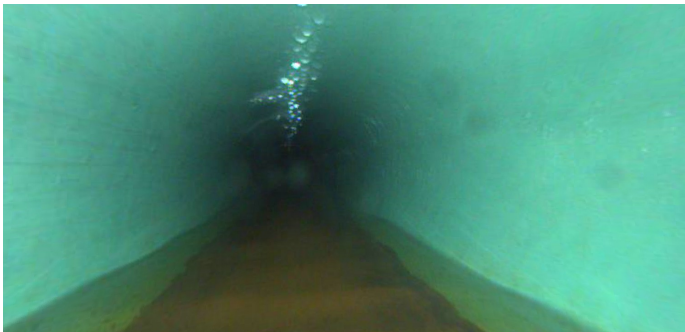
Code:	MWL
Description:	Water Level

Distance (ft):	156.5
Structural Grade:	0
O&M Grade:	0
Clock Start/From:	
Clock To:	
1st Value:	
2nd Value:	
Value Percent:	20.000
Continuous Index:	
Within 8" of Joint:	NO
Remarks:

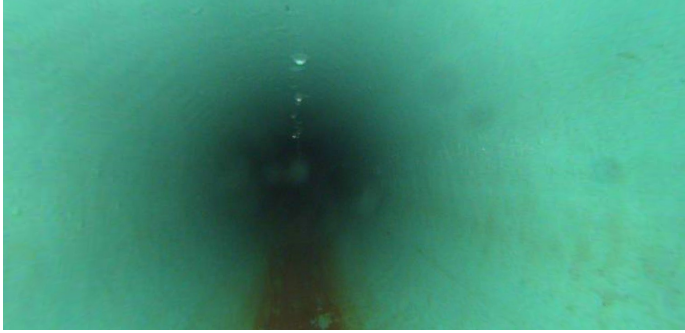
Code: **MWL**
Description: **Water Level**

Distance (ft): **163.5**
Structural Grade: **0**
O&M Grade: **0**
Clock Start/From:
Clock To:
1st Value:
2nd Value:
Value Percent: **5.000**
Continuous Index:
Within 8" of Joint: **NO**
Remarks:

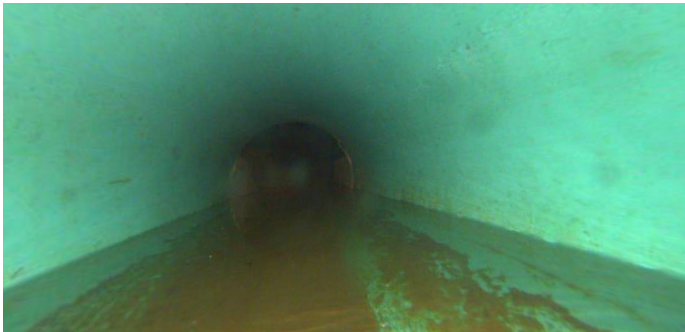
Code: **MWL**
Description: **Water Level**

Distance (ft): **395.5**
Structural Grade: **0**
O&M Grade: **0**
Clock Start/From:
Clock To:
1st Value:
2nd Value:
Value Percent: **30.000**
Continuous Index:
Within 8" of Joint: **NO**
Remarks:

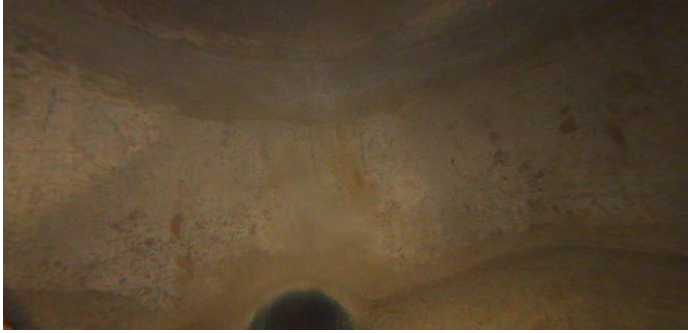
Code:	AMH
Description:	Manhole
Distance (ft):	399.0
Structural Grade:	0
O&M Grade:	0
Clock Start/From:	
Clock To:	
1st Value:	
2nd Value:	
Value Percent:	
Continuous Index:	
Within 8" of Joint:	NO
Remarks:	M-906-010
