## Profile/Photo Observation Report

Street:	<b>Capitol</b>	Flow Control:	<b>Not Controlled</b>
City:	<b>Hobart, IN</b>	Year Renewed:	
Location:	<b>Sidewalk</b>	Tape/Media #:	
Purpose:	<b>Maintenance Related</b>	Dia/Height:	<b>8"</b>
Use:	<b>Sanitary</b>	Material:	<b>PVC</b>
Drain Area:	<b>NA</b>	Lining:	<b>Cured in Place</b>
Category:	<b>NA</b>		
Comment:

Location Details:		Direction of Survey:	<b>Downstream</b>
US MH:	<b>M-906-011</b>	DS MH:	<b>M-906-010</b>
		Total Length Surveyed (ft):	<b>399.0</b>

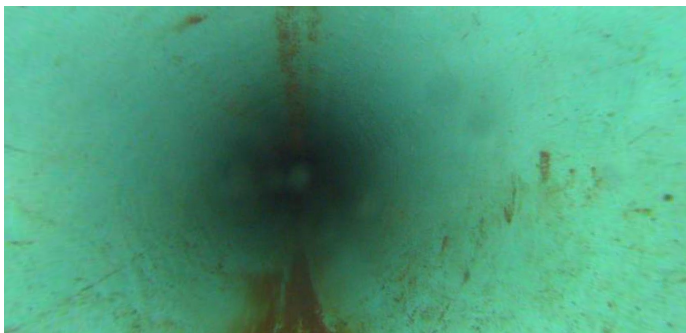
Code: **AMH**  
Description: **Manhole**

Distance (ft): **.0**  
Structural Grade: **0**  
O&M Grade: **0**  
Clock Start/From:  
Clock To:  
1st Value:  
2nd Value:  
Value Percent:  
Continuous Index:  
Within 8" of Joint: **NO**  
Remarks: **M-906-011**

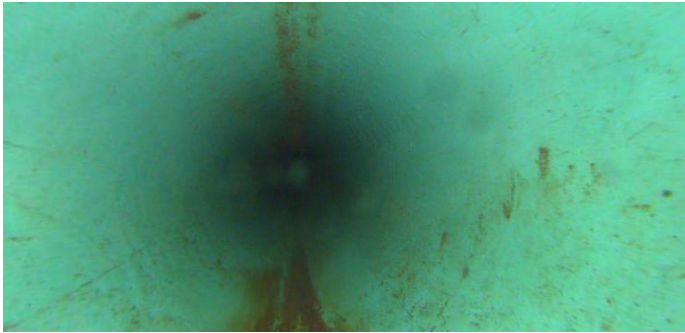
Code:	<b>MWL</b>
Description:	<b>Water Level</b>

Distance (ft):	<b>.0</b>
Structural Grade:	<b>0</b>
O&M Grade:	<b>0</b>
Clock Start/From:	
Clock To:	
1st Value:	
2nd Value:	
Value Percent:	<b>5.000</b>
Continuous Index:	
Within 8" of Joint:	<b>NO</b>
Remarks:

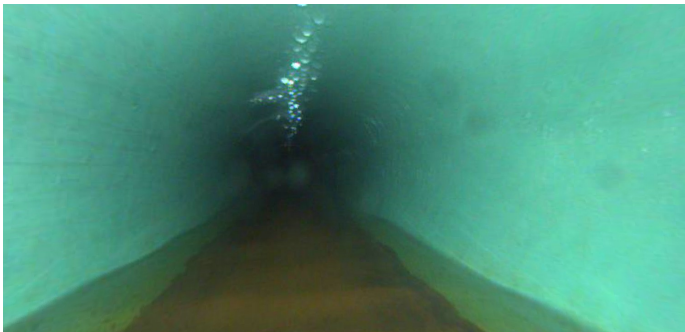
Code:	<b>MWL</b>
Description:	<b>Water Level</b>

Distance (ft):	<b>156.5</b>
Structural Grade:	<b>0</b>
O&M Grade:	<b>0</b>
Clock Start/From:	
Clock To:	
1st Value:	
2nd Value:	
Value Percent:	<b>20.000</b>
Continuous Index:	
Within 8" of Joint:	<b>NO</b>
Remarks:

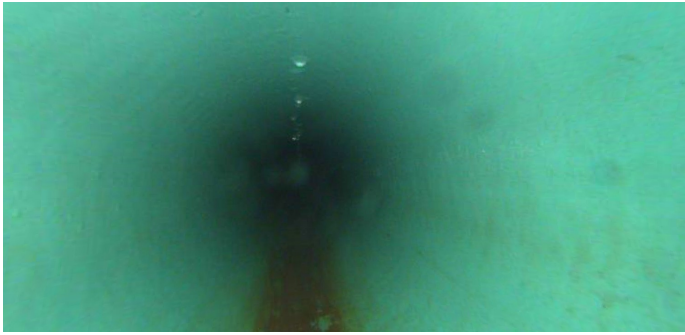
Code: **MWL**  
Description: **Water Level**

Distance (ft): **163.5**  
Structural Grade: **0**  
O&M Grade: **0**  
Clock Start/From:  
Clock To:  
1st Value:  
2nd Value:  
Value Percent: **5.000**  
Continuous Index:  
Within 8" of Joint: **NO**  
Remarks:

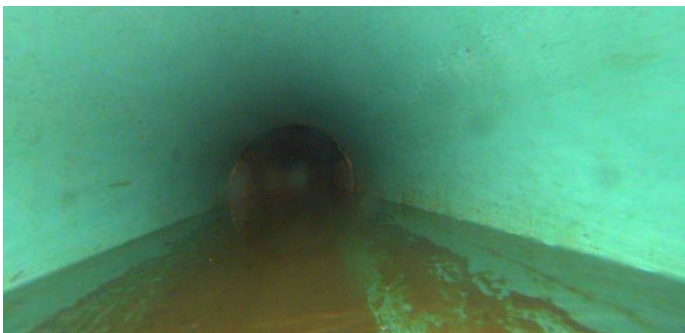
Code: **MWL**  
Description: **Water Level**

Distance (ft): **395.5**  
Structural Grade: **0**  
O&M Grade: **0**  
Clock Start/From:  
Clock To:  
1st Value:  
2nd Value:  
Value Percent: **30.000**  
Continuous Index:  
Within 8" of Joint: **NO**  
Remarks:

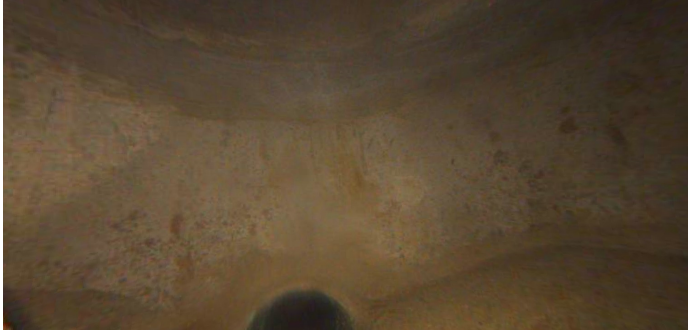
Code:	<b>AMH</b>
Description:	<b>Manhole</b>
Distance (ft):	<b>399.0</b>
Structural Grade:	<b>0</b>
O&M Grade:	<b>0</b>
Clock Start/From:	
Clock To:	
1st Value:	
2nd Value:	
Value Percent:	
Continuous Index:	
Within 8" of Joint:	<b>NO</b>
Remarks:	<b>M-906-010</b>
