Profile/Photo Observation Report

Date:	04/16/2018	Weather:		Coding:	PACP 6.0
Pipe Length (ft):	348.3	Owner:	NA	Pre Clean:	Not Known
P.O.#:		Surveyor:	Selasie Honu	PSR:	P-906-014-015
Customer:		Clean Date:	01/01/1900	Shape:	C

Street:	Capitol	Flow Control:	Not Controlled
City:	Hobart, IN	Year Renewed:	
Location:	Sidewalk	Tape/Media #:	
Purpose:	Maintenance Related	Dia/Height:	12"
Use:	Sanitary	Material:	PVC
Drain Area:	NA	Lining:	Cured in Place
Category:	NA		
Comment:

Location Details:		Direction of Survey:	Downstream
US MH:	M-906-014	DS MH:	M-906-015
		Total Length Surveyed (ft):	358.2

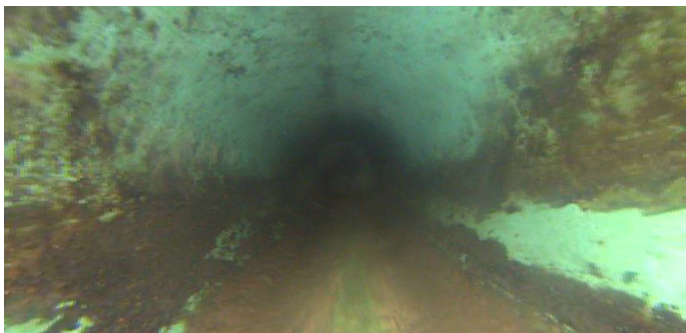
Code: **AMH**
Description: **Manhole**

Distance (ft): **.0**
Structural Grade: **0**
O&M Grade: **0**
Clock Start/From:
Clock To:
1st Value:
2nd Value:
Value Percent:
Continuous Index:
Within 8" of Joint: **NO**
Remarks: **M-906-014**

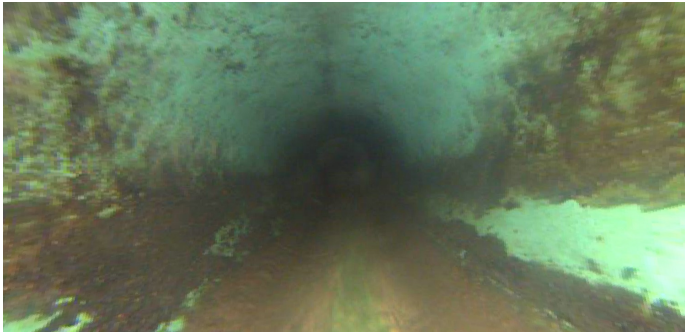
Code:	MWL
Description:	Water Level

Distance (ft):	.0
Structural Grade:	0
O&M Grade:	0
Clock Start/From:	
Clock To:	
1st Value:	
2nd Value:	
Value Percent:	5.000
Continuous Index:	
Within 8" of Joint:	NO
Remarks:

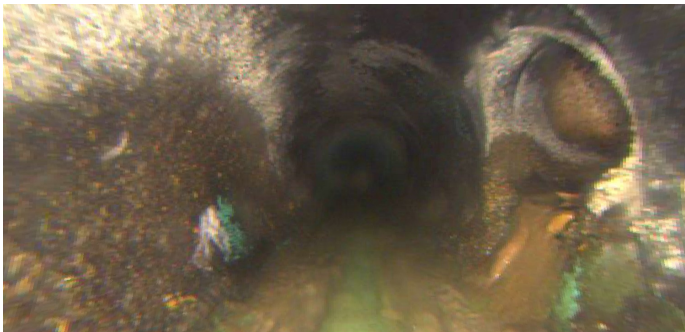
Code:	TF
Description:	Tap Factory

Distance (ft):	227.6
Structural Grade:	0
O&M Grade:	0
Clock Start/From:	3
Clock To:	
1st Value:	4.000
2nd Value:	
Value Percent:	
Continuous Index:	
Within 8" of Joint:	
Remarks:

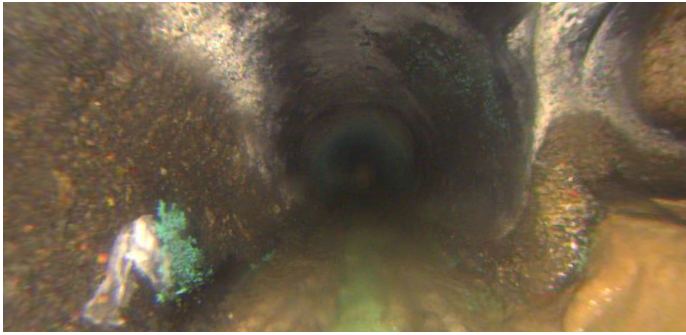
Code: **DAGS**
Description: **Deposits Attached Grease**

Distance (ft): **227.9**
Structural Grade: **0**
O&M Grade: **2**
Clock Start/From: **8**
Clock To: **4**
1st Value:
2nd Value:
Value Percent: **5.000**
Continuous Index:
Within 8" of Joint: **NO**
Remarks:

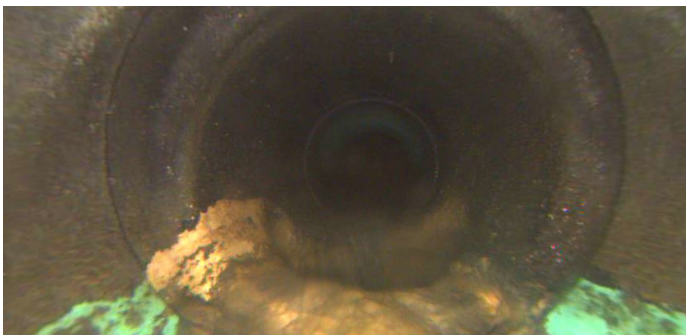
Code: **TF**
Description: **Tap Factory**

Distance (ft): **345.1**
Structural Grade: **0**
O&M Grade: **0**
Clock Start/From: **6**
Clock To:
1st Value: **6.000**
2nd Value:
Value Percent:
Continuous Index:
Within 8" of Joint:
Remarks: **DROP**

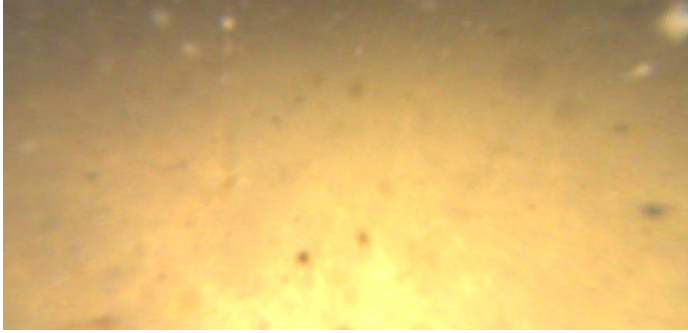
Code:	AMH
Description:	Manhole
Distance (ft):	358.2
Structural Grade:	0
O&M Grade:	0
Clock Start/From:	
Clock To:	
1st Value:	
2nd Value:	
Value Percent:	
Continuous Index:	
Within 8" of Joint:	NO
Remarks:	M-906-015
