Profile/Photo Observation Report

Street:	OFF E 10TH ST	Flow Control:	Not Controlled
City:	Hobart, IN	Year Renewed:	
Location:	Yard	Tape/Media #:	
Purpose:	Maintenance Related	Dia/Height:	8"
Use:	Sanitary	Material:	PVC
Drain Area:	NA	Lining:	Cured in Place
Category:	NA		
Comment:	flow incorrect.

Location Details:		Direction of Survey:	Upstream
US MH:	M-906-017	DS MH:	M-1006-002
		Total Length Surveyed (ft):	260.5

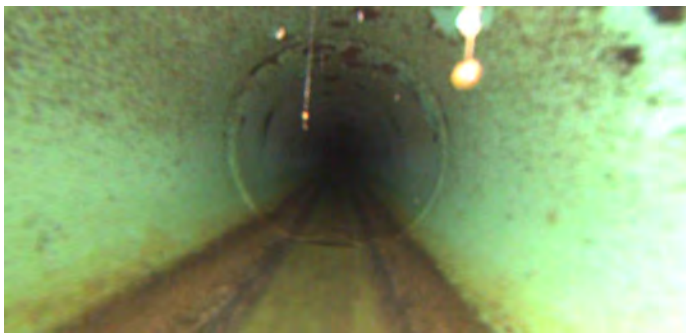
Code: **AMH**
Description: **Manhole**

Distance (ft): **.0**
Structural Grade: **0**
O&M Grade: **0**
Clock Start/From:
Clock To:
1st Value:
2nd Value:
Value Percent:
Continuous Index:
Within 8" of Joint: **NO**
Remarks: **M-1006-002**

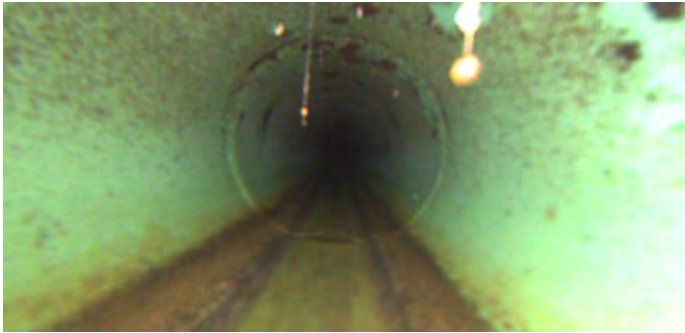
Code:	MWL
Description:	Water Level

Distance (ft):	.0
Structural Grade:	0
O&M Grade:	0
Clock Start/From:	
Clock To:	
1st Value:	
2nd Value:	
Value Percent:	5.000
Continuous Index:	
Within 8" of Joint:	NO
Remarks:

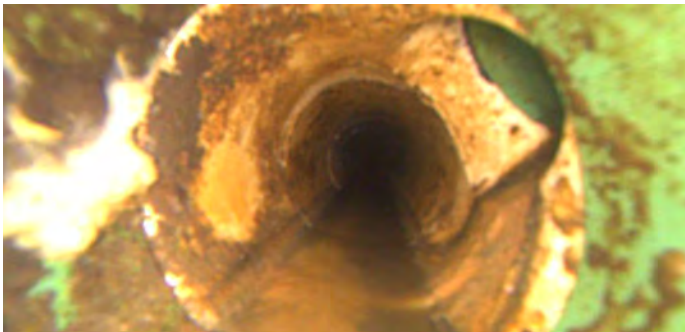
Code:	DAGS
Description:	Deposits Attached Grease

Distance (ft):	22.7
Structural Grade:	0
O&M Grade:	2
Clock Start/From:	8
Clock To:	4
1st Value:	
2nd Value:	
Value Percent:	5.000
Continuous Index:	
Within 8" of Joint:	NO
Remarks:

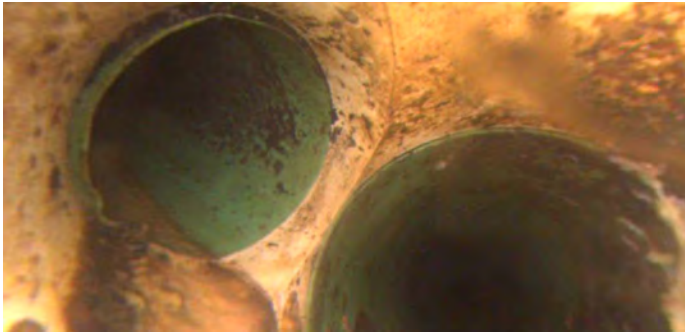
Code: **TF**
Description: **Tap Factory**

Distance (ft): **23.8**
Structural Grade: **0**
O&M Grade: **0**
Clock Start/From: **2**
Clock To:
1st Value: **4.000**
2nd Value:
Value Percent:
Continuous Index:
Within 8" of Joint:
Remarks:

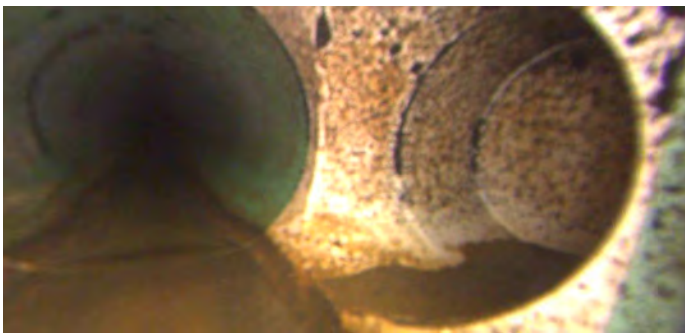
Code: **TFC**
Description: **Tap Factory Capped**

Distance (ft): **117.6**
Structural Grade: **0**
O&M Grade: **0**
Clock Start/From: **3**
Clock To:
1st Value: **4.000**
2nd Value:
Value Percent:
Continuous Index:
Within 8" of Joint:
Remarks:

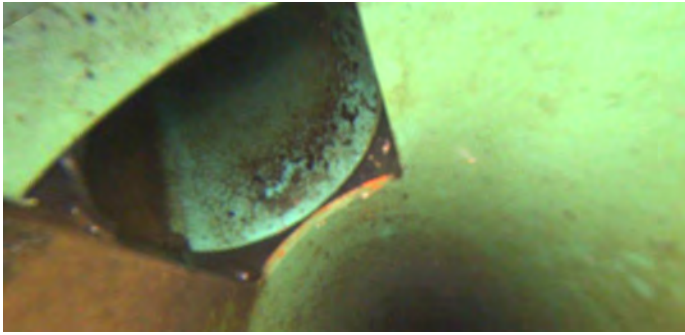
Code: **TB**
Description: **Tap Break-in**

Distance (ft): **132.2**
Structural Grade: **0**
O&M Grade: **0**
Clock Start/From: **11**
Clock To:
1st Value: **4.000**
2nd Value:
Value Percent:
Continuous Index:
Within 8" of Joint:
Remarks:

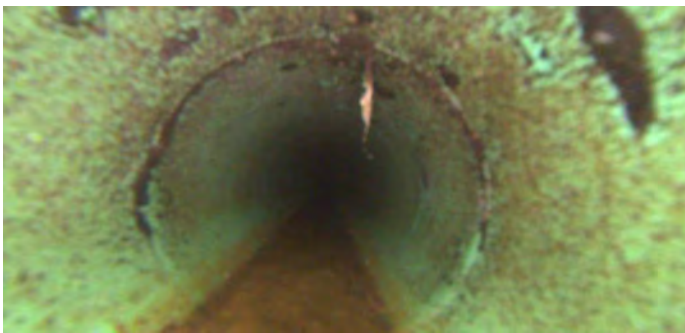
Code: **RFJ**
Description: **Roots Fine Joint**

Distance (ft): **181.7**
Structural Grade: **0**
O&M Grade: **1**
Clock Start/From: **12**
Clock To:
1st Value:
2nd Value:
Value Percent:
Continuous Index:
Within 8" of Joint: **YES**
Remarks:

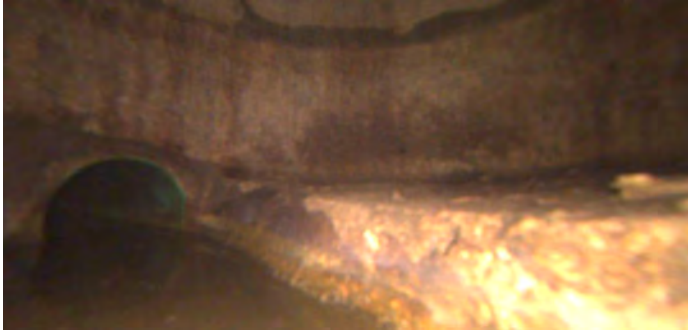
Code:	AMH
Description:	Manhole
Distance (ft):	260.5
Structural Grade:	0
O&M Grade:	0
Clock Start/From:	
Clock To:	
1st Value:	
2nd Value:	
Value Percent:	
Continuous Index:	
Within 8" of Joint:	NO
Remarks:	M-906-017
