Profile/Photo Observation Report

Date:	04/12/2018	Weather:		Coding:	PACP 6.0
Pipe Length (ft):	296.8	Owner:	NA	Pre Clean:	Not Known
P.O.#:		Surveyor:	Jen Costello	PSR:	P-1006-002-017
Customer:		Clean Date:	01/01/1900	Shape:	C

Street:	Capitol	Flow Control:	Not Controlled
City:	Hobart, IN	Year Renewed:	
Location:	Yard	Tape/Media #:	
Purpose:	Maintenance Related	Dia/Height:	8"
Use:	Sanitary	Material:	PVC
Drain Area:	NA	Lining:	Cured in Place
Category:	NA		
Comment:	flow incorrect.

Location Details:		Direction of Survey:	Upstream
US MH:	M-906-017	DS MH:	M-1006-002
		Total Length Surveyed (ft):	260.5

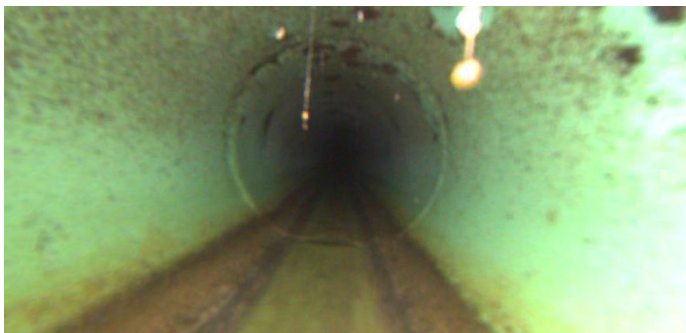
Code: **AMH**
Description: **Manhole**

Distance (ft): **.0**
Structural Grade: **0**
O&M Grade: **0**
Clock Start/From:
Clock To:
1st Value:
2nd Value:
Value Percent:
Continuous Index:
Within 8" of Joint: **NO**
Remarks: **M-1006-002**

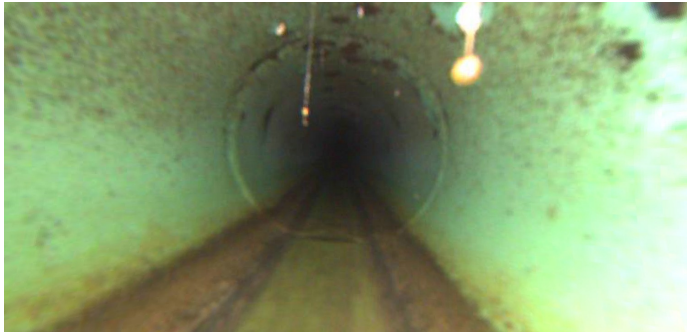
Code: **MWL**
Description: **Water Level**

Distance (ft): **.0**
Structural Grade: **0**
O&M Grade: **0**
Clock Start/From:
Clock To:
1st Value:
2nd Value:
Value Percent: **5.000**
Continuous Index:
Within 8" of Joint: **NO**
Remarks:

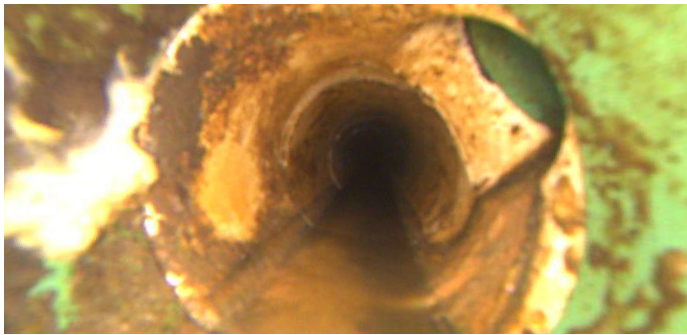
Code: **DAGS**
Description: **Deposits Attached Grease**

Distance (ft): **22.7**
Structural Grade: **0**
O&M Grade: **2**
Clock Start/From: **8**
Clock To: **4**
1st Value:
2nd Value:
Value Percent: **5.000**
Continuous Index:
Within 8" of Joint: **NO**
Remarks:

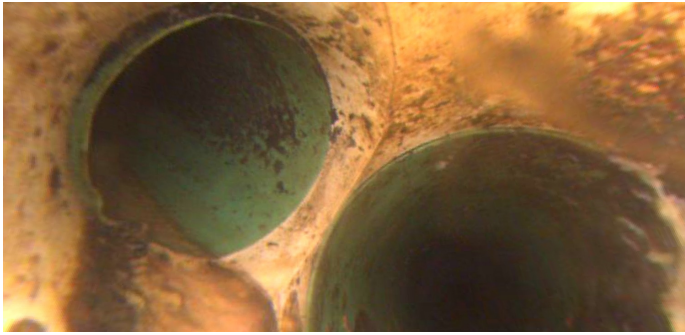
Code: **TF**
Description: **Tap Factory**

Distance (ft): **23.8**
Structural Grade: **0**
O&M Grade: **0**
Clock Start/From: **2**
Clock To:
1st Value: **4.000**
2nd Value:
Value Percent:
Continuous Index:
Within 8" of Joint:
Remarks:

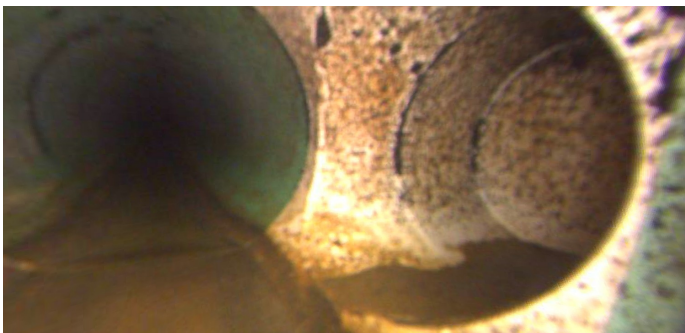
Code: **TFC**
Description: **Tap Factory Capped**

Distance (ft): **117.6**
Structural Grade: **0**
O&M Grade: **0**
Clock Start/From: **3**
Clock To:
1st Value: **4.000**
2nd Value:
Value Percent:
Continuous Index:
Within 8" of Joint:
Remarks:

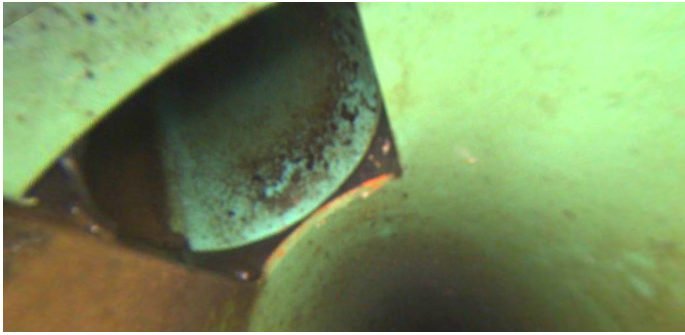
Code: **TB**
Description: **Tap Break-in**

Distance (ft): **132.2**
Structural Grade: **0**
O&M Grade: **0**
Clock Start/From: **11**
Clock To:
1st Value: **4.000**
2nd Value:
Value Percent:
Continuous Index:
Within 8" of Joint:
Remarks:

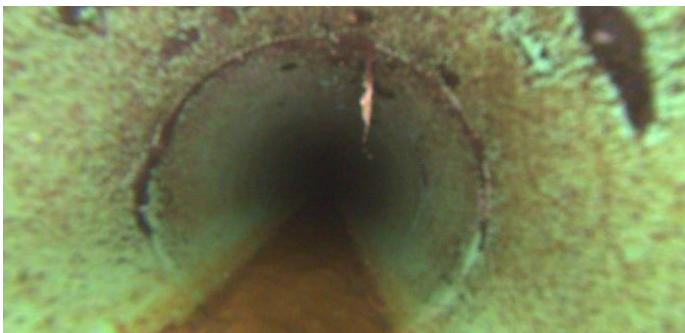
Code: **RFJ**
Description: **Roots Fine Joint**

Distance (ft): **181.7**
Structural Grade: **0**
O&M Grade: **1**
Clock Start/From: **12**
Clock To:
1st Value:
2nd Value:
Value Percent:
Continuous Index:
Within 8" of Joint: **YES**
Remarks:

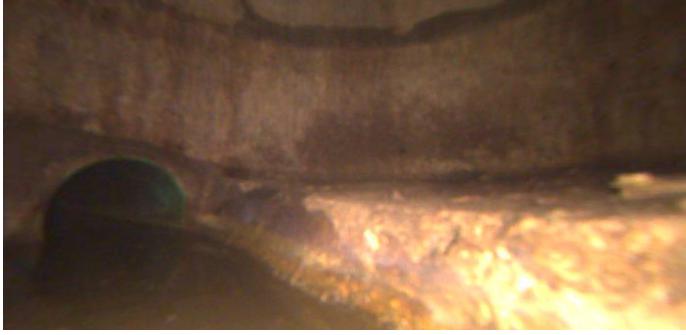
Code:	AMH
Description:	Manhole
Distance (ft):	260.5
Structural Grade:	0
O&M Grade:	0
Clock Start/From:	
Clock To:	
1st Value:	
2nd Value:	
Value Percent:	
Continuous Index:	
Within 8" of Joint:	NO
Remarks:	M-906-017
