Profile/Photo Observation Report

Date:	04/11/2018	Weather:		Coding:	PACP 6.0
Pipe Length (ft):	399.4	Owner:	NA	Pre Clean:	Not Known
P.O.#:		Surveyor:	Jen Costello	PSR:	P-907-007-001
Customer:		Clean Date:	01/01/1900	Shape:	C

Street:	S HOBART RD	Flow Control:	Not Controlled
City:	Hobart, IN	Year Renewed:	
Location:	Ditch	Tape/Media #:	
Purpose:	Maintenance Related	Dia/Height:	12"
Use:	Sanitary	Material:	PVC
Drain Area:	NA	Lining:	Cured in Place
Category:	NA		
Comment:	Reverse setup-flow incorrect. sidewall silt at 23'.		
Location Details:		Direction of Survey:	Upstream
US MH:	M-907-001	DS MH:	M-907-007
		Total Length Surveyed (ft):	24.1

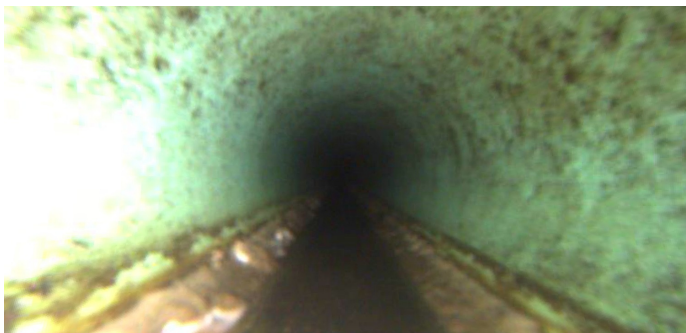
Code: **AMH**
Description: **Manhole**

Distance (ft): **.0**
Structural Grade: **0**
O&M Grade: **0**
Clock Start/From:
Clock To:
1st Value:
2nd Value:
Value Percent:
Continuous Index:
Within 8" of Joint: **NO**
Remarks: **M-907-007**

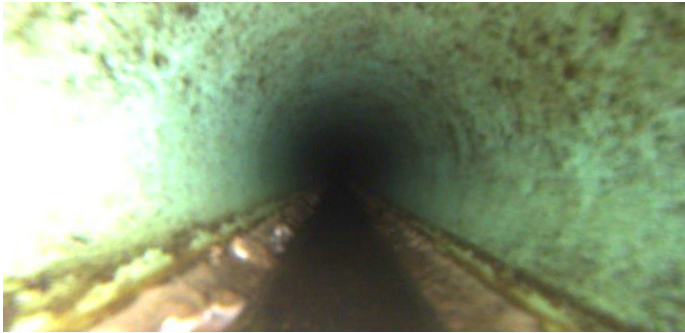
Code:	MWL
Description:	Water Level

Distance (ft):	.0
Structural Grade:	0
O&M Grade:	0
Clock Start/From:	
Clock To:	
1st Value:	
2nd Value:	
Value Percent:	10.000
Continuous Index:	
Within 8" of Joint:	NO
Remarks:

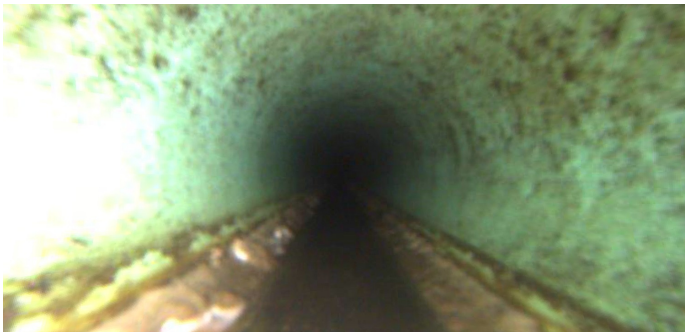
Code:	DAGS
Description:	Deposits Attached Grease

Distance (ft):	.0
Structural Grade:	0
O&M Grade:	2
Clock Start/From:	4
Clock To:	8
1st Value:	
2nd Value:	
Value Percent:	5.000
Continuous Index:	S01
Within 8" of Joint:	NO
Remarks:

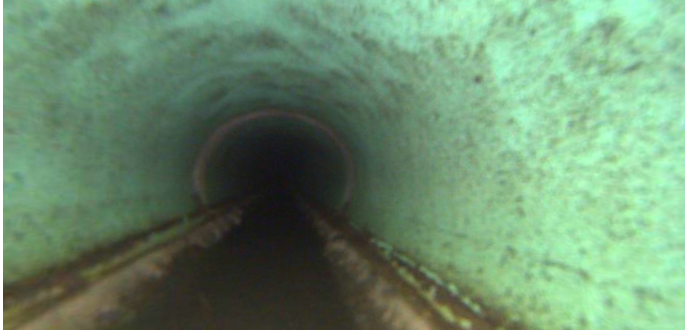
Code: **DAGS**
Description: **Deposits Attached Grease**

Distance (ft): **24.1**
Structural Grade: **0**
O&M Grade: **2**
Clock Start/From: **4**
Clock To: **8**
1st Value:
2nd Value:
Value Percent: **5.000**
Continuous Index: **F01**
Within 8" of Joint: **NO**
Remarks:

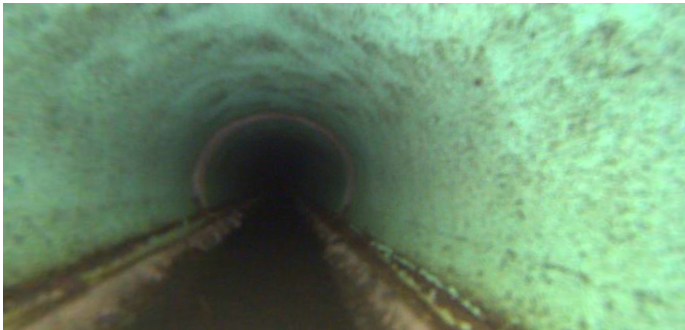
Code: **MSA**
Description: **Abandoned Survey**

Distance (ft): **24.1**
Structural Grade: **0**
O&M Grade: **0**
Clock Start/From:
Clock To:
1st Value:
2nd Value:
Value Percent:
Continuous Index:
Within 8" of Joint: **NO**
Remarks: **UNKNOWN**
