Profile/Photo Observation Report

Street:	Capitol	Flow Control:	Not Controlled
City:	Hobart, IN	Year Renewed:	
Location:	Ditch	Tape/Media #:	
Purpose:	Maintenance Related	Dia/Height:	12"
Use:	Sanitary	Material:	PVC
Drain Area:	NA	Lining:	Cured in Place
Category:	NA		
Comment:	Reverse setup-flow incorrect. sidewall silt at 23'.		
Location Details:		Direction of Survey:	Upstream
US MH:	M-907-001	DS MH:	M-907-007
		Total Length Surveyed (ft):	24.1

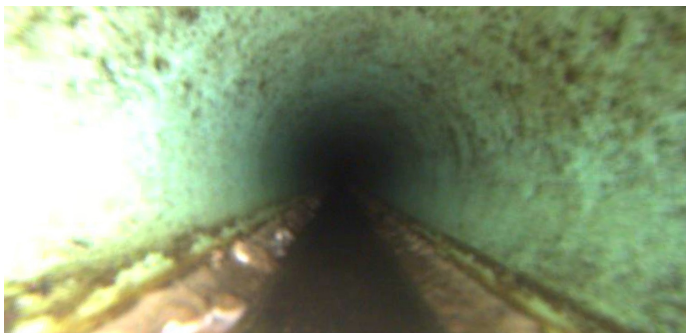
Code: **AMH**
Description: **Manhole**

Distance (ft): **.0**
Structural Grade: **0**
O&M Grade: **0**
Clock Start/From:
Clock To:
1st Value:
2nd Value:
Value Percent:
Continuous Index:
Within 8" of Joint: **NO**
Remarks: **M-907-007**

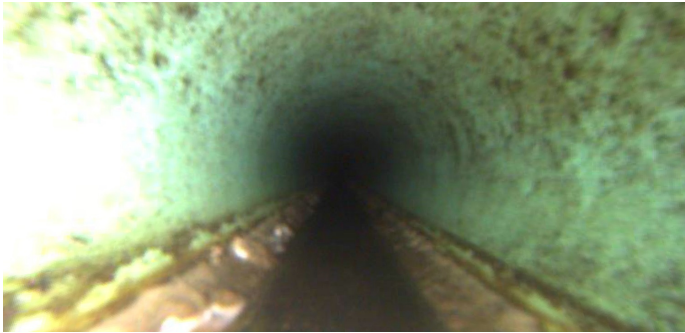
Code:	MWL
Description:	Water Level

Distance (ft):	.0
Structural Grade:	0
O&M Grade:	0
Clock Start/From:	
Clock To:	
1st Value:	
2nd Value:	
Value Percent:	10.000
Continuous Index:	
Within 8" of Joint:	NO
Remarks:

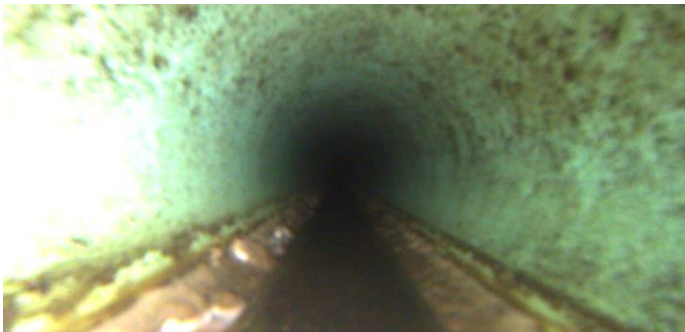
Code:	DAGS
Description:	Deposits Attached Grease

Distance (ft):	.0
Structural Grade:	0
O&M Grade:	2
Clock Start/From:	4
Clock To:	8
1st Value:	
2nd Value:	
Value Percent:	5.000
Continuous Index:	S01
Within 8" of Joint:	NO
Remarks:

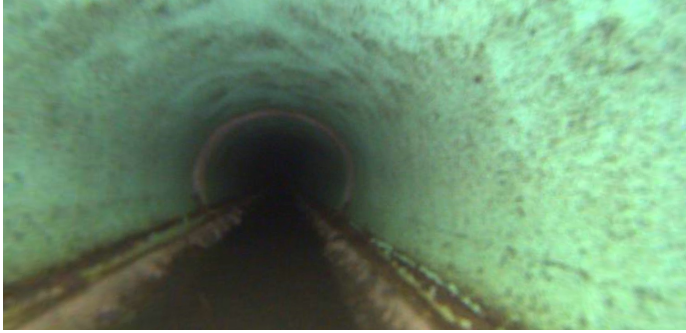
Code: **DAGS**
Description: **Deposits Attached Grease**

Distance (ft): **24.1**
Structural Grade: **0**
O&M Grade: **2**
Clock Start/From: **4**
Clock To: **8**
1st Value:
2nd Value:
Value Percent: **5.000**
Continuous Index: **F01**
Within 8" of Joint: **NO**
Remarks:

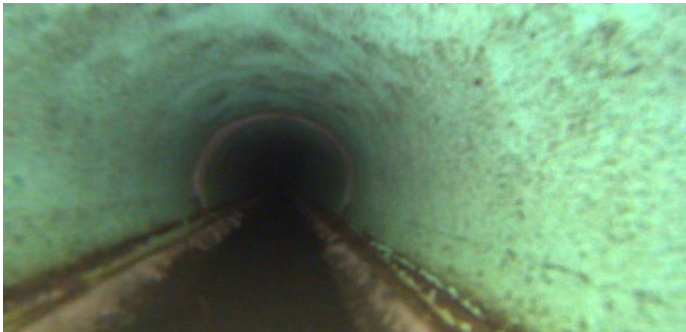
Code: **MSA**
Description: **Abandoned Survey**

Distance (ft): **24.1**
Structural Grade: **0**
O&M Grade: **0**
Clock Start/From:
Clock To:
1st Value:
2nd Value:
Value Percent:
Continuous Index:
Within 8" of Joint: **NO**
Remarks: **UNKNOWN**
