Profile/Photo Observation Report

Date:	04/11/2018	Weather:		Coding:	PACP 6.0
Pipe Length (ft):	210.7	Owner:	NA	Pre Clean:	Not Known
P.O.#:		Surveyor:	Jen Costello	PSR:	P-907-002-003
Customer:		Clean Date:	01/01/1900	Shape:	C

Street:	Capitol	Flow Control:	Not Controlled
City:	Hobart, IN	Year Renewed:	
Location:	Light Highway	Tape/Media #:	
Purpose:	Maintenance Related	Dia/Height:	12"
Use:	Sanitary	Material:	PVC
Drain Area:	NA	Lining:	Cured in Place
Category:	NA		
Comment:	flow incorrect.

Location Details:		Direction of Survey:	Downstream
US MH:	M-907-003	DS MH:	M-907-002
		Total Length Surveyed (ft):	203.5

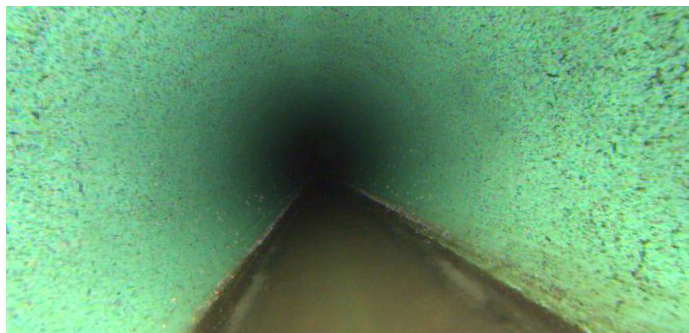
Code: **AMH**
 Description: **Manhole**
 Distance (ft): **.0**
 Structural Grade: **0**
 O&M Grade: **0**
 Clock Start/From:
 Clock To:
 1st Value:
 2nd Value:
 Value Percent:
 Continuous Index:
 Within 8" of Joint: **NO**
 Remarks: **M-907-003**

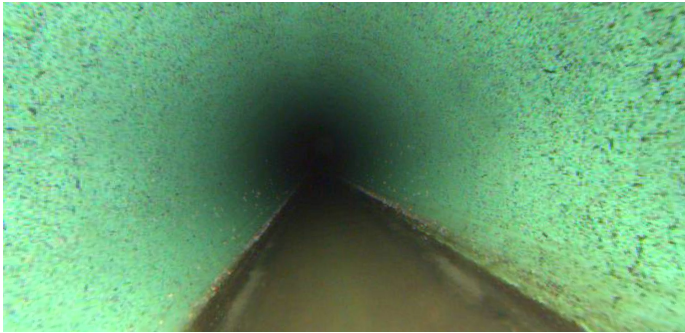
Code:	MWL
Description:	Water Level

Distance (ft):	.0
Structural Grade:	0
O&M Grade:	0
Clock Start/From:	
Clock To:	
1st Value:	
2nd Value:	
Value Percent:	10.000
Continuous Index:	
Within 8" of Joint:	NO
Remarks:

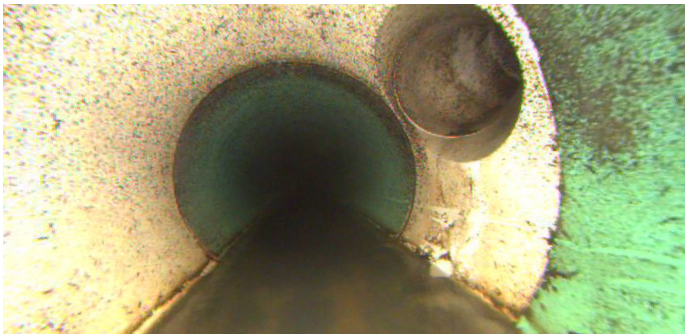
Code:	TF
Description:	Tap Factory

Distance (ft):	100.1
Structural Grade:	0
O&M Grade:	0
Clock Start/From:	2
Clock To:	
1st Value:	4.000
2nd Value:	
Value Percent:	
Continuous Index:	
Within 8" of Joint:	
Remarks:

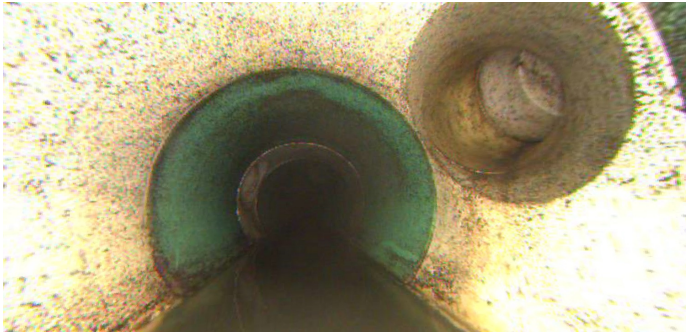
Code: **TF**
Description: **Tap Factory**

Distance (ft): **166.2**
Structural Grade: **0**
O&M Grade: **0**
Clock Start/From: **2**
Clock To:
1st Value: **4.000**
2nd Value:
Value Percent:
Continuous Index:
Within 8" of Joint:
Remarks:

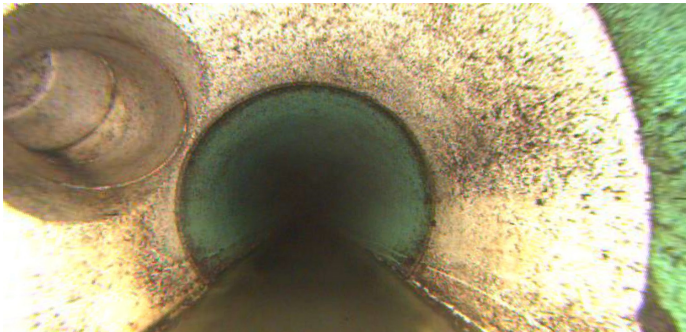
Code: **TF**
Description: **Tap Factory**

Distance (ft): **168.2**
Structural Grade: **0**
O&M Grade: **0**
Clock Start/From: **9**
Clock To:
1st Value: **4.000**
2nd Value:
Value Percent:
Continuous Index:
Within 8" of Joint:
Remarks:

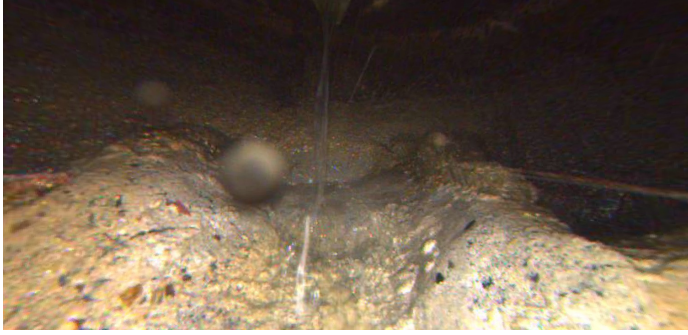
Code:	AMH
Description:	Manhole
Distance (ft):	203.5
Structural Grade:	0
O&M Grade:	0
Clock Start/From:	
Clock To:	
1st Value:	
2nd Value:	
Value Percent:	
Continuous Index:	
Within 8" of Joint:	NO
Remarks:	M-907-002
