## Profile/Photo Observation Report

Street:	<b>Capitol</b>	Flow Control:	<b>Not Controlled</b>
City:	<b>Hobart, IN</b>	Year Renewed:	
Location:	<b>Light Highway</b>	Tape/Media #:	
Purpose:	<b>Maintenance Related</b>	Dia/Height:	<b>12"</b>
Use:	<b>Sanitary</b>	Material:	<b>PVC</b>
Drain Area:	<b>NA</b>	Lining:	<b>Cured in Place</b>
Category:	<b>NA</b>		
Comment:	<b>mh found, shorter than mapped.</b>

Location Details:		Direction of Survey:	<b>Downstream</b>
US MH:	<b>M-907-004</b>	DS MH:	<b>M-907-003</b>
		Total Length Surveyed (ft):	<b>202.0</b>

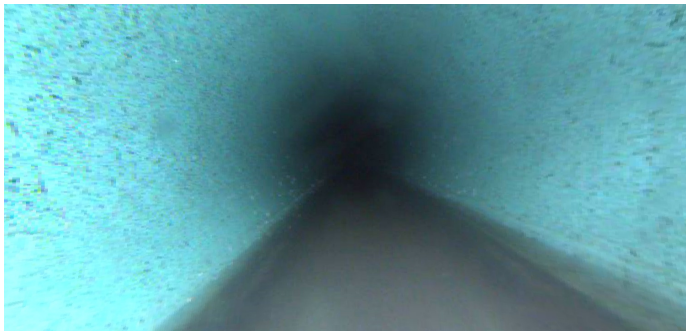
Code: **AMH**  
Description: **Manhole**

Distance (ft): **.0**  
Structural Grade: **0**  
O&M Grade: **0**  
Clock Start/From:  
Clock To:  
1st Value:  
2nd Value:  
Value Percent:  
Continuous Index:  
Within 8" of Joint: **NO**  
Remarks: **M-907-004**

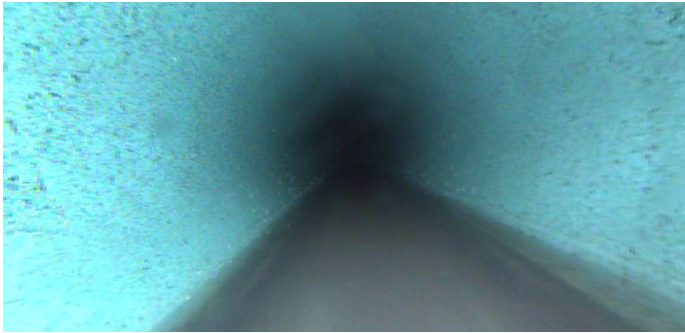
Code:	<b>MWL</b>
Description:	<b>Water Level</b>

Distance (ft):	<b>.0</b>
Structural Grade:	<b>0</b>
O&M Grade:	<b>0</b>
Clock Start/From:	
Clock To:	
1st Value:	
2nd Value:	
Value Percent:	<b>5.000</b>
Continuous Index:	
Within 8" of Joint:	<b>NO</b>
Remarks:

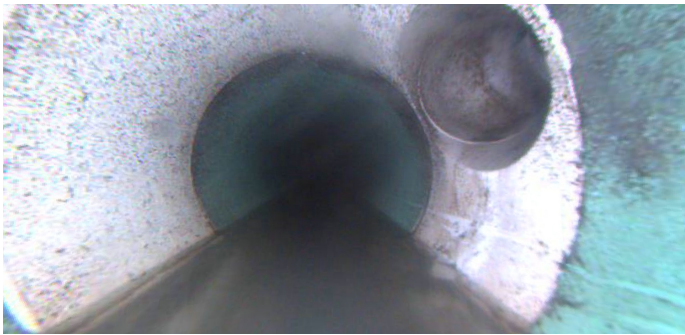
Code:	<b>TF</b>
Description:	<b>Tap Factory</b>

Distance (ft):	<b>99.4</b>
Structural Grade:	<b>0</b>
O&M Grade:	<b>0</b>
Clock Start/From:	<b>2</b>
Clock To:	
1st Value:	<b>4.000</b>
2nd Value:	
Value Percent:	
Continuous Index:	
Within 8" of Joint:	
Remarks:

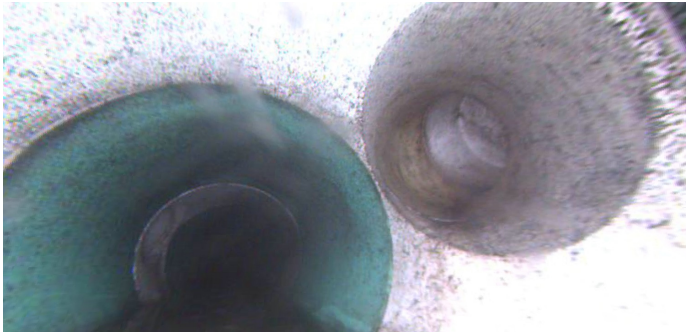
Code: **TF**  
Description: **Tap Factory**

Distance (ft): **165.3**  
Structural Grade: **0**  
O&M Grade: **0**  
Clock Start/From: **2**  
Clock To:  
1st Value: **4.000**  
2nd Value:  
Value Percent:  
Continuous Index:  
Within 8" of Joint:  
Remarks:

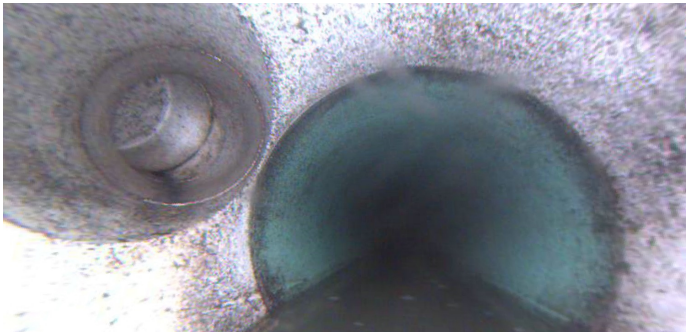
Code: **TF**  
Description: **Tap Factory**

Distance (ft): **167.2**  
Structural Grade: **0**  
O&M Grade: **0**  
Clock Start/From: **10**  
Clock To:  
1st Value: **4.000**  
2nd Value:  
Value Percent:  
Continuous Index:  
Within 8" of Joint:  
Remarks:

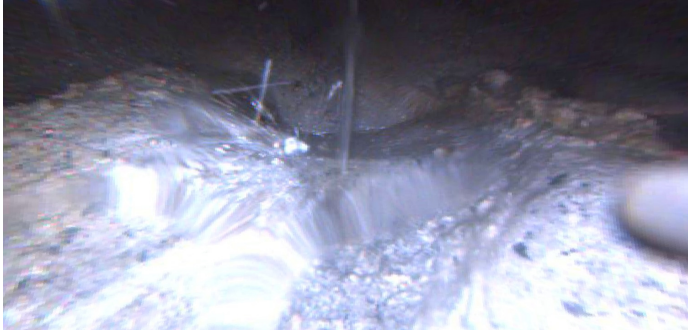
Code:	<b>AMH</b>
Description:	<b>Manhole</b>
Distance (ft):	<b>202.0</b>
Structural Grade:	<b>0</b>
O&M Grade:	<b>0</b>
Clock Start/From:	
Clock To:	
1st Value:	
2nd Value:	
Value Percent:	
Continuous Index:	
Within 8" of Joint:	<b>NO</b>
Remarks:	<b>M-907-003</b>
