## Profile/Photo Observation Report

Location Details:		Direction of Survey:	<b>Downstream</b>
US MH:	<b>M-907-006</b>	DS MH:	<b>M-907-005</b>
		Total Length Surveyed (ft):	<b>81.6</b>

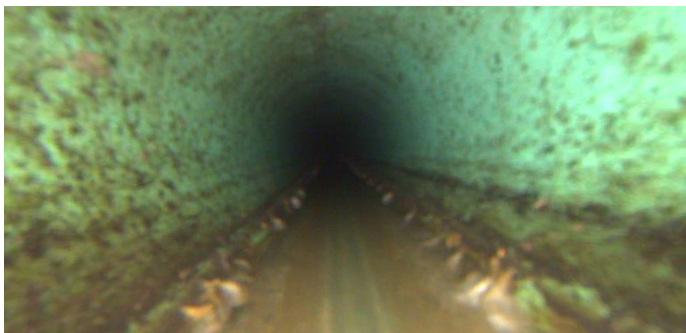
Code: **AMH**  
Description: **Manhole**

Distance (ft): **.0**  
Structural Grade: **0**  
O&M Grade: **0**  
Clock Start/From:  
Clock To:  
1st Value:  
2nd Value:  
Value Percent:  
Continuous Index:  
Within 8" of Joint: **NO**  
Remarks: **M-907-006**

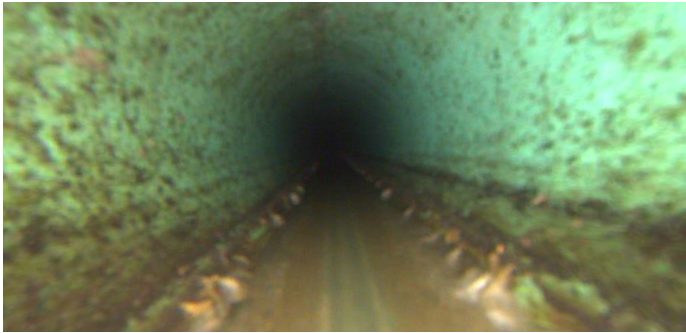
Code:	<b>MWL</b>
Description:	<b>Water Level</b>

Distance (ft):	<b>.0</b>
Structural Grade:	<b>0</b>
O&M Grade:	<b>0</b>
Clock Start/From:	
Clock To:	
1st Value:	
2nd Value:	
Value Percent:	<b>5.000</b>
Continuous Index:	
Within 8" of Joint:	<b>NO</b>
Remarks:

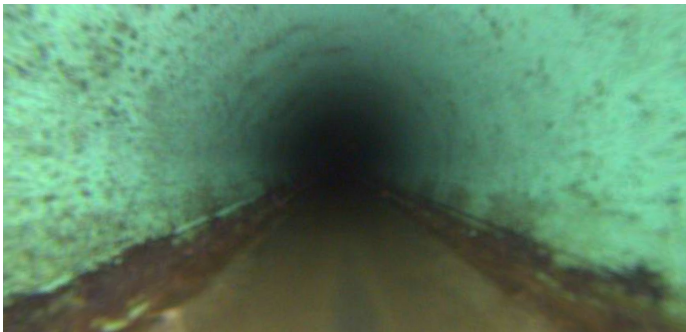
Code:	<b>MSA</b>
Description:	<b>Abandoned Survey</b>

Distance (ft):	<b>81.6</b>
Structural Grade:	<b>0</b>
O&M Grade:	<b>0</b>
Clock Start/From:	
Clock To:	
1st Value:	
2nd Value:	
Value Percent:	
Continuous Index:	
Within 8" of Joint:	<b>NO</b>
Remarks:	<b>debris under water</b>
