Profile/Photo Observation Report

Date:	04/11/2018	Weather:		Coding:	PACP 6.0
Pipe Length (ft):	358.7	Owner:	NA	Pre Clean:	Not Known
P.O.#:		Surveyor:	Jen Costello	PSR:	P-907-006-007
Customer:		Clean Date:	01/01/1900	Shape:	C

Street:	Capitol	Flow Control:	Not Controlled
City:	Hobart, IN	Year Renewed:	
Location:	Ditch	Tape/Media #:	
Purpose:	Maintenance Related	Dia/Height:	12"
Use:	Sanitary	Material:	PVC
Drain Area:	NA	Lining:	Cured in Place
Category:	NA		
Comment:	battery at 350'-flow incorrect		
Location Details:		Direction of Survey:	Upstream
US MH:	M-907-007	DS MH:	M-907-006
		Total Length Surveyed (ft):	351.3

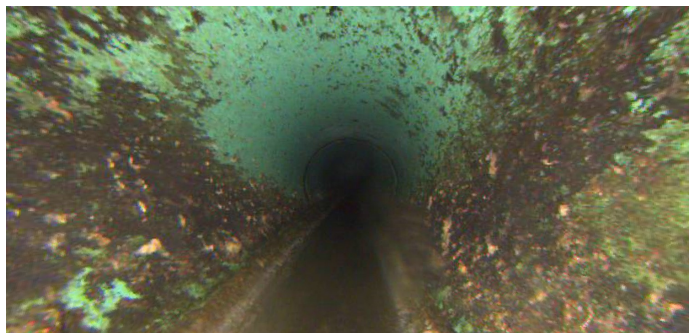
Code: **AMH**
 Description: **Manhole**

Distance (ft): **.0**
 Structural Grade: **0**
 O&M Grade: **0**
 Clock Start/From:
 Clock To:
 1st Value:
 2nd Value:
 Value Percent:
 Continuous Index:
 Within 8" of Joint: **NO**
 Remarks: **M-907-006**

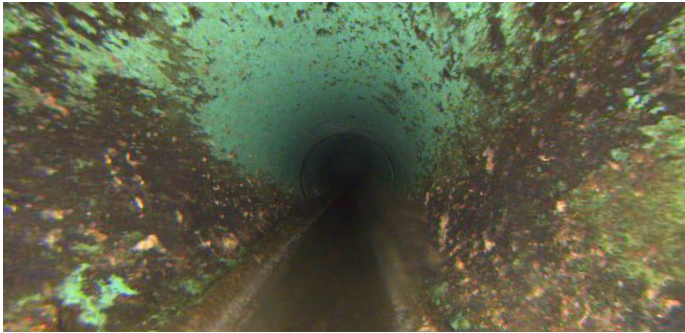
Code:	MWL
Description:	Water Level

Distance (ft):	.0
Structural Grade:	0
O&M Grade:	0
Clock Start/From:	
Clock To:	
1st Value:	
2nd Value:	
Value Percent:	5.000
Continuous Index:	
Within 8" of Joint:	NO
Remarks:

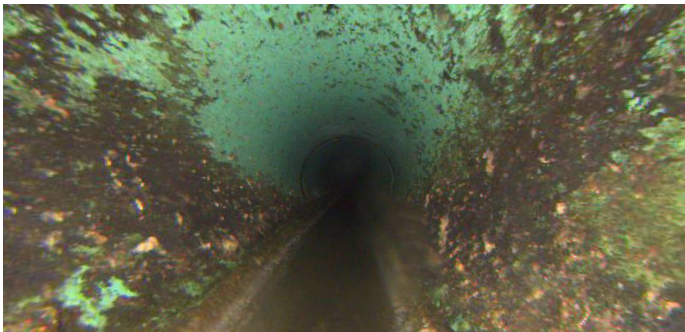
Code:	DAGS
Description:	Deposits Attached Grease

Distance (ft):	.0
Structural Grade:	0
O&M Grade:	2
Clock Start/From:	8
Clock To:	4
1st Value:	
2nd Value:	
Value Percent:	5.000
Continuous Index:	S01
Within 8" of Joint:	NO
Remarks:

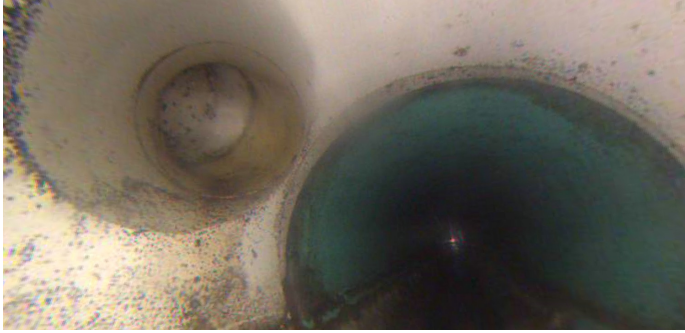
Code: **TF**
Description: **Tap Factory**

Distance (ft): **67.0**
Structural Grade: **0**
O&M Grade: **0**
Clock Start/From: **2**
Clock To:
1st Value: **4.000**
2nd Value:
Value Percent:
Continuous Index:
Within 8" of Joint:
Remarks:

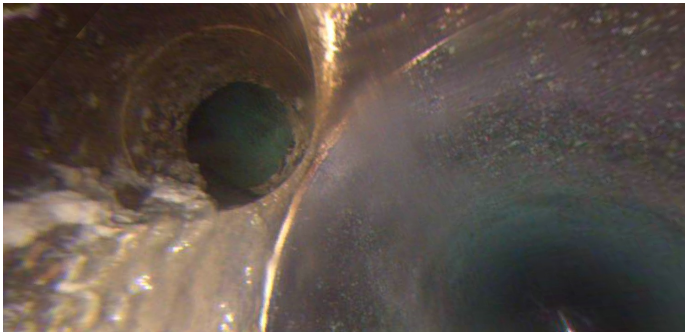
Code: **TF**
Description: **Tap Factory**

Distance (ft): **104.2**
Structural Grade: **0**
O&M Grade: **0**
Clock Start/From: **2**
Clock To:
1st Value: **4.000**
2nd Value:
Value Percent:
Continuous Index:
Within 8" of Joint:
Remarks:

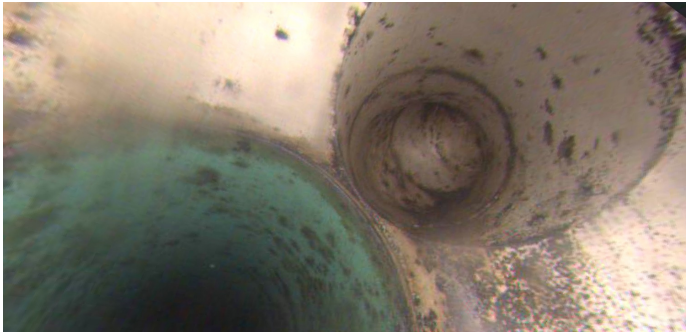
Code: **TF**
Description: **Tap Factory**

Distance (ft): **312.7**
Structural Grade: **0**
O&M Grade: **0**
Clock Start/From: **10**
Clock To:
1st Value: **4.000**
2nd Value:
Value Percent:
Continuous Index:
Within 8" of Joint:
Remarks:

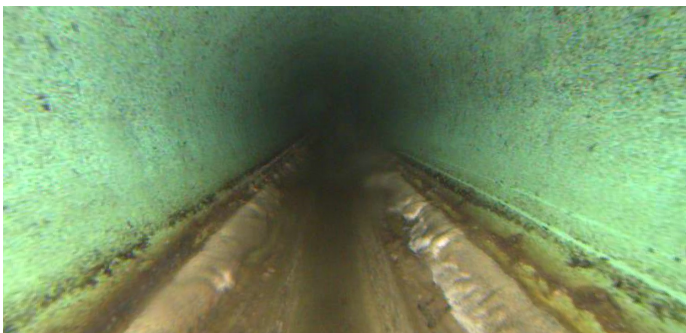
Code: **MSA**
Description: **Abandoned Survey**

Distance (ft): **351.3**
Structural Grade: **0**
O&M Grade: **0**
Clock Start/From:
Clock To:
1st Value:
2nd Value:
Value Percent:
Continuous Index:
Within 8" of Joint: **NO**
Remarks: **dags**

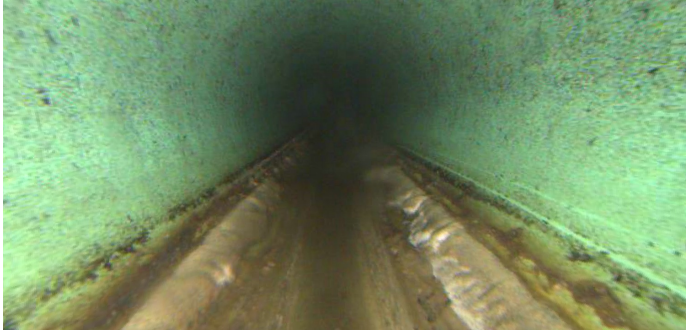
Code:	DAGS
Description:	Deposits Attached Grease
Distance (ft):	351.3
Structural Grade:	0
O&M Grade:	2
Clock Start/From:	8
Clock To:	4
1st Value:	
2nd Value:	
Value Percent:	5.000
Continuous Index:	F01
Within 8" of Joint:	NO
Remarks:
