Profile/Photo Observation Report

Street:	S UNION ST	Flow Control:	Not Controlled
City:	Hobart, IN	Year Renewed:	
Location:	Light Highway	Tape/Media #:	
Purpose:	Maintenance Related	Dia/Height:	8"
Use:	Sanitary	Material:	PVC
Drain Area:	NA	Lining:	Cured in Place
Category:	NA		
Comment:

Location Details:		Direction of Survey:	Downstream
US MH:	M-907-008	DS MH:	M-907-023
		Total Length Surveyed (ft):	348.2

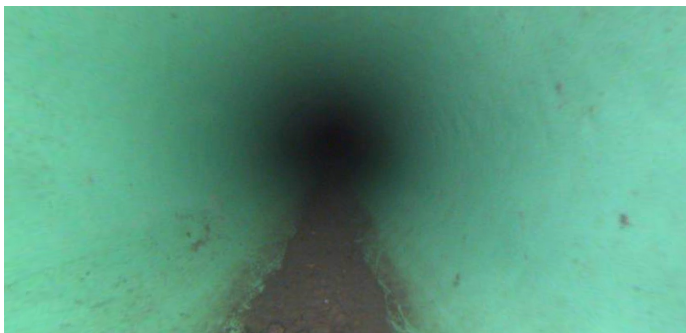
Code: **AMH**
Description: **Manhole**

Distance (ft): **.0**
Structural Grade: **0**
O&M Grade: **0**
Clock Start/From:
Clock To:
1st Value:
2nd Value:
Value Percent:
Continuous Index:
Within 8" of Joint: **NO**
Remarks: **M-907-008**

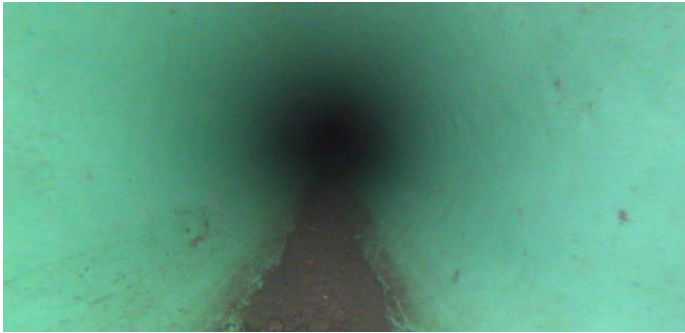
Code:	MWL
Description:	Water Level

Distance (ft):	.0
Structural Grade:	0
O&M Grade:	0
Clock Start/From:	
Clock To:	
1st Value:	
2nd Value:	
Value Percent:	0.000
Continuous Index:	
Within 8" of Joint:	NO
Remarks:

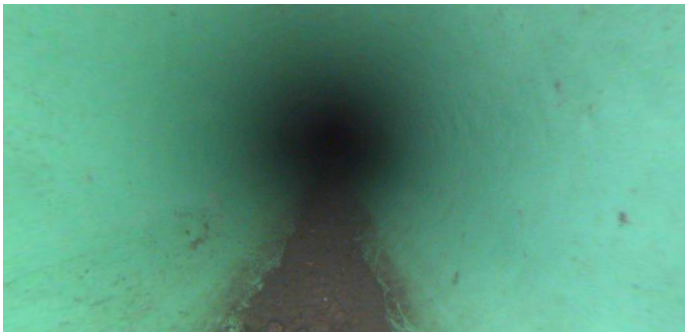
Code:	DSF
Description:	Deposits Settled Fine

Distance (ft):	.0
Structural Grade:	0
O&M Grade:	2
Clock Start/From:	6
Clock To:	
1st Value:	
2nd Value:	
Value Percent:	5.000
Continuous Index:	S01
Within 8" of Joint:	NO
Remarks:

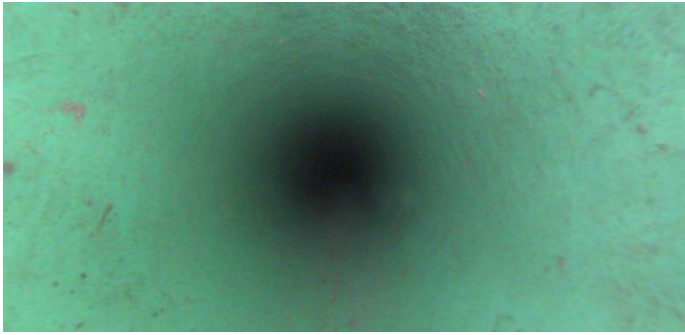
Code: **DSF**
Description: **Deposits Settled Fine**

Distance (ft): **7.3**
Structural Grade: **0**
O&M Grade: **2**
Clock Start/From: **6**
Clock To:
1st Value:
2nd Value:
Value Percent: **5.000**
Continuous Index: **F01**
Within 8" of Joint: **NO**
Remarks:

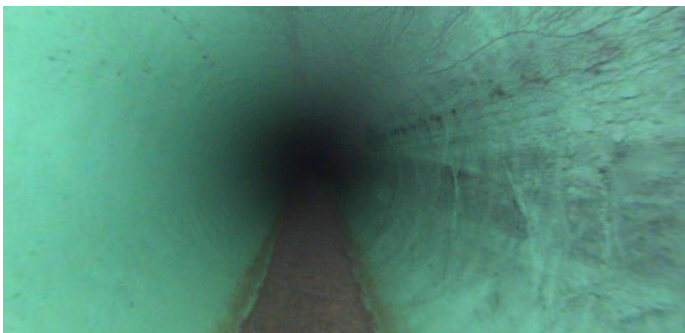
Code: **DSF**
Description: **Deposits Settled Fine**

Distance (ft): **193.3**
Structural Grade: **0**
O&M Grade: **2**
Clock Start/From: **6**
Clock To:
1st Value:
2nd Value:
Value Percent: **5.000**
Continuous Index: **S02**
Within 8" of Joint: **NO**
Remarks:

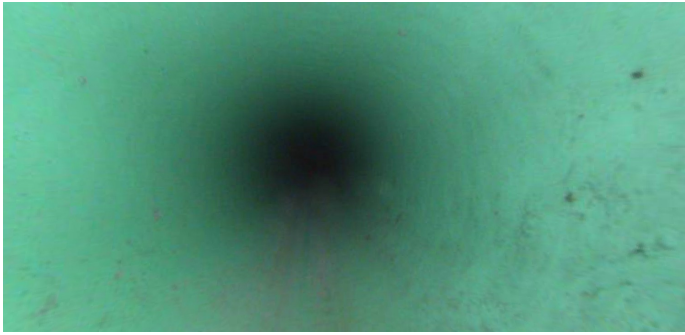
Code: **DSF**
Description: **Deposits Settled Fine**

Distance (ft): **211.8**
Structural Grade: **0**
O&M Grade: **2**
Clock Start/From: **6**
Clock To:
1st Value:
2nd Value:
Value Percent: **5.000**
Continuous Index: **F02**
Within 8" of Joint: **NO**
Remarks:

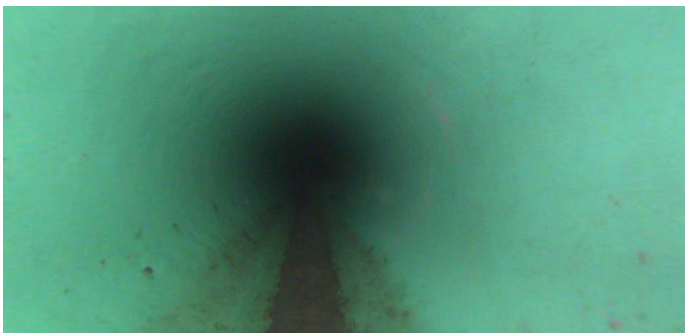
Code: **DSF**
Description: **Deposits Settled Fine**

Distance (ft): **281.2**
Structural Grade: **0**
O&M Grade: **2**
Clock Start/From: **6**
Clock To:
1st Value:
2nd Value:
Value Percent: **5.000**
Continuous Index: **S03**
Within 8" of Joint: **NO**
Remarks:

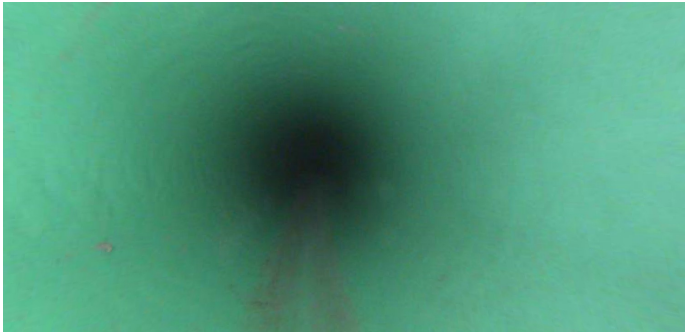
Code: **DSF**
Description: **Deposits Settled Fine**

Distance (ft): **296.4**
Structural Grade: **0**
O&M Grade: **2**
Clock Start/From: **6**
Clock To:
1st Value:
2nd Value:
Value Percent: **5.000**
Continuous Index: **F03**
Within 8" of Joint: **NO**
Remarks:

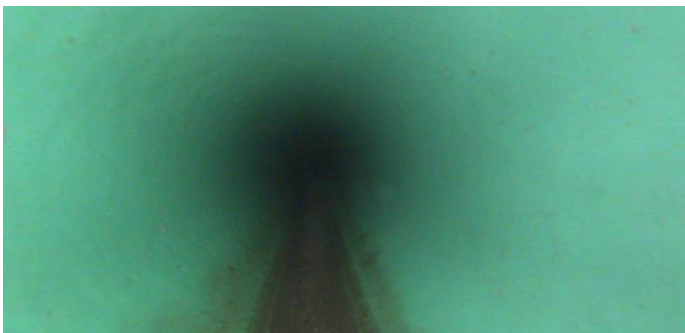
Code: **DSF**
Description: **Deposits Settled Fine**

Distance (ft): **331.7**
Structural Grade: **0**
O&M Grade: **2**
Clock Start/From: **6**
Clock To:
1st Value:
2nd Value:
Value Percent: **5.000**
Continuous Index: **S04**
Within 8" of Joint: **NO**
Remarks:

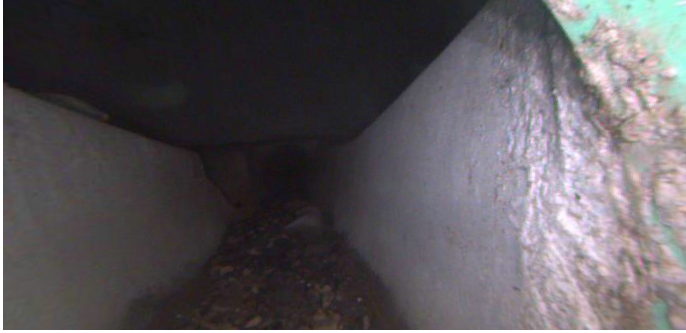
Code: **DSF**
Description: **Deposits Settled Fine**

Distance (ft): **346.2**
Structural Grade: **0**
O&M Grade: **2**
Clock Start/From: **6**
Clock To:
1st Value:
2nd Value:
Value Percent: **5.000**
Continuous Index: **F04**
Within 8" of Joint: **NO**
Remarks:

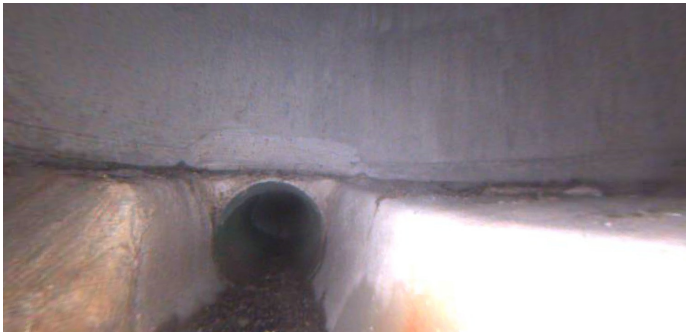
Code: **AMH**
Description: **Manhole**

Distance (ft): **348.2**
Structural Grade: **0**
O&M Grade: **0**
Clock Start/From:
Clock To:
1st Value:
2nd Value:
Value Percent:
Continuous Index:
Within 8" of Joint: **NO**
Remarks: **M-907-023**
