## Profile/Photo Observation Report

Date:	<b>04/13/2018</b>	Weather:		Coding:	<b>PACP 6.0</b>
Pipe Length (ft):	<b>355.1</b>	Owner:	<b>NA</b>	Pre Clean:	<b>Not Known</b>
P.O.#:		Surveyor:	<b>Jen Costello</b>	PSR:	<b>P-907-023-008</b>
Customer:		Clean Date:	<b>01/01/1900</b>	Shape:	<b>C</b>

Location Details:		Direction of Survey:	<b>Downstream</b>
US MH:	<b>M-907-008</b>	DS MH:	<b>M-907-023</b>
		Total Length Surveyed (ft):	<b>348.2</b>

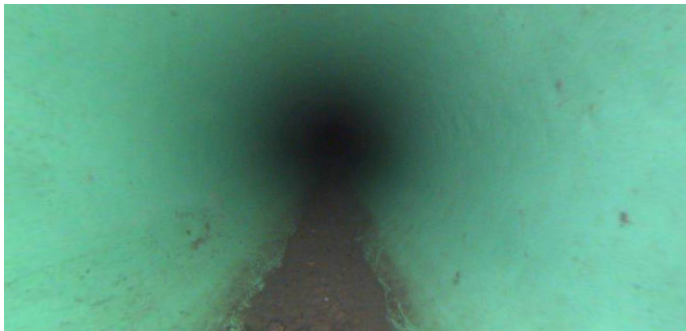
Code: **AMH**  
Description: **Manhole**

Distance (ft): **.0**  
Structural Grade: **0**  
O&M Grade: **0**  
Clock Start/From:  
Clock To:  
1st Value:  
2nd Value:  
Value Percent:  
Continuous Index:  
Within 8" of Joint: **NO**  
Remarks: **M-907-008**

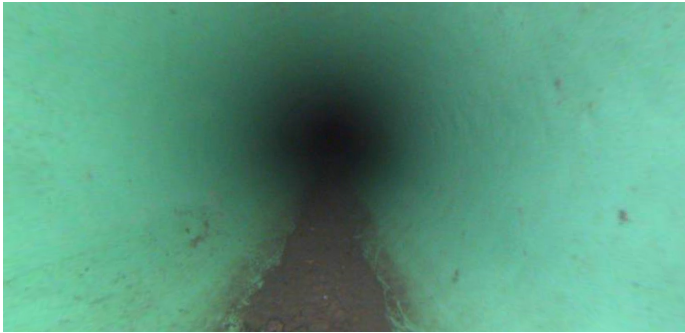
Code:	<b>MWL</b>
Description:	<b>Water Level</b>

Distance (ft):	<b>.0</b>
Structural Grade:	<b>0</b>
O&M Grade:	<b>0</b>
Clock Start/From:	
Clock To:	
1st Value:	
2nd Value:	
Value Percent:	<b>0.000</b>
Continuous Index:	
Within 8" of Joint:	<b>NO</b>
Remarks:

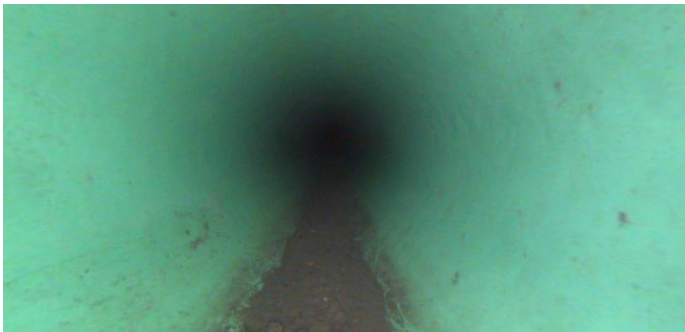
Code:	<b>DSF</b>
Description:	<b>Deposits Settled Fine</b>

Distance (ft):	<b>.0</b>
Structural Grade:	<b>0</b>
O&M Grade:	<b>2</b>
Clock Start/From:	<b>6</b>
Clock To:	
1st Value:	
2nd Value:	
Value Percent:	<b>5.000</b>
Continuous Index:	<b>S01</b>
Within 8" of Joint:	<b>NO</b>
Remarks:

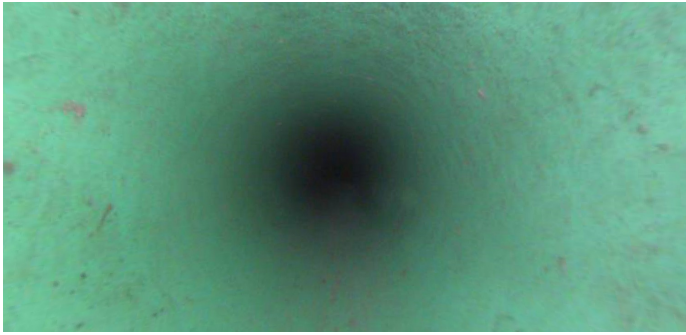
Code: **DSF**  
Description: **Deposits Settled Fine**

Distance (ft): **7.3**  
Structural Grade: **0**  
O&M Grade: **2**  
Clock Start/From: **6**  
Clock To:  
1st Value:  
2nd Value:  
Value Percent: **5.000**  
Continuous Index: **F01**  
Within 8" of Joint: **NO**  
Remarks:

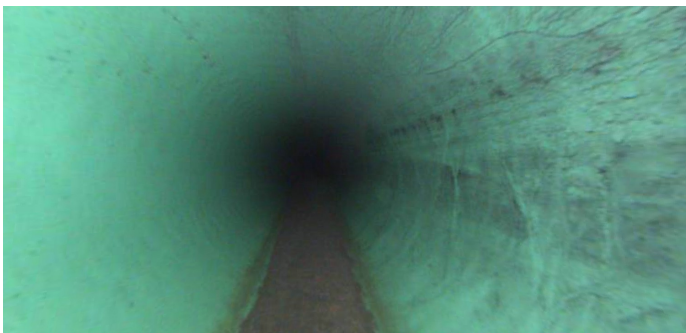
Code: **DSF**  
Description: **Deposits Settled Fine**

Distance (ft): **193.3**  
Structural Grade: **0**  
O&M Grade: **2**  
Clock Start/From: **6**  
Clock To:  
1st Value:  
2nd Value:  
Value Percent: **5.000**  
Continuous Index: **S02**  
Within 8" of Joint: **NO**  
Remarks:

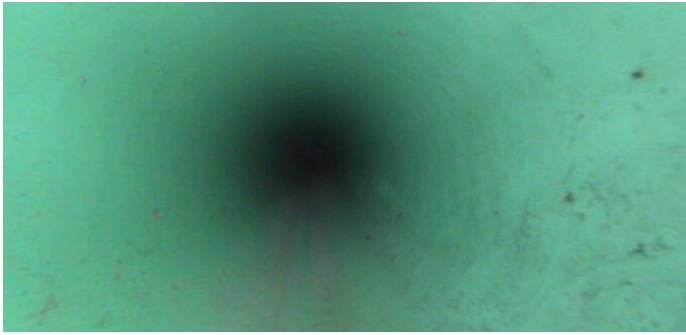
Code: **DSF**  
Description: **Deposits Settled Fine**

Distance (ft): **211.8**  
Structural Grade: **0**  
O&M Grade: **2**  
Clock Start/From: **6**  
Clock To:  
1st Value:  
2nd Value:  
Value Percent: **5.000**  
Continuous Index: **F02**  
Within 8" of Joint: **NO**  
Remarks:

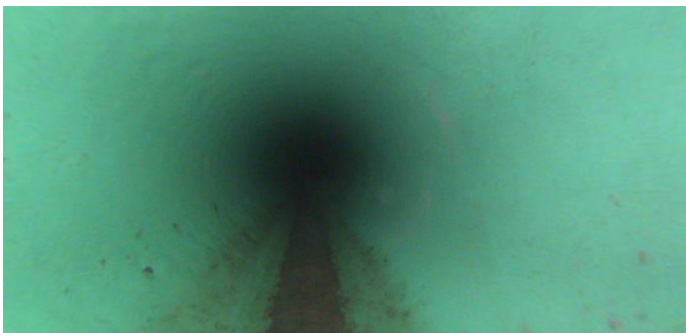
Code: **DSF**  
Description: **Deposits Settled Fine**

Distance (ft): **281.2**  
Structural Grade: **0**  
O&M Grade: **2**  
Clock Start/From: **6**  
Clock To:  
1st Value:  
2nd Value:  
Value Percent: **5.000**  
Continuous Index: **S03**  
Within 8" of Joint: **NO**  
Remarks:

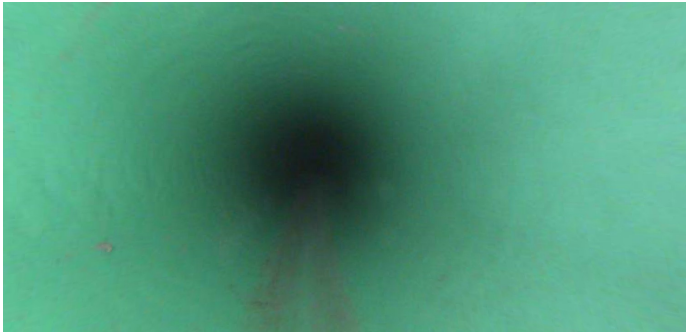
Code: **DSF**  
Description: **Deposits Settled Fine**

Distance (ft): **296.4**  
Structural Grade: **0**  
O&M Grade: **2**  
Clock Start/From: **6**  
Clock To:  
1st Value:  
2nd Value:  
Value Percent: **5.000**  
Continuous Index: **F03**  
Within 8" of Joint: **NO**  
Remarks:

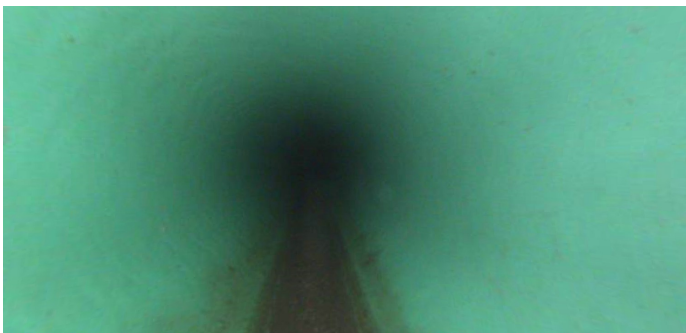
Code: **DSF**  
Description: **Deposits Settled Fine**

Distance (ft): **331.7**  
Structural Grade: **0**  
O&M Grade: **2**  
Clock Start/From: **6**  
Clock To:  
1st Value:  
2nd Value:  
Value Percent: **5.000**  
Continuous Index: **S04**  
Within 8" of Joint: **NO**  
Remarks:

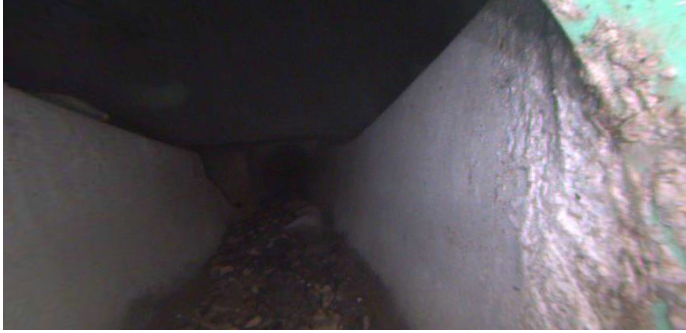
Code: **DSF**  
Description: **Deposits Settled Fine**

Distance (ft): **346.2**  
Structural Grade: **0**  
O&M Grade: **2**  
Clock Start/From: **6**  
Clock To:  
1st Value:  
2nd Value:  
Value Percent: **5.000**  
Continuous Index: **F04**  
Within 8" of Joint: **NO**  
Remarks:

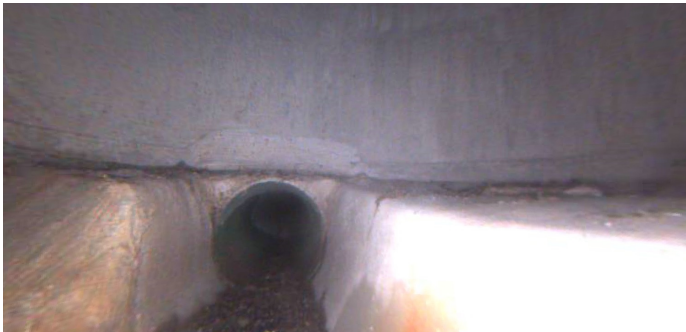
Code: **AMH**  
Description: **Manhole**

Distance (ft): **348.2**  
Structural Grade: **0**  
O&M Grade: **0**  
Clock Start/From:  
Clock To:  
1st Value:  
2nd Value:  
Value Percent:  
Continuous Index:  
Within 8" of Joint: **NO**  
Remarks: **M-907-023**
