## Profile/Photo Observation Report

Street:	<b>South Union Street</b>	Flow Control:	<b>Not Controlled</b>
City:	<b>Hobart, IN</b>	Year Renewed:	
Location:	<b>Sidewalk</b>	Tape/Media #:	<b>DEP281</b>
Purpose:	<b>Routine Assessment</b>	Dia/Height:	<b>8"</b>
Use:	<b>Sanitary</b>	Material:	<b>PVC</b>
Drain Area:		Lining:	
Category:	<b>NA</b>		
Comment:	<b>5-21-2018</b>

Location Details:		Direction of Survey:	<b>Upstream</b>
US MH:	<b>M-907-009</b>	DS MH:	<b>M-907-009</b>
		Total Length Surveyed (ft):	<b>116.6</b>

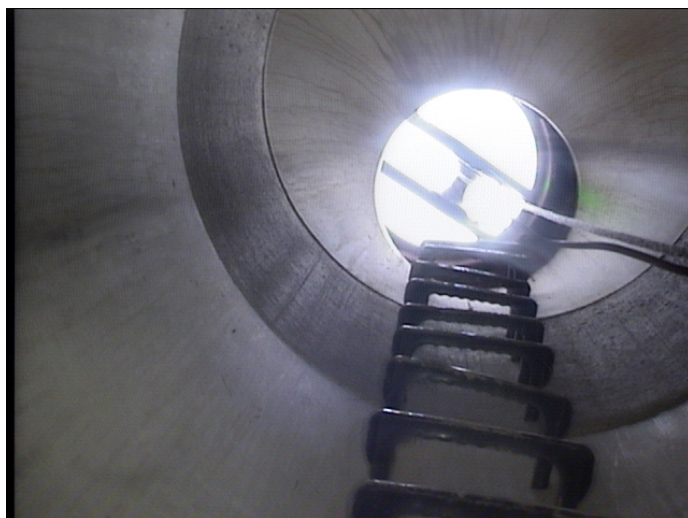
Code: **AMH**  
Description: **Manhole**

Distance (ft): **.0**  
Structural Grade: **0**  
O&M Grade: **0**  
Clock Start/From:  
Clock To:  
1st Value:  
2nd Value:  
Value Percent:  
Continuous Index:  
Within 8" of Joint: **NO**  
Remarks: **M-907-009**

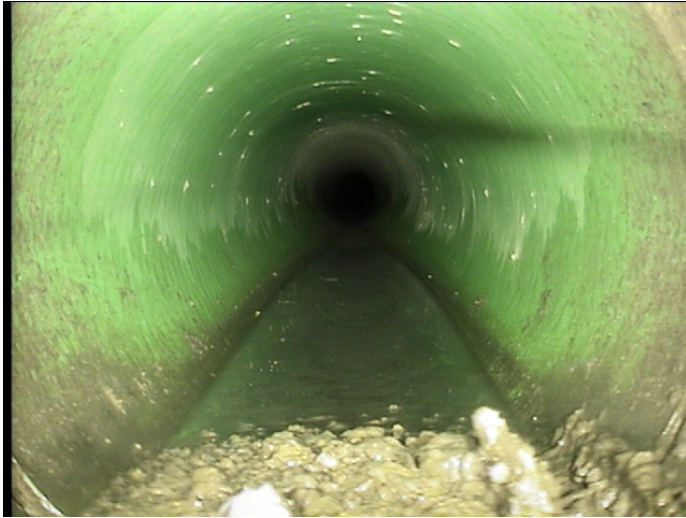
Code:	<b>MWL</b>
Description:	<b>Water Level</b>
Distance (ft):	<b>.0</b>
Structural Grade:	<b>0</b>
O&M Grade:	<b>0</b>
Clock Start/From:	
Clock To:	
1st Value:	
2nd Value:	
Value Percent:	<b>5.000</b>
Continuous Index:	
Within 8" of Joint:	<b>NO</b>
Remarks:

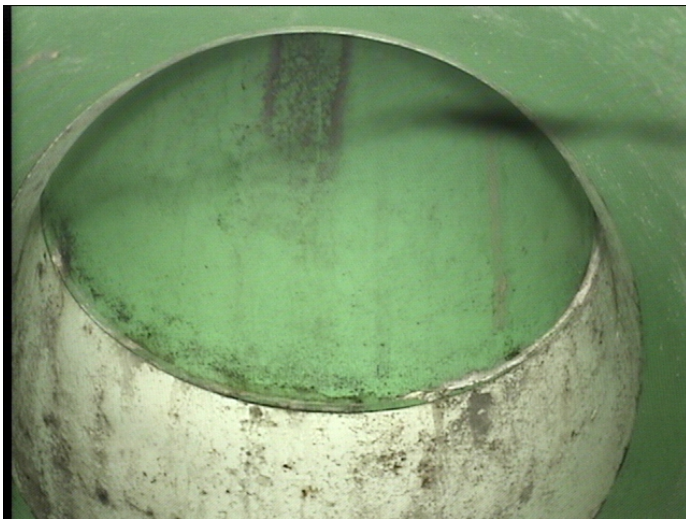
Code:	<b>TF</b>
Description:	<b>Tap Factory</b>
Distance (ft):	<b>111.2</b>
Structural Grade:	<b>0</b>
O&M Grade:	<b>0</b>
Clock Start/From:	<b>3</b>
Clock To:	
1st Value:	<b>4.000</b>
2nd Value:	
Value Percent:	
Continuous Index:	
Within 8" of Joint:	<b>NO</b>
Remarks:

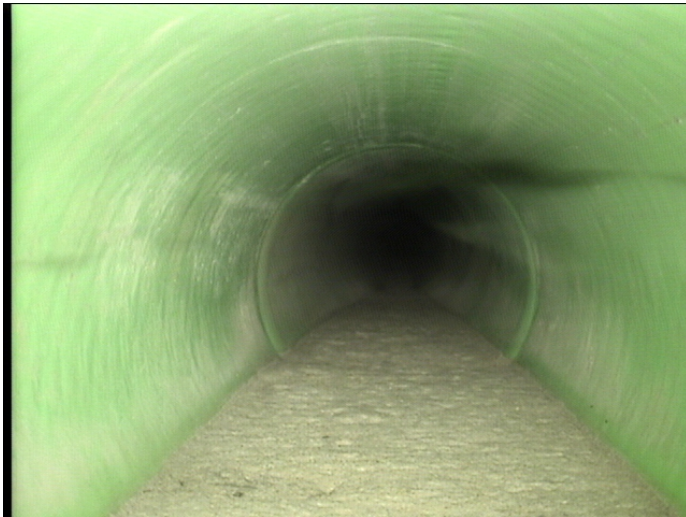
Code: **DSF**  
Description: **Deposits Settled Fine**

Distance (ft): **114.3**  
Structural Grade: **0**  
O&M Grade: **2**  
Clock Start/From: **5**  
Clock To: **7**  
1st Value:  
2nd Value:  
Value Percent: **5.000**  
Continuous Index:  
Within 8" of Joint: **NO**  
Remarks:

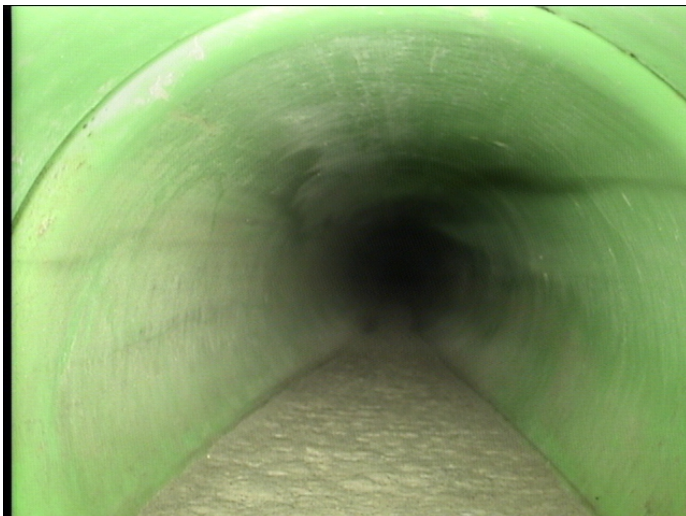
Code: **MSA**  
Description: **Abandoned Survey**

Distance (ft): **116.6**  
Structural Grade: **0**  
O&M Grade: **0**  
Clock Start/From:  
Clock To:  
1st Value:  
2nd Value:  
Value Percent:  
Continuous Index:  
Within 8" of Joint: **NO**  
Remarks: **Headspace**
