Profile/Photo Observation Report

Street:	South Union Street	Flow Control:	Not Controlled
City:	Hobart, IN	Year Renewed:	
Location:	Ditch	Tape/Media #:	
Purpose:	Routine Assessment	Dia/Height:	8"
Use:	Sanitary Sewage Pipe	Material:	PVC
Drain Area:		Lining:	None
Category:	NA		
Comment:

Location Details:		Direction of Survey:	Downstream
US MH:	M-907-009	DS MH:	M-907-009.1
		Total Length Surveyed (ft):	315.6

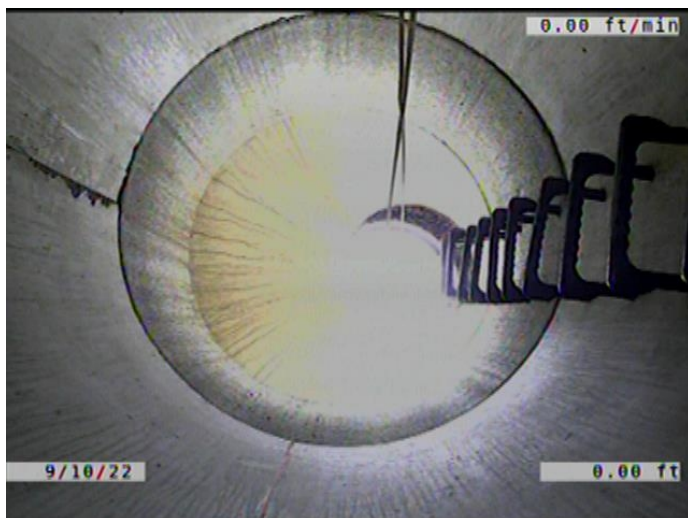
Code: **AMH**
 Description: **Manhole**

Distance (ft): **.0**
 Structural Grade: **0**
 O&M Grade: **0**
 Clock Start/From:
 Clock To:
 1st Value:
 2nd Value:
 Value Percent:
 Continuous Index:
 Within 8" of Joint: **NO**
 Remarks: **M-907-009**

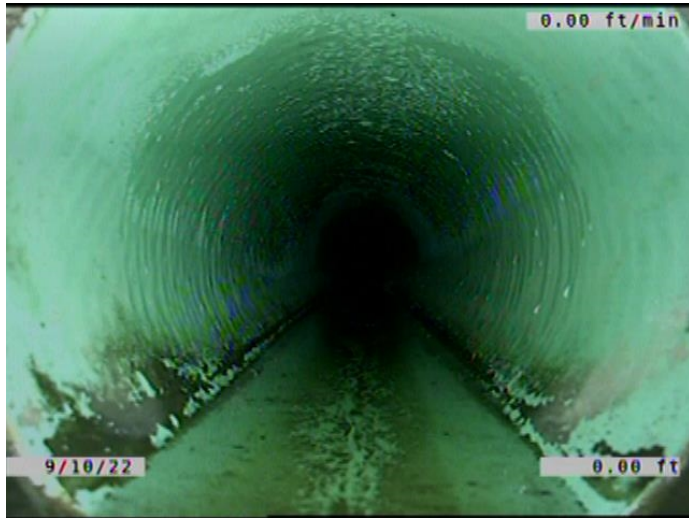
Code: **MWL**
Description: **Miscellaneous Water Level**

Distance (ft): **.0**
Structural Grade: **0**
O&M Grade: **0**
Clock Start/From:
Clock To:
1st Value:
2nd Value:
Value Percent: **5.000**
Continuous Index:
Within 8" of Joint: **NO**
Remarks:

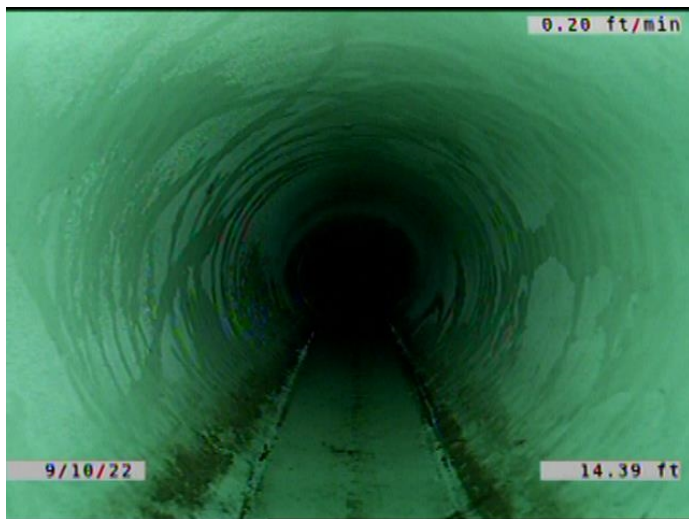
Code: **MWLS**
Description: **Miscellaneous Water Level Sag**

Distance (ft): **14.4**
Structural Grade: **2**
O&M Grade: **0**
Clock Start/From:
Clock To:
1st Value:
2nd Value:
Value Percent: **5.000**
Continuous Index: **S01**
Within 8" of Joint: **NO**
Remarks:

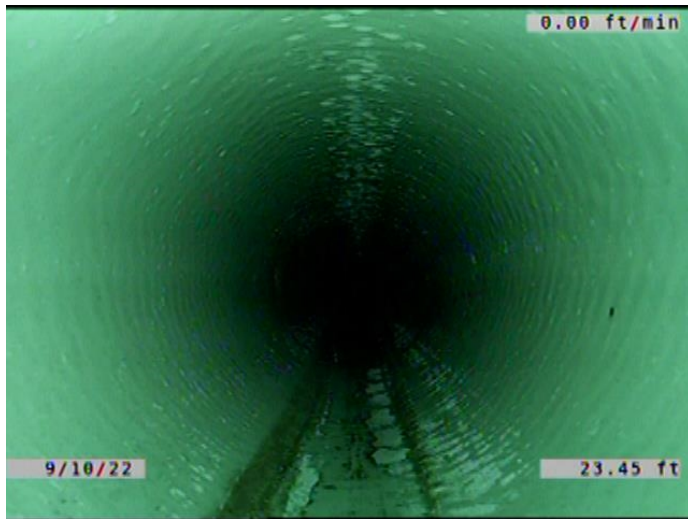
Code: **MWLS**
Description: **Miscellaneous Water Level Sag**

Distance (ft): **23.4**
Structural Grade: **2**
O&M Grade: **0**
Clock Start/From:
Clock To:
1st Value:
2nd Value:
Value Percent: **5.000**
Continuous Index: **F01**
Within 8" of Joint: **NO**
Remarks:

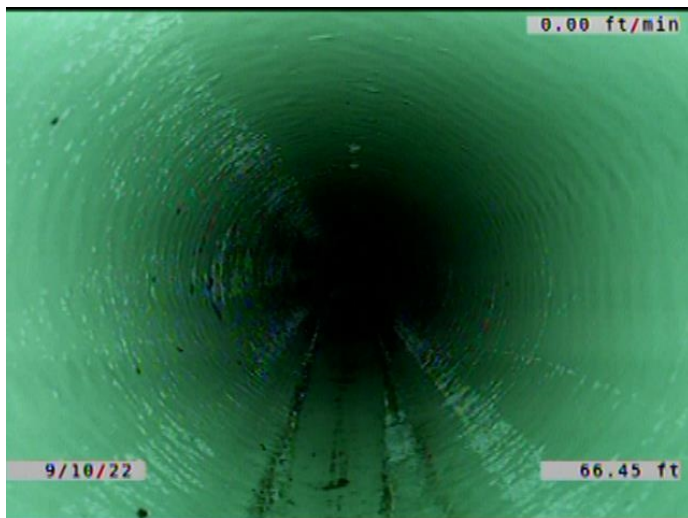
Code: **MWLS**
Description: **Miscellaneous Water Level Sag**

Distance (ft): **66.4**
Structural Grade: **2**
O&M Grade: **0**
Clock Start/From:
Clock To:
1st Value:
2nd Value:
Value Percent: **5.000**
Continuous Index: **S02**
Within 8" of Joint: **NO**
Remarks:

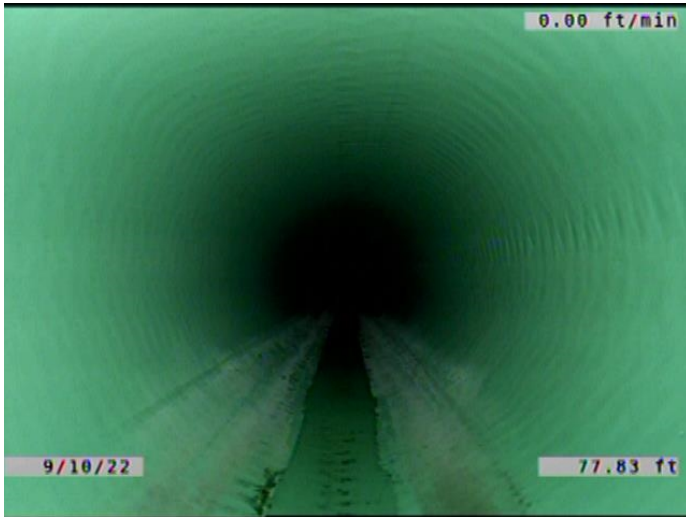
Code: **MWLS**
Description: **Miscellaneous Water Level Sag**

Distance (ft): **77.8**
Structural Grade: **2**
O&M Grade: **0**
Clock Start/From:
Clock To:
1st Value:
2nd Value:
Value Percent: **5.000**
Continuous Index: **F02**
Within 8" of Joint: **NO**
Remarks:

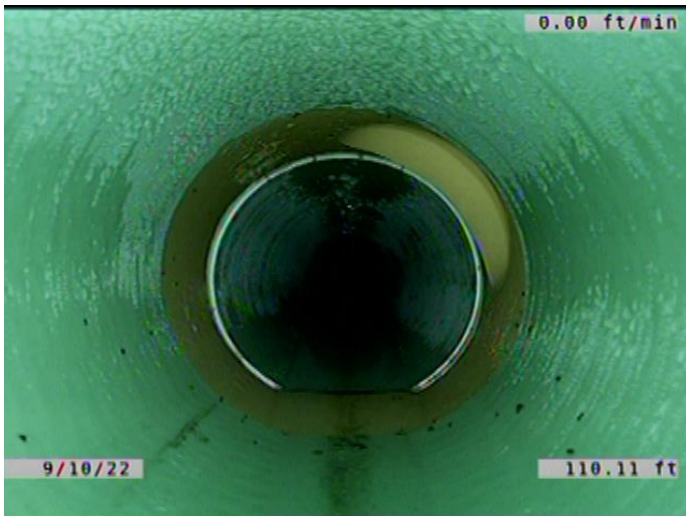
Code: **MWLS**
Description: **Miscellaneous Water Level Sag**

Distance (ft): **110.1**
Structural Grade: **2**
O&M Grade: **0**
Clock Start/From:
Clock To:
1st Value:
2nd Value:
Value Percent: **5.000**
Continuous Index: **S03**
Within 8" of Joint: **NO**
Remarks:

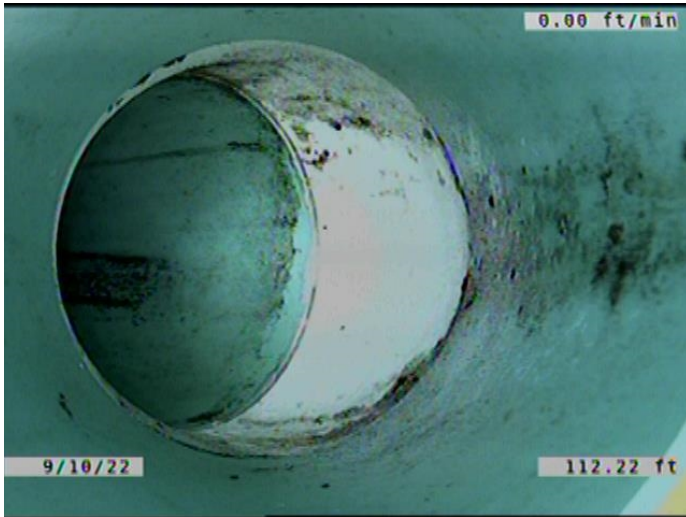
Code: **TF**
 Description: **Tap Factory**

Distance (ft): **112.2**
 Structural Grade: **0**
 O&M Grade: **0**
 Clock Start/From: **2**
 Clock To:
 1st Value: **4.000**
 2nd Value:
 Value Percent:
 Continuous Index:
 Within 8" of Joint: **YES**
 Remarks:

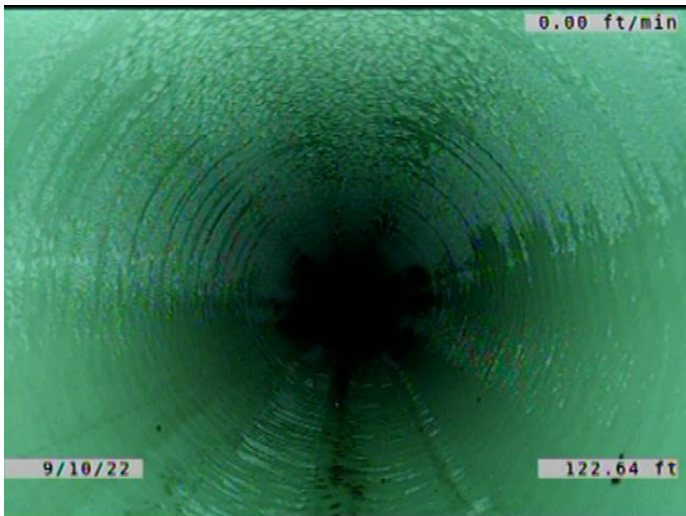
Code: **MWLS**
 Description: **Miscellaneous Water Level Sag**

Distance (ft): **122.6**
 Structural Grade: **2**
 O&M Grade: **0**
 Clock Start/From:
 Clock To:
 1st Value:
 2nd Value:
 Value Percent: **5.000**
 Continuous Index: **F03**
 Within 8" of Joint: **NO**
 Remarks:

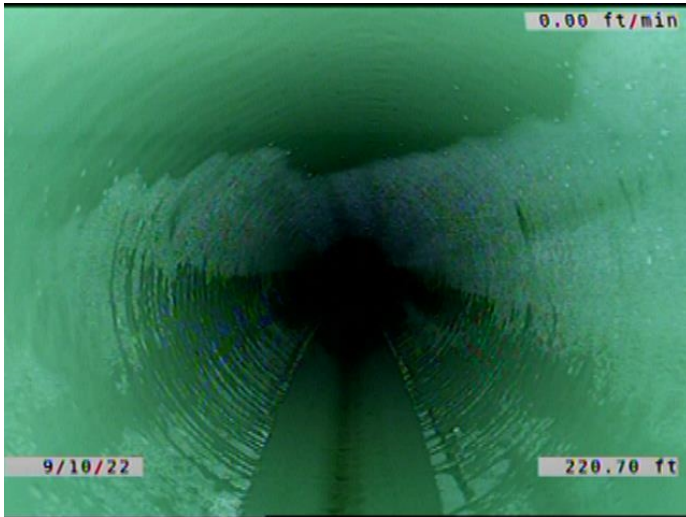
Code: **MWLS**
Description: **Miscellaneous Water Level Sag**

Distance (ft): **220.7**
Structural Grade: **2**
O&M Grade: **0**
Clock Start/From:
Clock To:
1st Value:
2nd Value:
Value Percent: **5.000**
Continuous Index: **S04**
Within 8" of Joint: **NO**
Remarks:

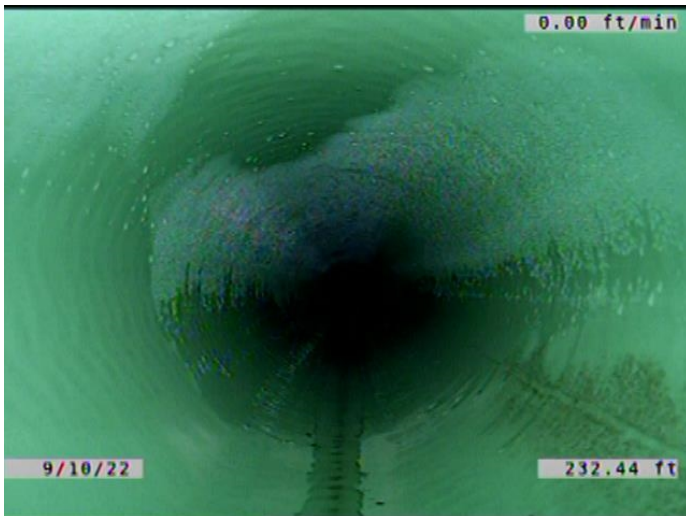
Code: **MWLS**
Description: **Miscellaneous Water Level Sag**

Distance (ft): **232.4**
Structural Grade: **2**
O&M Grade: **0**
Clock Start/From:
Clock To:
1st Value:
2nd Value:
Value Percent: **5.000**
Continuous Index: **F04**
Within 8" of Joint: **NO**
Remarks:

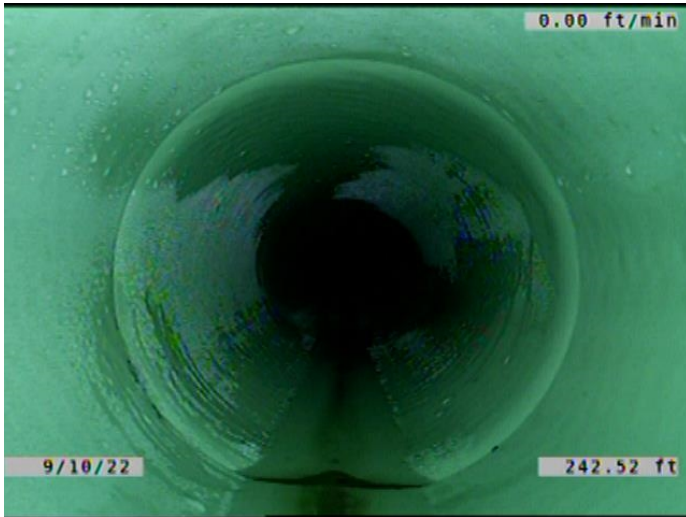
Code: **MWLS**
Description: **Miscellaneous Water Level Sag**

Distance (ft): **242.5**
Structural Grade: **2**
O&M Grade: **0**
Clock Start/From:
Clock To:
1st Value:
2nd Value:
Value Percent: **5.000**
Continuous Index:
Within 8" of Joint: **NO**
Remarks:

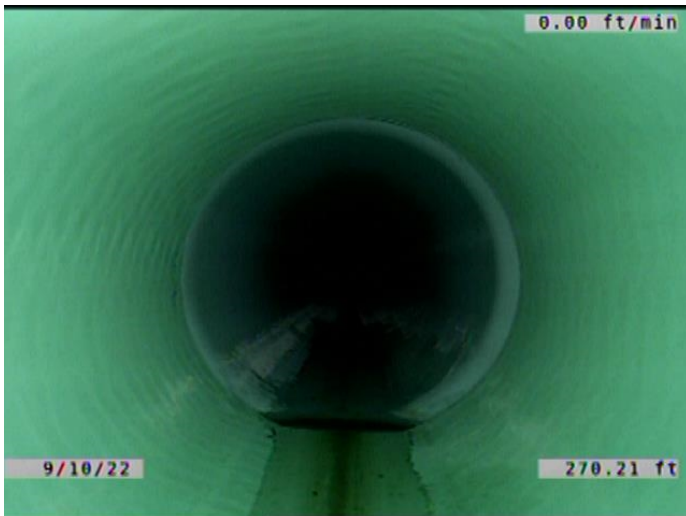
Code: **MWLS**
Description: **Miscellaneous Water Level Sag**

Distance (ft): **270.2**
Structural Grade: **2**
O&M Grade: **0**
Clock Start/From:
Clock To:
1st Value:
2nd Value:
Value Percent: **5.000**
Continuous Index:
Within 8" of Joint: **NO**
Remarks:

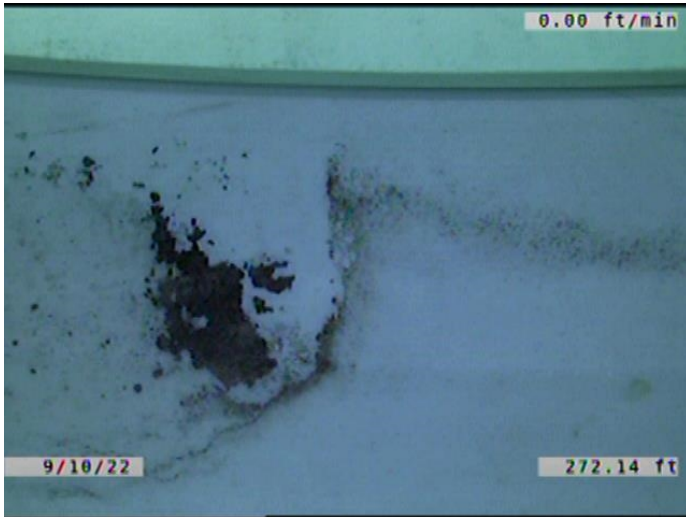
Code: **MGO**
Description: **Miscellaneous General Observation**

Distance (ft): **272.1**
Structural Grade: **0**
O&M Grade: **0**
Clock Start/From:
Clock To:
1st Value:
2nd Value:
Value Percent:
Continuous Index:
Within 8" of Joint: **NO**
Remarks: **JOINT/ PIPES NOT PUSHED ALL THE WAY TOGETHER WHEN INSTALLED**

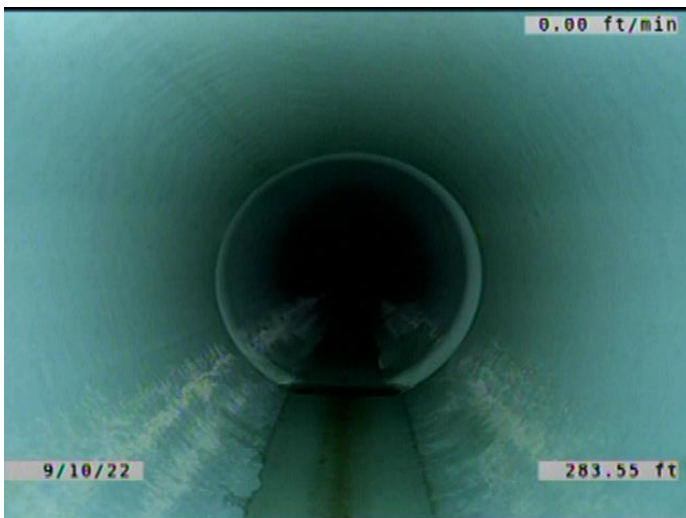
Code: **MWLS**
Description: **Miscellaneous Water Level Sag**

Distance (ft): **283.5**
Structural Grade: **2**
O&M Grade: **0**
Clock Start/From:
Clock To:
1st Value:
2nd Value:
Value Percent: **5.000**
Continuous Index:
Within 8" of Joint: **NO**
Remarks:

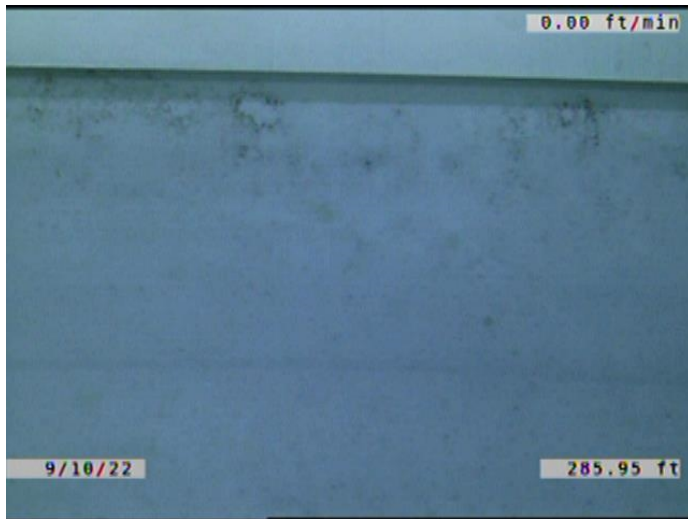
Code: **MGO**
 Description: **Miscellaneous General Observation**

Distance (ft): **286.0**
 Structural Grade: **0**
 O&M Grade: **0**
 Clock Start/From:
 Clock To:
 1st Value:
 2nd Value:
 Value Percent:
 Continuous Index:
 Within 8" of Joint: **NO**
 Remarks: **JOINT/ PIPES NOT PUSHED ALL THE WAY TOGETHER WHEN INSTALLED**

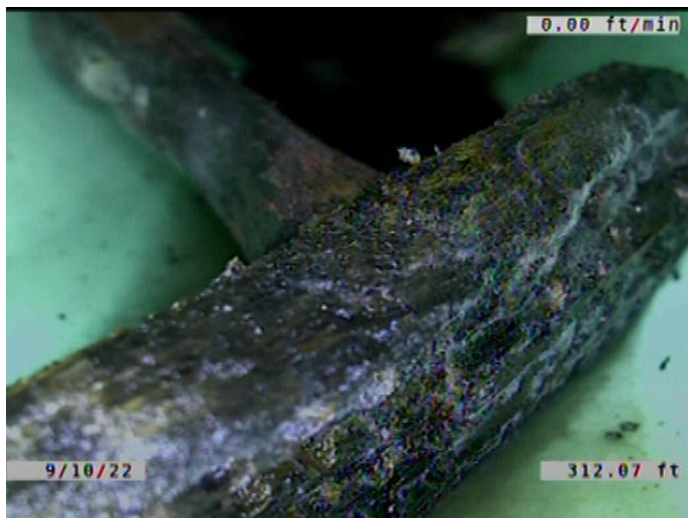
Code: **OBZ**
 Description: **Obstruction Other**

Distance (ft): **312.1**
 Structural Grade: **0**
 O&M Grade: **2**
 Clock Start/From: **5**
 Clock To: **7**
 1st Value:
 2nd Value:
 Value Percent: **5.000**
 Continuous Index:
 Within 8" of Joint: **YES**
 Remarks: **PAINT BRUSH HANDLE**

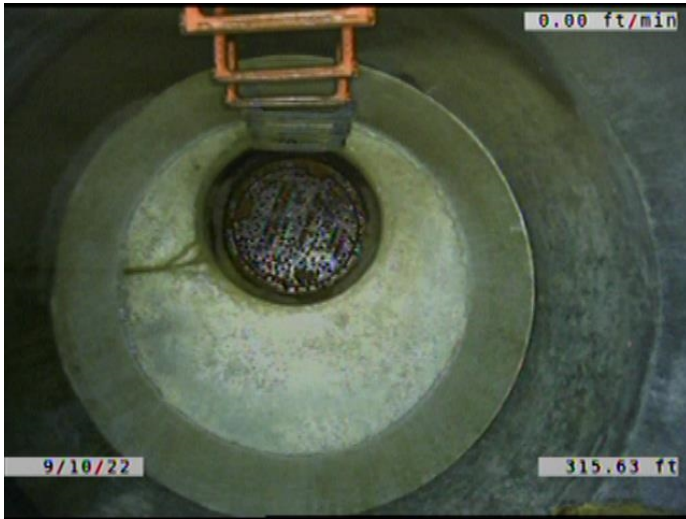
Code:	AMH
Description:	Manhole
Distance (ft):	315.6
Structural Grade:	0
O&M Grade:	0
Clock Start/From:	
Clock To:	
1st Value:	
2nd Value:	
Value Percent:	
Continuous Index:	
Within 8" of Joint:	NO
Remarks:	M-907-009.1
