## Profile/Photo Observation Report

Street:	<b>OFF S UNION ST</b>	Flow Control:	<b>Not Controlled</b>
City:	<b>Hobart, IN</b>	Year Renewed:	
Location:	<b>Parking Lot</b>	Tape/Media #:	
Purpose:	<b>Maintenance Related</b>	Dia/Height:	<b>8"</b>
Use:	<b>Sanitary</b>	Material:	<b>PVC</b>
Drain Area:	<b>NA</b>	Lining:	<b>Cured in Place</b>
Category:	<b>NA</b>		
Comment:

Location Details:		Direction of Survey:	<b>Downstream</b>
US MH:	<b>M-907-011</b>	DS MH:	<b>M-907-010</b>
		Total Length Surveyed (ft):	<b>401.0</b>

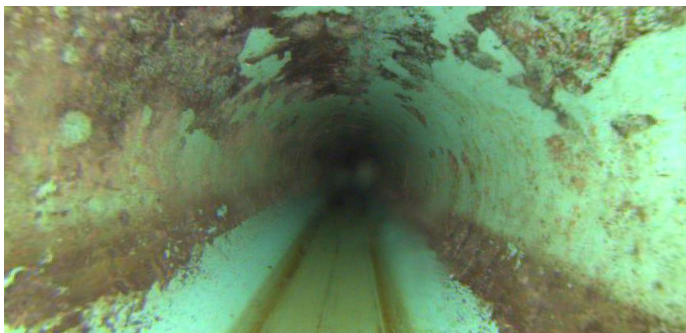
Code: **AMH**  
Description: **Manhole**

Distance (ft): **.0**  
Structural Grade: **0**  
O&M Grade: **0**  
Clock Start/From:  
Clock To:  
1st Value:  
2nd Value:  
Value Percent:  
Continuous Index:  
Within 8" of Joint: **NO**  
Remarks: **M-907-011**

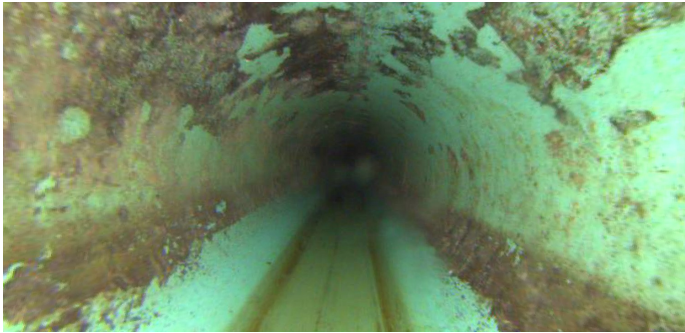
Code:	<b>MWL</b>
Description:	<b>Water Level</b>

Distance (ft):	<b>.0</b>
Structural Grade:	<b>0</b>
O&M Grade:	<b>0</b>
Clock Start/From:	
Clock To:	
1st Value:	
2nd Value:	
Value Percent:	<b>5.000</b>
Continuous Index:	
Within 8" of Joint:	<b>NO</b>
Remarks:

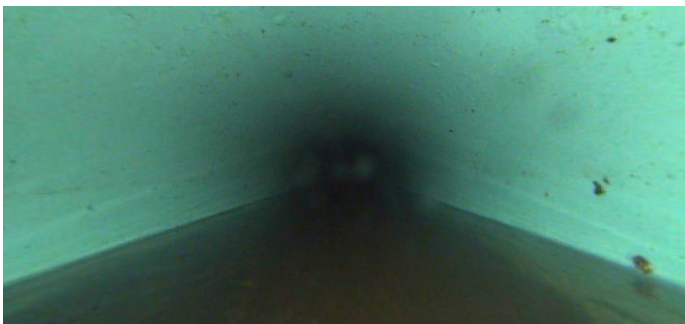
Code:	<b>MWL</b>
Description:	<b>Water Level</b>

Distance (ft):	<b>56.2</b>
Structural Grade:	<b>0</b>
O&M Grade:	<b>0</b>
Clock Start/From:	
Clock To:	
1st Value:	
2nd Value:	
Value Percent:	<b>30.000</b>
Continuous Index:	
Within 8" of Joint:	<b>NO</b>
Remarks:

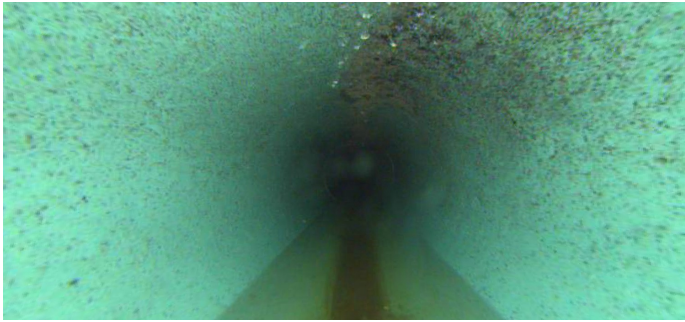
Code: **MWL**  
Description: **Water Level**

Distance (ft): **80.6**  
Structural Grade: **0**  
O&M Grade: **0**  
Clock Start/From:  
Clock To:  
1st Value:  
2nd Value:  
Value Percent: **5.000**  
Continuous Index:  
Within 8" of Joint: **NO**  
Remarks:

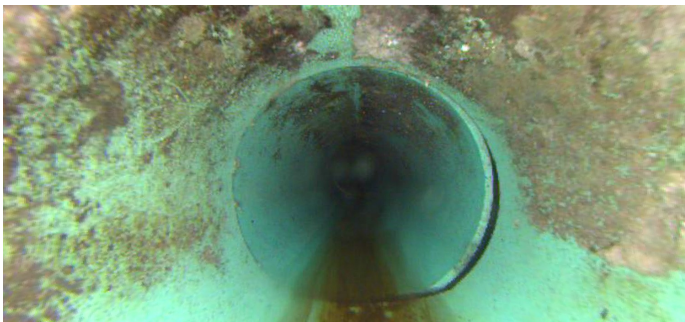
Code: **JOM**  
Description: **Joint Offset Medium**

Distance (ft): **139.4**  
Structural Grade: **1**  
O&M Grade: **0**  
Clock Start/From:  
Clock To:  
1st Value:  
2nd Value:  
Value Percent:  
Continuous Index:  
Within 8" of Joint: **NO**  
Remarks:

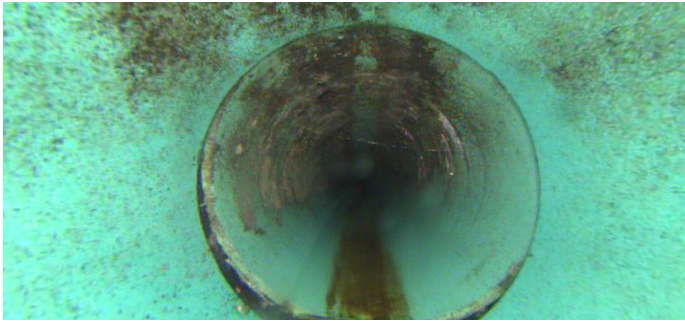
Code: **JOM**  
Description: **Joint Offset Medium**

Distance (ft): **142.5**  
Structural Grade: **1**  
O&M Grade: **0**  
Clock Start/From:  
Clock To:  
1st Value:  
2nd Value:  
Value Percent:  
Continuous Index:  
Within 8" of Joint: **NO**  
Remarks:

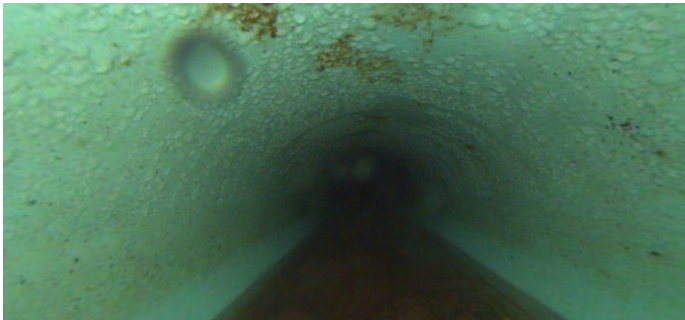
Code: **MWL**  
Description: **Water Level**

Distance (ft): **199.8**  
Structural Grade: **0**  
O&M Grade: **0**  
Clock Start/From:  
Clock To:  
1st Value:  
2nd Value:  
Value Percent: **10.000**  
Continuous Index:  
Within 8" of Joint: **NO**  
Remarks:

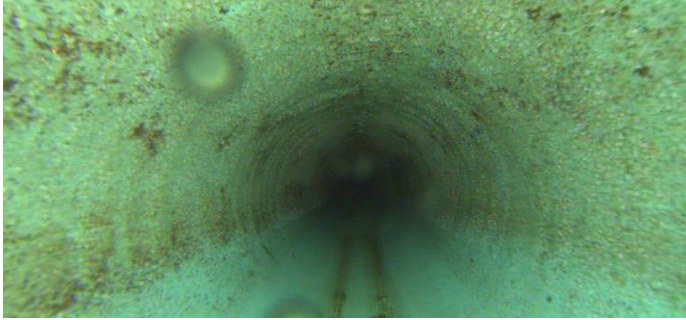
Code: **MWL**  
Description: **Water Level**

Distance (ft): **204.7**  
Structural Grade: **0**  
O&M Grade: **0**  
Clock Start/From:  
Clock To:  
1st Value:  
2nd Value:  
Value Percent: **5.000**  
Continuous Index:  
Within 8" of Joint: **NO**  
Remarks:

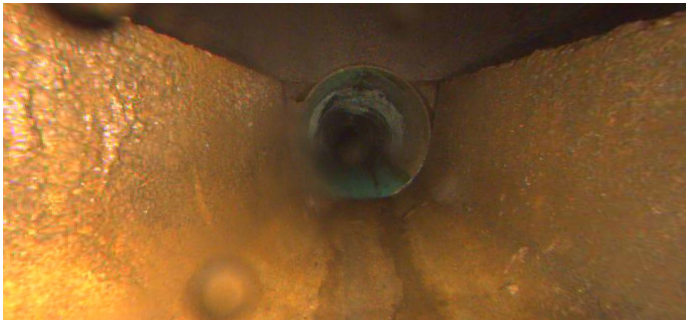
Code: **AMH**  
Description: **Manhole**

Distance (ft): **401.0**  
Structural Grade: **0**  
O&M Grade: **0**  
Clock Start/From:  
Clock To:  
1st Value:  
2nd Value:  
Value Percent:  
Continuous Index:  
Within 8" of Joint: **NO**  
Remarks: **M-907-010**
