Profile/Photo Observation Report

Date:	04/12/2018	Weather:		Coding:	PACP 6.0
Pipe Length (ft):	331.1	Owner:	NA	Pre Clean:	Not Known
P.O.#:		Surveyor:	Jen Costello	PSR:	P-907-012-013
Customer:		Clean Date:	01/01/1900	Shape:	C

Location Details:		Direction of Survey:	Upstream
US MH:	M-907-013	DS MH:	M-907-012
		Total Length Surveyed (ft):	325.6

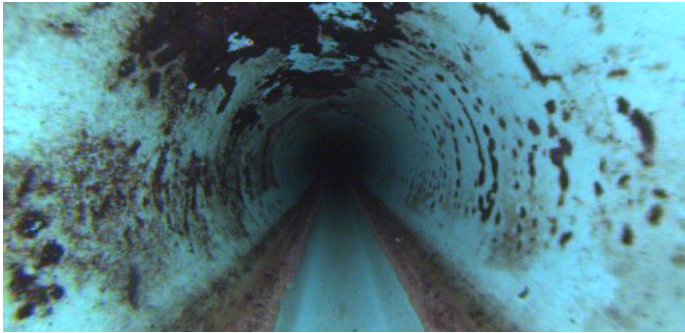
Code:	MWL
Description:	Water Level

Distance (ft):	.0
Structural Grade:	0
O&M Grade:	0
Clock Start/From:	
Clock To:	
1st Value:	
2nd Value:	
Value Percent:	5.000
Continuous Index:	
Within 8" of Joint:	NO
Remarks:

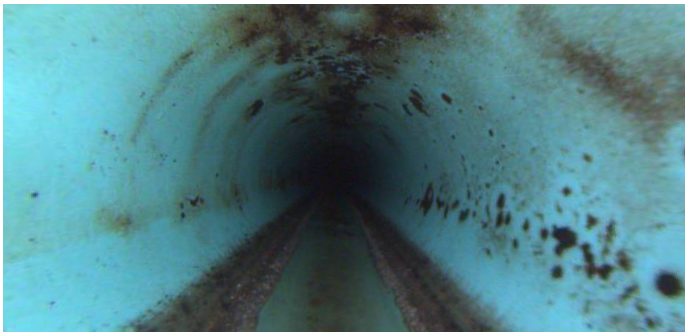
Code:	DAGS
Description:	Deposits Attached Grease

Distance (ft):	4.4
Structural Grade:	0
O&M Grade:	2
Clock Start/From:	5
Clock To:	7
1st Value:	
2nd Value:	
Value Percent:	5.000
Continuous Index:	S01
Within 8" of Joint:	NO
Remarks:

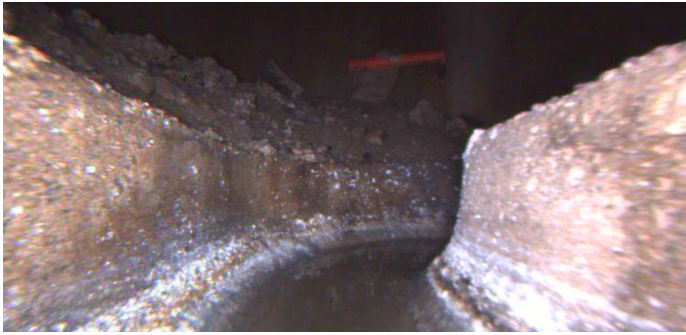
Code: **DAGS**
Description: **Deposits Attached Grease**

Distance (ft): **324.0**
Structural Grade: **0**
O&M Grade: **2**
Clock Start/From: **5**
Clock To: **7**
1st Value:
2nd Value:
Value Percent: **5.000**
Continuous Index: **F01**
Within 8" of Joint: **NO**
Remarks:

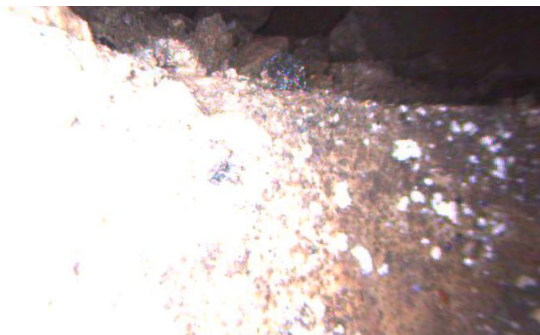
Code: **AMH**
Description: **Manhole**

Distance (ft): **325.6**
Structural Grade: **0**
O&M Grade: **0**
Clock Start/From:
Clock To:
1st Value:
2nd Value:
Value Percent:
Continuous Index:
Within 8" of Joint: **NO**
Remarks: **M-907-013**
