Profile/Photo Observation Report

Date:	04/12/2018	Weather:		Coding:	PACP 6.0
Pipe Length (ft):	331.1	Owner:	NA	Pre Clean:	Not Known
P.O.#:		Surveyor:	Jen Costello	PSR:	P-907-012-013
Customer:		Clean Date:	01/01/1900	Shape:	C

Street:	Capitol	Flow Control:	Not Controlled
City:	Hobart, IN	Year Renewed:	
Location:	Parking Lot	Tape/Media #:	
Purpose:	Maintenance Related	Dia/Height:	8"
Use:	Sanitary	Material:	PVC
Drain Area:	NA	Lining:	Cured in Place
Category:	NA		
Comment:	flow incorrect.

Location Details:		Direction of Survey:	Upstream
US MH:	M-907-013	DS MH:	M-907-012
		Total Length Surveyed (ft):	325.6

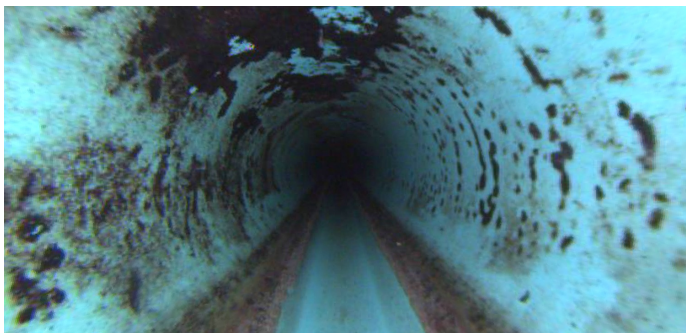
Code: **AMH**
Description: **Manhole**

Distance (ft): **.0**
Structural Grade: **0**
O&M Grade: **0**
Clock Start/From:
Clock To:
1st Value:
2nd Value:
Value Percent:
Continuous Index:
Within 8" of Joint: **NO**
Remarks: **M-907-012**

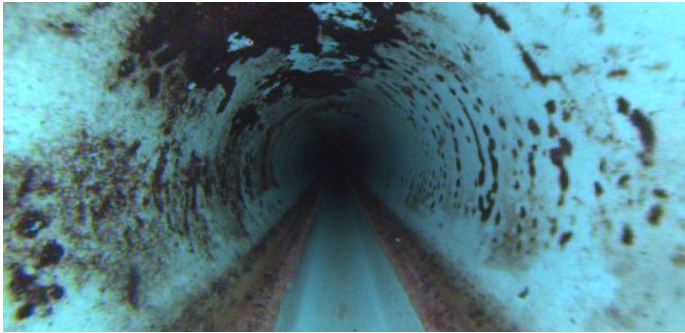
Code:	MWL
Description:	Water Level

Distance (ft):	.0
Structural Grade:	0
O&M Grade:	0
Clock Start/From:	
Clock To:	
1st Value:	
2nd Value:	
Value Percent:	5.000
Continuous Index:	
Within 8" of Joint:	NO
Remarks:

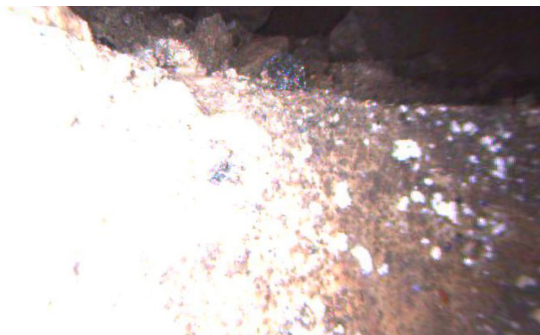
Code: **AMH**
Description: **Manhole**

Distance (ft): **325.6**
Structural Grade: **0**
O&M Grade: **0**
Clock Start/From:
Clock To:
1st Value:
2nd Value:
Value Percent:
Continuous Index:
Within 8" of Joint: **NO**
Remarks: **M-907-013**
