Profile/Photo Observation Report

| Street: | East 10th Street | Flow Control: | Not Controlled |
| Use: | Sanitary Sewage Pipe | Material: | PVC |

| US MH: | M-907-014 | DS MH: | M-907-013 |

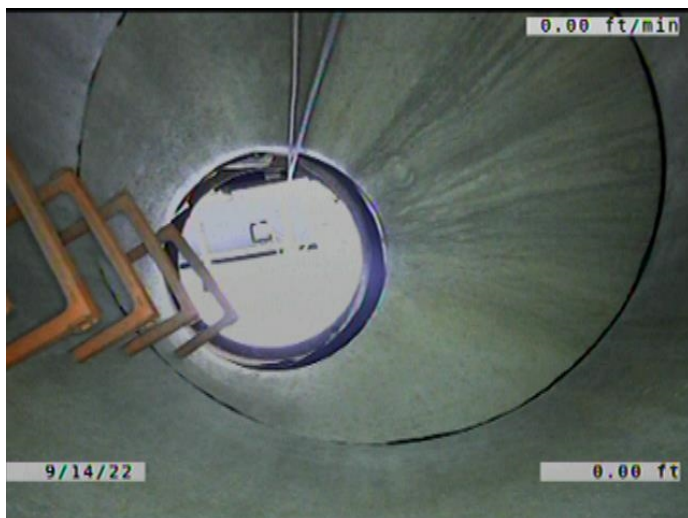
Code: **AMH**
Description: **Manhole**

Distance (ft): **.0**
Structural Grade: **0**
O&M Grade: **0**
Clock Start/From:
Clock To:
1st Value:
2nd Value:
Value Percent:
Continuous Index:
Within 8" of Joint: **NO**
Remarks: **M-907-014**

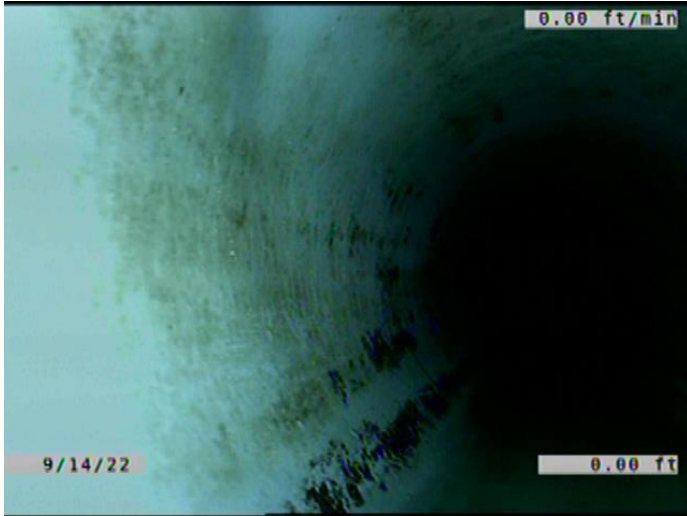
Code: **MWL**
Description: **Miscellaneous Water Level**

Distance (ft): **.0**
Structural Grade: **0**
O&M Grade: **0**
Clock Start/From:
Clock To:
1st Value:
2nd Value:
Value Percent: **5.000**
Continuous Index:
Within 8" of Joint: **NO**
Remarks:

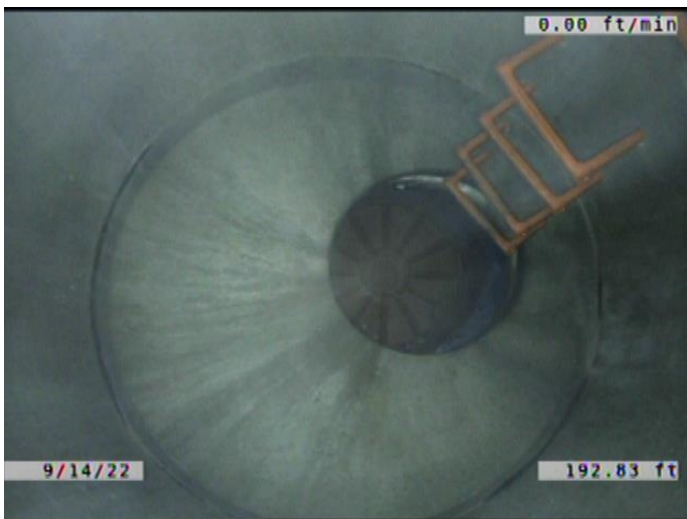
Code: **AMH**
Description: **Manhole**

Distance (ft): **192.8**
Structural Grade: **0**
O&M Grade: **0**
Clock Start/From:
Clock To:
1st Value:
2nd Value:
Value Percent:
Continuous Index:
Within 8" of Joint: **NO**
Remarks: **M-907-013**
