Profile/Photo Observation Report

Date:	04/13/2018	Weather:		Coding:	PACP 6.0
Pipe Length (ft):	387.0	Owner:	NA	Pre Clean:	Not Known
P.O.#:		Surveyor:	John Kuglmaier	PSR:	P-907-015-016
Customer:		Clean Date:	01/01/1900	Shape:	C

Street:	OFF S UNION ST	Flow Control:	Not Controlled		
City:	Hobart, IN	Year Renewed:			
Location:	Parking Lot	Tape/Media #:			
Purpose:	Maintenance Related	Dia/Height:	8"		
Use:	Sanitary	Material:	PVC		
Drain Area:	NA	Lining:	Cured in Place		
Category:	NA				
Comment:	rear camera only				
Location Details:		Direction of Survey:	Downstream		
US MH:	M-907-016	DS MH:	M-907-015	Total Length Surveyed (ft):	390.7

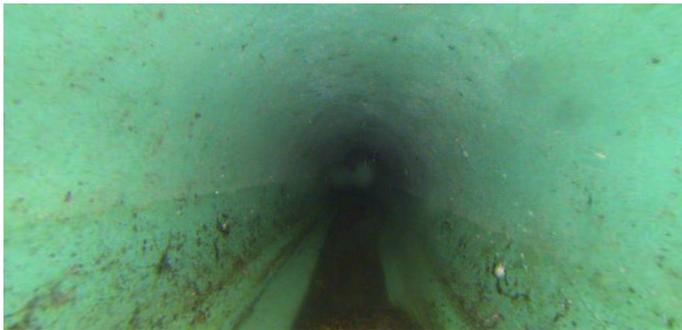
Code: **AMH**
Description: **Manhole**

Distance (ft): **.0**
Structural Grade: **0**
O&M Grade: **0**
Clock Start/From:
Clock To:
1st Value:
2nd Value:
Value Percent:
Continuous Index:
Within 8" of Joint: **NO**
Remarks: **M-907-016**

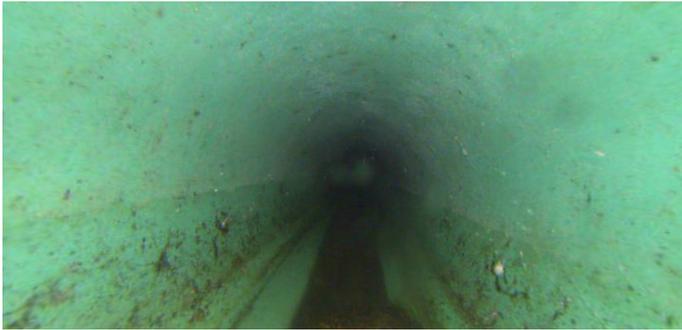
Code: **MWL**
Description: **Water Level**

Distance (ft): **.0**
Structural Grade: **0**
O&M Grade: **0**
Clock Start/From:
Clock To:
1st Value:
2nd Value:
Value Percent: **5.000**
Continuous Index:
Within 8" of Joint: **NO**
Remarks:

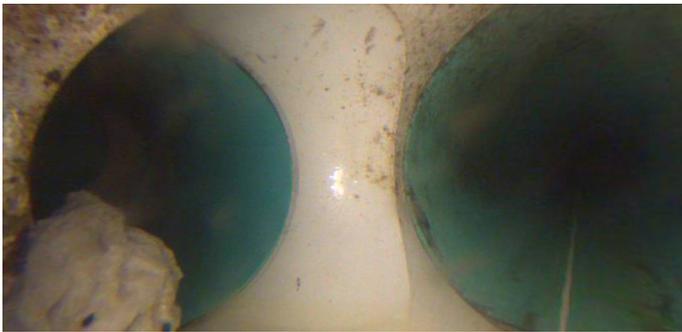
Code: **TFD**
Description: **Tap Factory Defective**

Distance (ft): **280.7**
Structural Grade: **0**
O&M Grade: **2**
Clock Start/From: **3**
Clock To:
1st Value: **4.000**
2nd Value:
Value Percent:
Continuous Index:
Within 8" of Joint:
Remarks: **dags**

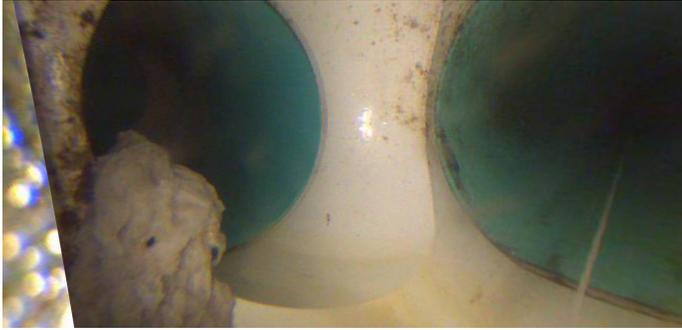
Code: **DAR**
Description: **Deposits Attached Ragging**

Distance (ft): **280.7**
Structural Grade: **0**
O&M Grade: **2**
Clock Start/From: **3**
Clock To: **4**
1st Value:
2nd Value:
Value Percent: **5.000**
Continuous Index:
Within 8" of Joint: **NO**
Remarks:
