Profile/Photo Observation Report

Location Details:		Direction of Survey:	Downstream
US MH:	M-907-016	DS MH:	M-907-015
		Total Length Surveyed (ft):	390.7

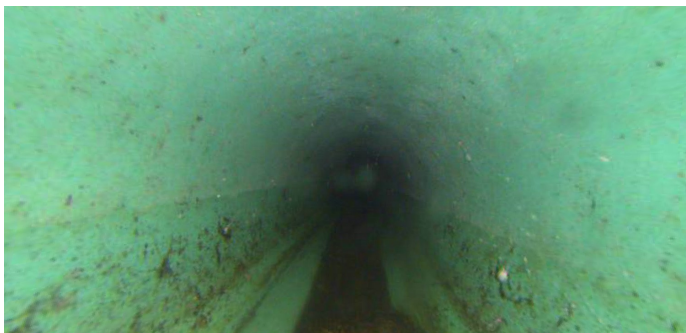
Code: **AMH**
Description: **Manhole**

Distance (ft): **.0**
Structural Grade: **0**
O&M Grade: **0**
Clock Start/From:
Clock To:
1st Value:
2nd Value:
Value Percent:
Continuous Index:
Within 8" of Joint: **NO**
Remarks: **M-907-016**

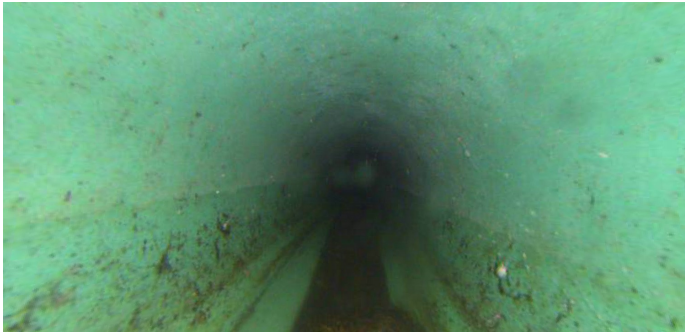
Code:	MWL
Description:	Water Level

Distance (ft):	.0
Structural Grade:	0
O&M Grade:	0
Clock Start/From:	
Clock To:	
1st Value:	
2nd Value:	
Value Percent:	5.000
Continuous Index:	
Within 8" of Joint:	NO
Remarks:

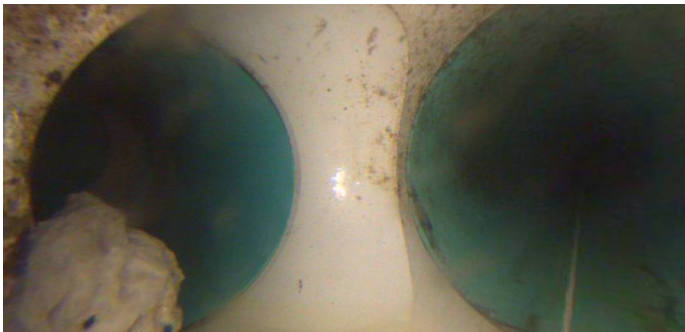
Code:	TFD
Description:	Tap Factory Defective

Distance (ft):	280.7
Structural Grade:	0
O&M Grade:	2
Clock Start/From:	3
Clock To:	
1st Value:	4.000
2nd Value:	
Value Percent:	
Continuous Index:	
Within 8" of Joint:	
Remarks:	dags

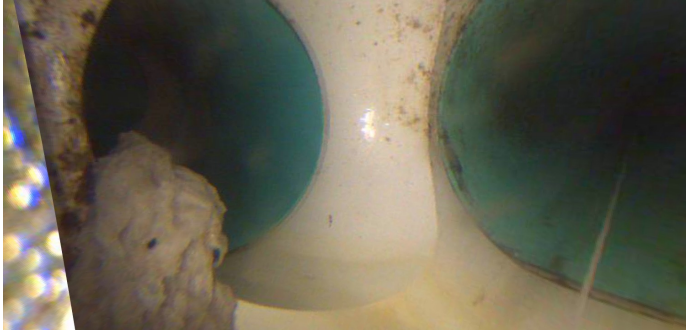
Code: **DAR**
Description: **Deposits Attached Ragging**

Distance (ft): **280.7**
Structural Grade: **0**
O&M Grade: **2**
Clock Start/From: **3**
Clock To: **4**
1st Value:
2nd Value:
Value Percent: **5.000**
Continuous Index:
Within 8" of Joint: **NO**
Remarks:

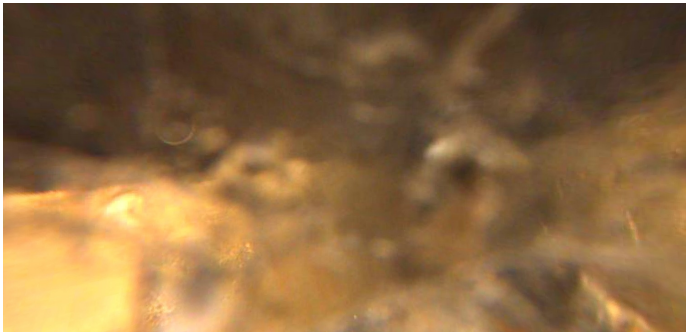
Code: **AMH**
Description: **Manhole**

Distance (ft): **390.7**
Structural Grade: **0**
O&M Grade: **0**
Clock Start/From:
Clock To:
1st Value:
2nd Value:
Value Percent:
Continuous Index:
Within 8" of Joint: **NO**
Remarks: **M-907-015**
