## Profile/Photo Observation Report

Street:	<b>OFF S UNION ST</b>	Flow Control:	<b>Not Controlled</b>
City:	<b>Hobart, IN</b>	Year Renewed:	
Location:	<b>Parking Lot</b>	Tape/Media #:	
Purpose:	<b>Maintenance Related</b>	Dia/Height:	<b>8"</b>
Use:	<b>Sanitary</b>	Material:	<b>PVC</b>
Drain Area:	<b>NA</b>	Lining:	<b>Cured in Place</b>
Category:	<b>NA</b>		
Comment:	<b>flow incorrect.</b>

Location Details:		Direction of Survey:	<b>Downstream</b>
US MH:	<b>M-907-017</b>	DS MH:	<b>M-907-016</b>
		Total Length Surveyed (ft):	<b>397.0</b>

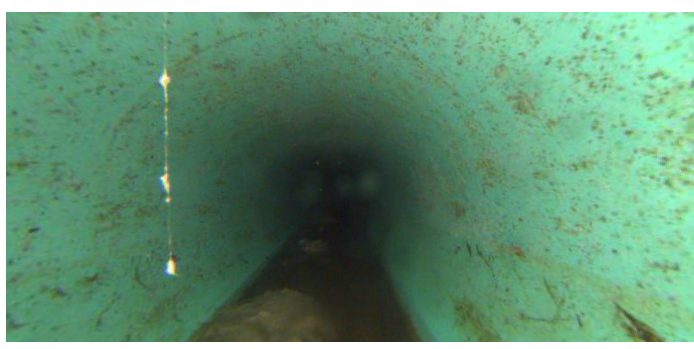
Code: **AMH**  
Description: **Manhole**

Distance (ft): **.0**  
Structural Grade: **0**  
O&M Grade: **0**  
Clock Start/From:  
Clock To:  
1st Value:  
2nd Value:  
Value Percent:  
Continuous Index:  
Within 8" of Joint: **NO**  
Remarks: **M-907-017**

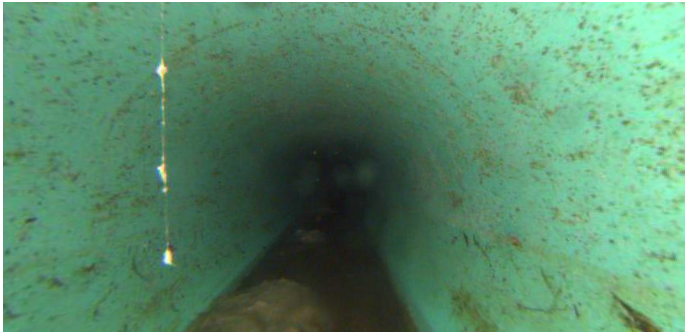
Code:	<b>MWL</b>
Description:	<b>Water Level</b>

Distance (ft):	<b>.0</b>
Structural Grade:	<b>0</b>
O&M Grade:	<b>0</b>
Clock Start/From:	
Clock To:	
1st Value:	
2nd Value:	
Value Percent:	<b>5.000</b>
Continuous Index:	
Within 8" of Joint:	<b>NO</b>
Remarks:

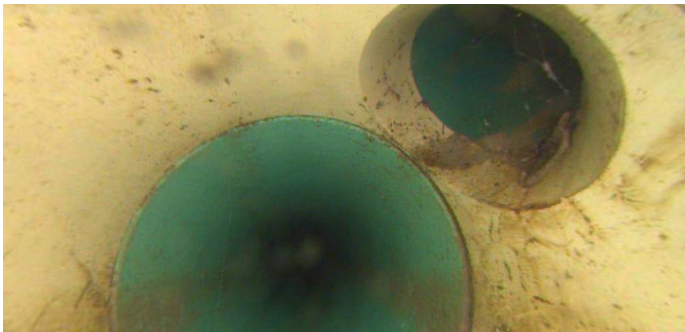
Code:	<b>TF</b>
Description:	<b>Tap Factory</b>

Distance (ft):	<b>229.3</b>
Structural Grade:	<b>0</b>
O&M Grade:	<b>0</b>
Clock Start/From:	<b>1</b>
Clock To:	
1st Value:	<b>4.000</b>
2nd Value:	
Value Percent:	
Continuous Index:	
Within 8" of Joint:	
Remarks:

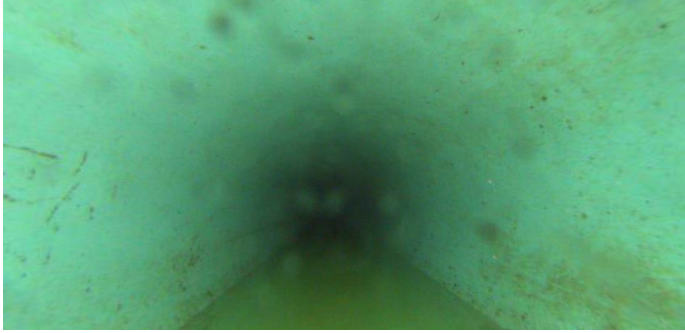
Code: **MWL**  
Description: **Water Level**

Distance (ft): **370.9**  
Structural Grade: **0**  
O&M Grade: **0**  
Clock Start/From:  
Clock To:  
1st Value:  
2nd Value:  
Value Percent: **10.000**  
Continuous Index:  
Within 8" of Joint: **NO**  
Remarks:

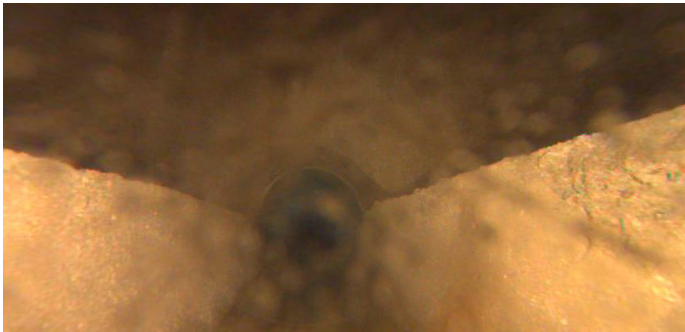
Code: **AMH**  
Description: **Manhole**

Distance (ft): **397.0**  
Structural Grade: **0**  
O&M Grade: **0**  
Clock Start/From:  
Clock To:  
1st Value:  
2nd Value:  
Value Percent:  
Continuous Index:  
Within 8" of Joint: **NO**  
Remarks: **M-907-016**
