Profile/Photo Observation Report

Street:	Capitol	Flow Control:	Not Controlled
City:	Hobart, IN	Year Renewed:	
Location:	Parking Lot	Tape/Media #:	
Purpose:	Maintenance Related	Dia/Height:	8"
Use:	Sanitary	Material:	PVC
Drain Area:	NA	Lining:	Cured in Place
Category:	NA		
Comment:	flow incorrect.

Location Details:		Direction of Survey:	Downstream
US MH:	M-907-017	DS MH:	M-907-016
		Total Length Surveyed (ft):	397.0

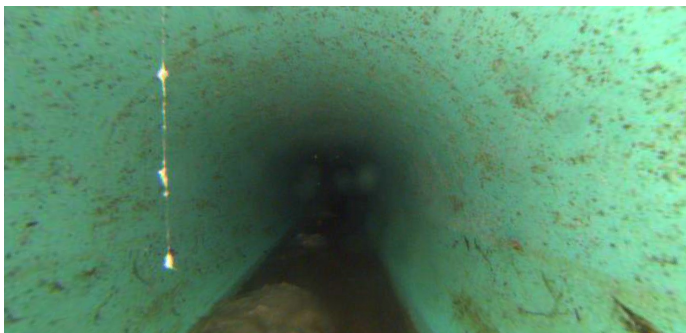
Code: **AMH**
Description: **Manhole**

Distance (ft): **.0**
Structural Grade: **0**
O&M Grade: **0**
Clock Start/From:
Clock To:
1st Value:
2nd Value:
Value Percent:
Continuous Index:
Within 8" of Joint: **NO**
Remarks: **M-907-017**

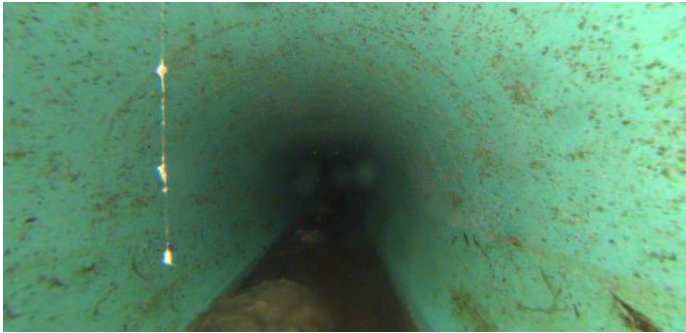
Code:	MWL
Description:	Water Level

Distance (ft):	.0
Structural Grade:	0
O&M Grade:	0
Clock Start/From:	
Clock To:	
1st Value:	
2nd Value:	
Value Percent:	5.000
Continuous Index:	
Within 8" of Joint:	NO
Remarks:

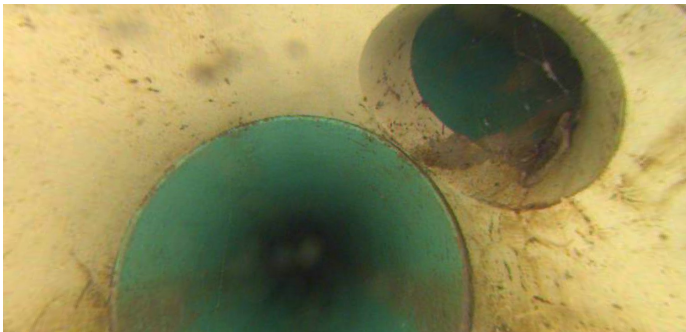
Code:	TF
Description:	Tap Factory

Distance (ft):	229.3
Structural Grade:	0
O&M Grade:	0
Clock Start/From:	1
Clock To:	
1st Value:	4.000
2nd Value:	
Value Percent:	
Continuous Index:	
Within 8" of Joint:	
Remarks:

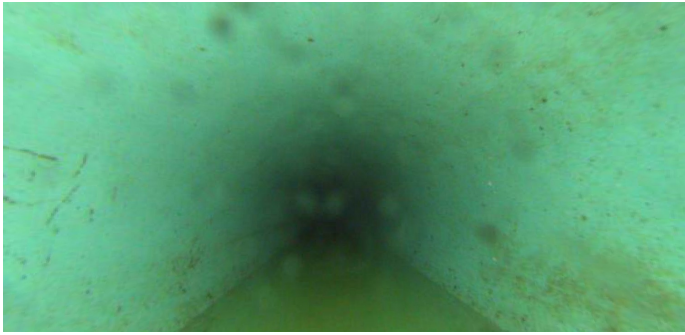
Code: **MWL**
Description: **Water Level**

Distance (ft): **370.9**
Structural Grade: **0**
O&M Grade: **0**
Clock Start/From:
Clock To:
1st Value:
2nd Value:
Value Percent: **10.000**
Continuous Index:
Within 8" of Joint: **NO**
Remarks:

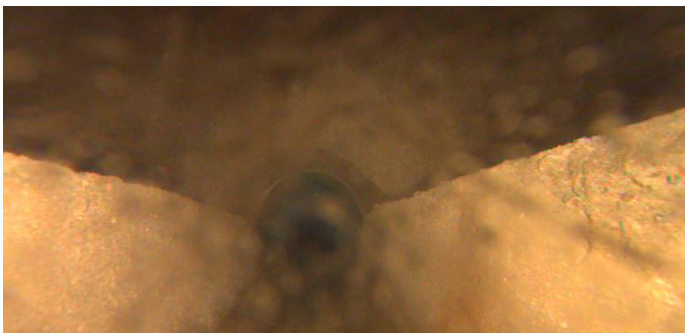
Code: **AMH**
Description: **Manhole**

Distance (ft): **397.0**
Structural Grade: **0**
O&M Grade: **0**
Clock Start/From:
Clock To:
1st Value:
2nd Value:
Value Percent:
Continuous Index:
Within 8" of Joint: **NO**
Remarks: **M-907-016**
