## Profile/Photo Observation Report

Street:	<b>OFF S UNION ST</b>	Flow Control:	<b>Not Controlled</b>
City:	<b>Hobart, IN</b>	Year Renewed:	
Location:	<b>Parking Lot</b>	Tape/Media #:	
Purpose:	<b>Maintenance Related</b>	Dia/Height:	<b>8"</b>
Use:	<b>Sanitary</b>	Material:	<b>PVC</b>
Drain Area:	<b>NA</b>	Lining:	<b>Cured in Place</b>
Category:	<b>NA</b>		
Comment:	<b>flow incorrect.</b>

Location Details:		Direction of Survey:	<b>Upstream</b>
US MH:	<b>M-907-018</b>	DS MH:	<b>M-907-017</b>
		Total Length Surveyed (ft):	<b>285.1</b>

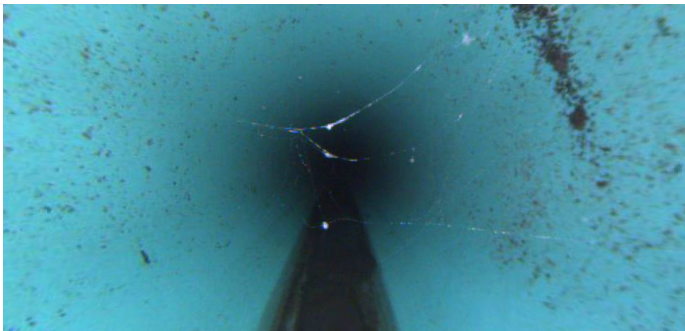
Code: **AMH**  
Description: **Manhole**

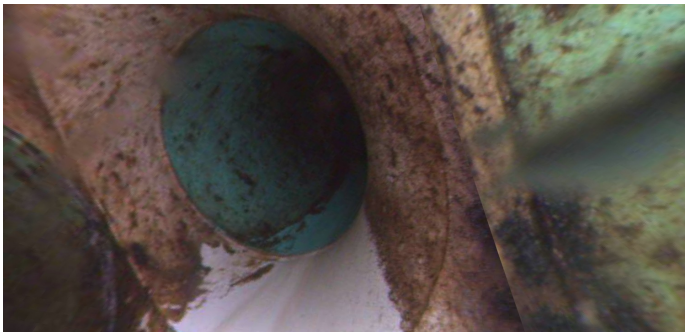
Code:	<b>TF</b>
Description:	<b>Tap Factory</b>

Distance (ft):	<b>60.4</b>
Structural Grade:	<b>0</b>
O&M Grade:	<b>0</b>
Clock Start/From:	<b>10</b>
Clock To:	
1st Value:	<b>4.000</b>
2nd Value:	
Value Percent:	
Continuous Index:	
Within 8" of Joint:	
Remarks:

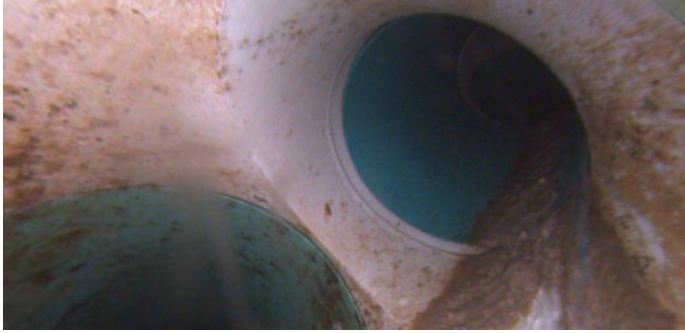
Code: **TF**  
Description: **Tap Factory**

Distance (ft): **247.2**  
Structural Grade: **0**  
O&M Grade: **0**  
Clock Start/From: **11**  
Clock To:  
1st Value: **4.000**  
2nd Value:  
Value Percent:  
Continuous Index:  
Within 8" of Joint:  
Remarks:

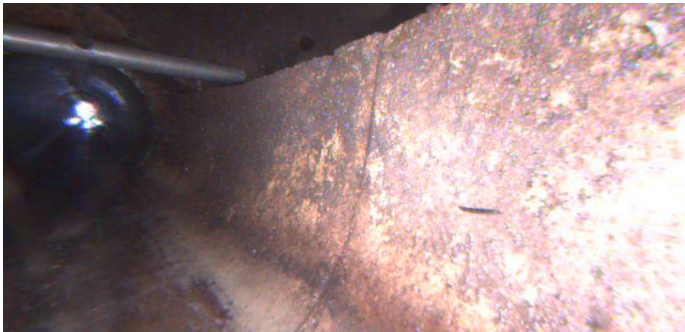
Code: **AMH**  
Description: **Manhole**

Distance (ft): **285.1**  
Structural Grade: **0**  
O&M Grade: **0**  
Clock Start/From:  
Clock To:  
1st Value:  
2nd Value:  
Value Percent:  
Continuous Index:  
Within 8" of Joint: **NO**  
Remarks: **M-907-018**
