Profile/Photo Observation Report

Date:	04/12/2018	Weather:		Coding:	PACP 6.0
Pipe Length (ft):	295.3	Owner:	NA	Pre Clean:	Not Known
P.O.#:		Surveyor:	Jen Costello	PSR:	P-907-017-018
Customer:		Clean Date:	01/01/1900	Shape:	C

Location Details:		Direction of Survey:	Upstream
US MH:	M-907-018	DS MH:	M-907-017
		Total Length Surveyed (ft):	285.1

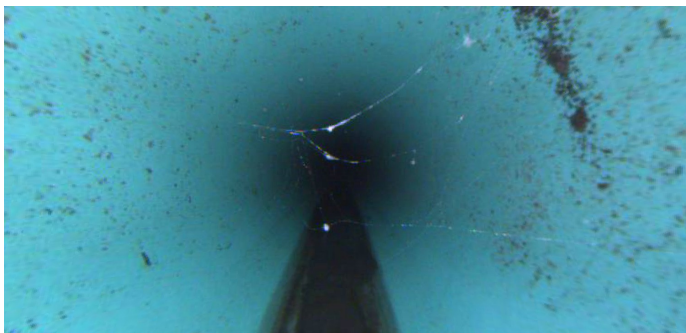
Code: **AMH**
Description: **Manhole**

Distance (ft): **.0**
Structural Grade: **0**
O&M Grade: **0**
Clock Start/From:
Clock To:
1st Value:
2nd Value:
Value Percent:
Continuous Index:
Within 8" of Joint: **NO**
Remarks: **M-907-017**

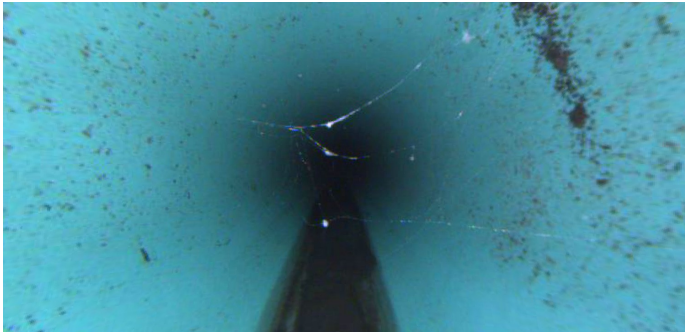
Code:	MWL
Description:	Water Level

Distance (ft):	.0
Structural Grade:	0
O&M Grade:	0
Clock Start/From:	
Clock To:	
1st Value:	
2nd Value:	
Value Percent:	5.000
Continuous Index:	
Within 8" of Joint:	NO
Remarks:

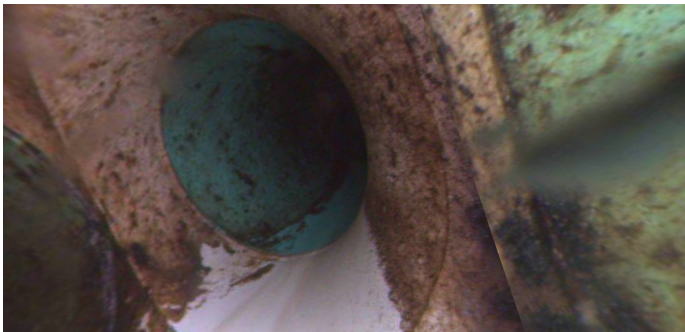
Code:	TF
Description:	Tap Factory

Distance (ft):	60.4
Structural Grade:	0
O&M Grade:	0
Clock Start/From:	10
Clock To:	
1st Value:	4.000
2nd Value:	
Value Percent:	
Continuous Index:	
Within 8" of Joint:	
Remarks:

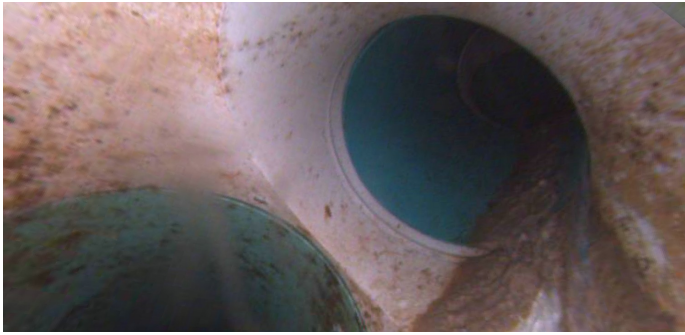
Code: **TF**
Description: **Tap Factory**

Distance (ft): **247.2**
Structural Grade: **0**
O&M Grade: **0**
Clock Start/From: **11**
Clock To:
1st Value: **4.000**
2nd Value:
Value Percent:
Continuous Index:
Within 8" of Joint:
Remarks:

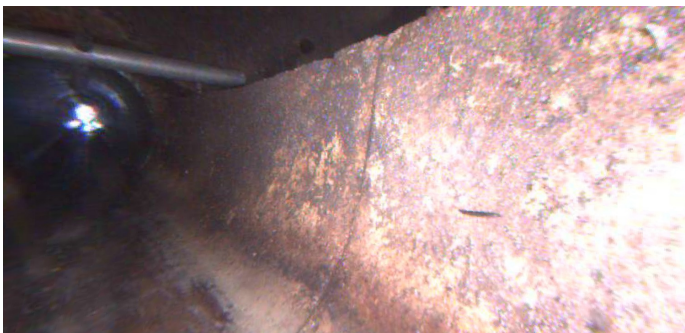
Code: **AMH**
Description: **Manhole**

Distance (ft): **285.1**
Structural Grade: **0**
O&M Grade: **0**
Clock Start/From:
Clock To:
1st Value:
2nd Value:
Value Percent:
Continuous Index:
Within 8" of Joint: **NO**
Remarks: **M-907-018**
