## Profile/Photo Observation Report

Street:	<b>OFF E 10TH ST</b>	Flow Control:	<b>Not Controlled</b>
City:	<b>Hobart, IN</b>	Year Renewed:	
Location:	<b>Parking Lot</b>	Tape/Media #:	
Purpose:	<b>Maintenance Related</b>	Dia/Height:	<b>8"</b>
Use:	<b>Sanitary</b>	Material:	<b>PVC</b>
Drain Area:	<b>NA</b>	Lining:	<b>Cured in Place</b>
Category:	<b>NA</b>		
Comment:	<b>pipe change at 391' just before drop connection-flow incorrect.</b>		
Location Details:		Direction of Survey:	<b>Downstream</b>
US MH:	<b>M-907-020</b>	DS MH:	<b>M-907-014</b>
		Total Length Surveyed (ft):	<b>392.6</b>

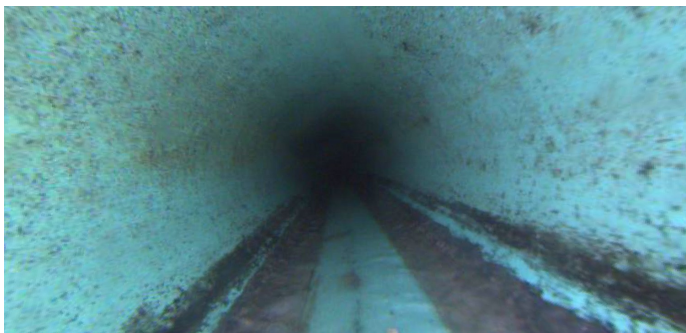
Code: **AMH**  
Description: **Manhole**

Distance (ft): **.0**  
Structural Grade: **0**  
O&M Grade: **0**  
Clock Start/From:  
Clock To:  
1st Value:  
2nd Value:  
Value Percent:  
Continuous Index:  
Within 8" of Joint: **NO**  
Remarks: **M-907-020**

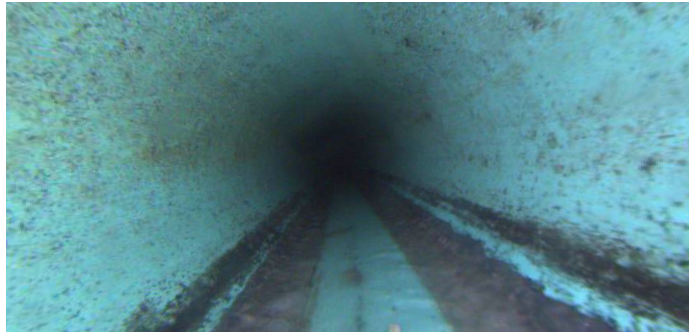
Code: **MWL**  
Description: **Water Level**

Distance (ft): **.0**  
Structural Grade: **0**  
O&M Grade: **0**  
Clock Start/From:  
Clock To:  
1st Value:  
2nd Value:  
Value Percent: **5.000**  
Continuous Index:  
Within 8" of Joint: **NO**  
Remarks:

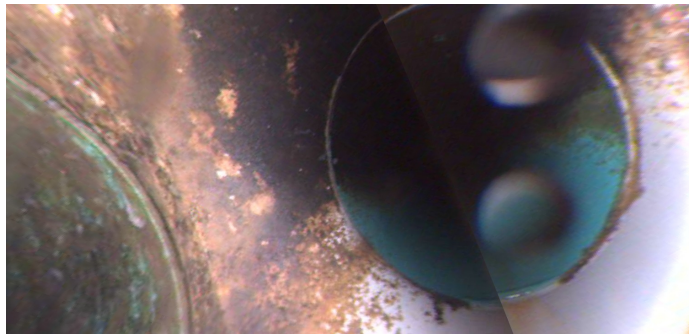
Code: **TF**  
Description: **Tap Factory**

Distance (ft): **51.3**  
Structural Grade: **0**  
O&M Grade: **0**  
Clock Start/From: **2**  
Clock To:  
1st Value: **4.000**  
2nd Value:  
Value Percent:  
Continuous Index:  
Within 8" of Joint:  
Remarks:

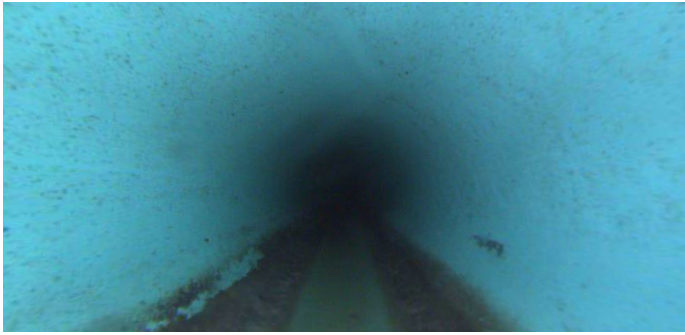
Code: **DAGS**  
Description: **Deposits Attached Grease**

Distance (ft): **124.8**  
Structural Grade: **0**  
O&M Grade: **2**  
Clock Start/From: **5**  
Clock To: **7**  
1st Value:  
2nd Value:  
Value Percent: **5.000**  
Continuous Index: **S01**  
Within 8" of Joint: **NO**  
Remarks:

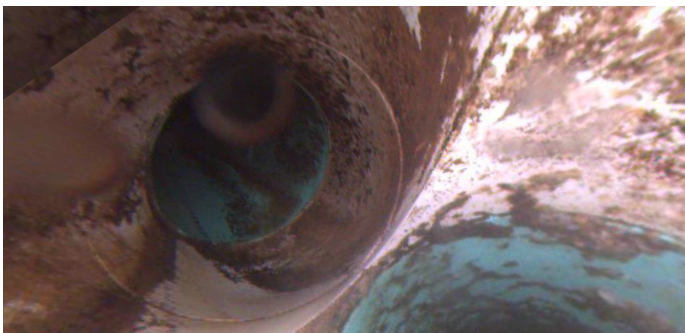
Code: **TF**  
Description: **Tap Factory**

Distance (ft): **200.3**  
Structural Grade: **0**  
O&M Grade: **0**  
Clock Start/From: **2**  
Clock To:  
1st Value: **4.000**  
2nd Value:  
Value Percent:  
Continuous Index:  
Within 8" of Joint:  
Remarks:

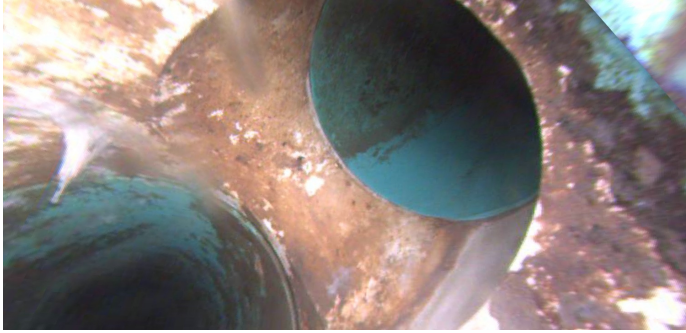
Code: **TF**  
Description: **Tap Factory**

Distance (ft): **218.9**  
Structural Grade: **0**  
O&M Grade: **0**  
Clock Start/From: **2**  
Clock To:  
1st Value: **4.000**  
2nd Value:  
Value Percent:  
Continuous Index:  
Within 8" of Joint:  
Remarks:

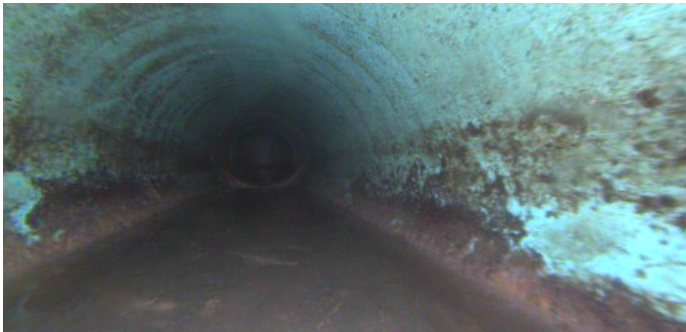
Code: **DAGS**  
Description: **Deposits Attached Grease**

Distance (ft): **388.7**  
Structural Grade: **0**  
O&M Grade: **2**  
Clock Start/From: **5**  
Clock To: **7**  
1st Value:  
2nd Value:  
Value Percent: **5.000**  
Continuous Index: **F01**  
Within 8" of Joint: **NO**  
Remarks:

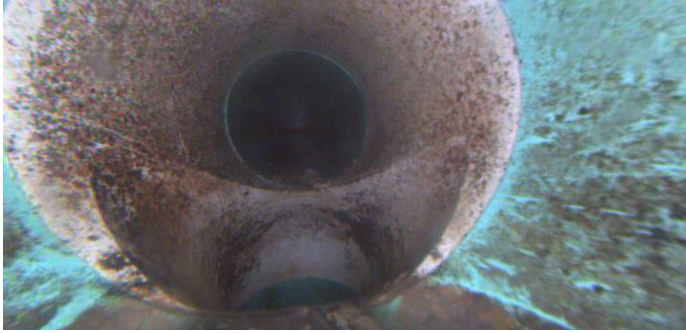
Code: **TF**  
Description: **Tap Factory**

Distance (ft): **390.6**  
Structural Grade: **0**  
O&M Grade: **0**  
Clock Start/From: **6**  
Clock To:  
1st Value: **6.000**  
2nd Value:  
Value Percent:  
Continuous Index:  
Within 8" of Joint:  
Remarks: **drop connection**

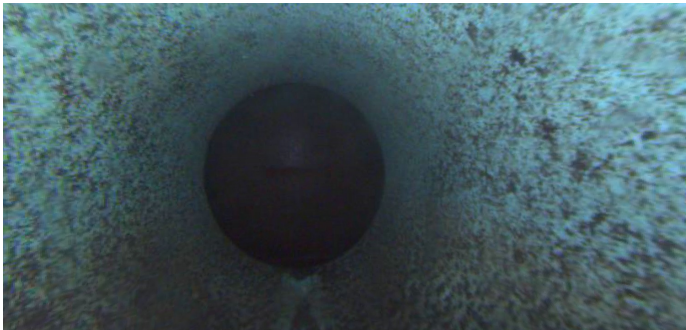
Code: **AMH**  
Description: **Manhole**

Distance (ft): **392.6**  
Structural Grade: **0**  
O&M Grade: **0**  
Clock Start/From:  
Clock To:  
1st Value:  
2nd Value:  
Value Percent:  
Continuous Index:  
Within 8" of Joint: **NO**  
Remarks: **M-907-014 in drop**
