Profile/Photo Observation Report

Date:	04/14/2018	Weather:		Coding:	PACP 6.0
Pipe Length (ft):	400.8	Owner:	NA	Pre Clean:	Not Known
P.O.#:		Surveyor:	Jen Costello	PSR:	P-907-014-020
Customer:		Clean Date:	01/01/1900	Shape:	C

Street:	Capitol	Flow Control:	Not Controlled
City:	Hobart, IN	Year Renewed:	
Location:	Parking Lot	Tape/Media #:	
Purpose:	Maintenance Related	Dia/Height:	8"
Use:	Sanitary	Material:	PVC
Drain Area:	NA	Lining:	Cured in Place
Category:	NA		
Comment:	pipe change at 391' just before drop connection-flow incorrect.		
Location Details:		Direction of Survey:	Downstream
US MH:	M-907-020	DS MH:	M-907-014
		Total Length Surveyed (ft):	392.6

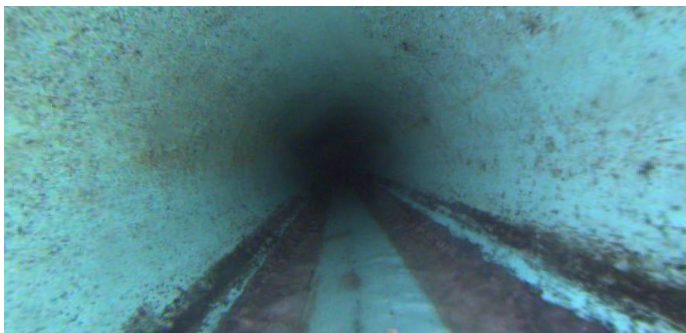
Code: **AMH**
Description: **Manhole**

Distance (ft): **.0**
Structural Grade: **0**
O&M Grade: **0**
Clock Start/From:
Clock To:
1st Value:
2nd Value:
Value Percent:
Continuous Index:
Within 8" of Joint: **NO**
Remarks: **M-907-020**

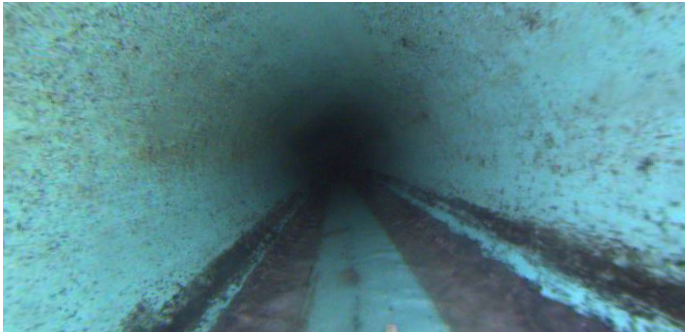
Code:	MWL
Description:	Water Level

Distance (ft):	.0
Structural Grade:	0
O&M Grade:	0
Clock Start/From:	
Clock To:	
1st Value:	
2nd Value:	
Value Percent:	5.000
Continuous Index:	
Within 8" of Joint:	NO
Remarks:

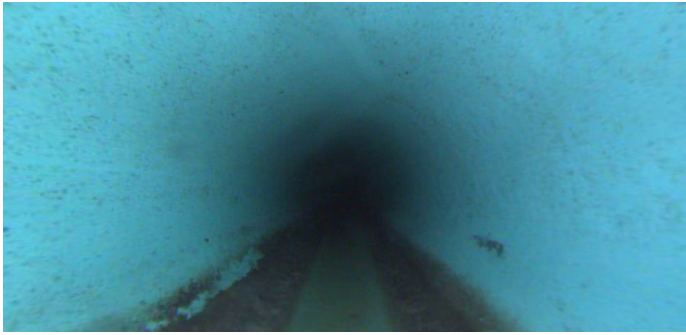
Code: **DAGS**
Description: **Deposits Attached Grease**

Distance (ft): **124.8**
Structural Grade: **0**
O&M Grade: **2**
Clock Start/From: **5**
Clock To: **7**
1st Value:
2nd Value:
Value Percent: **5.000**
Continuous Index: **S01**
Within 8" of Joint: **NO**
Remarks:

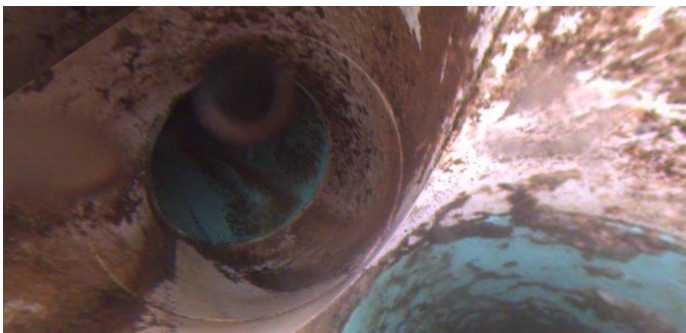
Code: **TF**
Description: **Tap Factory**

Distance (ft): **200.3**
Structural Grade: **0**
O&M Grade: **0**
Clock Start/From: **2**
Clock To:
1st Value: **4.000**
2nd Value:
Value Percent:
Continuous Index:
Within 8" of Joint:
Remarks:

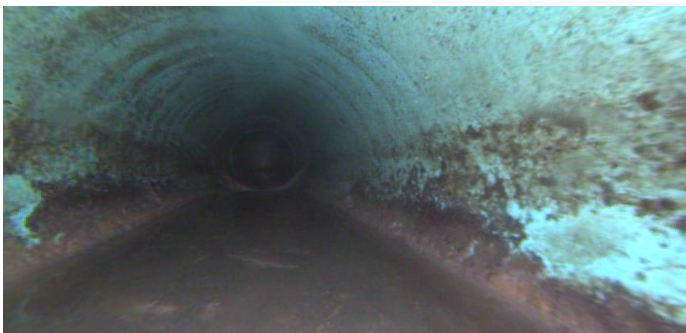
Code: **DAGS**
Description: **Deposits Attached Grease**

Distance (ft): **388.7**
Structural Grade: **0**
O&M Grade: **2**
Clock Start/From: **5**
Clock To: **7**
1st Value:
2nd Value:
Value Percent: **5.000**
Continuous Index: **F01**
Within 8" of Joint: **NO**
Remarks:

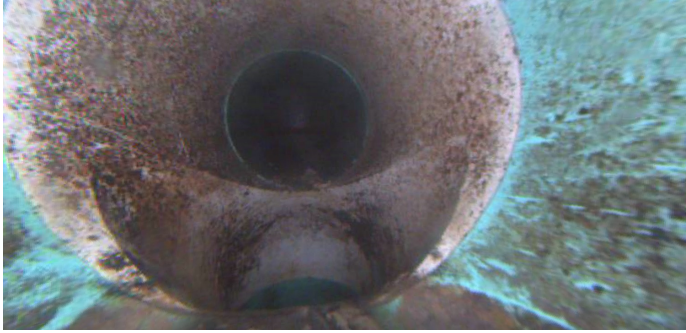
Code: **TF**
Description: **Tap Factory**

Distance (ft): **390.6**
Structural Grade: **0**
O&M Grade: **0**
Clock Start/From: **6**
Clock To:
1st Value: **6.000**
2nd Value:
Value Percent:
Continuous Index:
Within 8" of Joint:
Remarks: **drop connection**
