Profile/Photo Observation Report

Street:	E 10TH ST	Flow Control:	Not Controlled
City:	Hobart, IN	Year Renewed:	
Location:	Parking Lot	Tape/Media #:	
Purpose:	Maintenance Related	Dia/Height:	8"
Use:	Sanitary	Material:	PVC
Drain Area:	NA	Lining:	Cured in Place
Category:	NA		
Comment:	unknown pipe change at 137'.

Location Details:		Direction of Survey:	Downstream
US MH:	M-907-020	DS MH:	M-907-021
		Total Length Surveyed (ft):	138.6

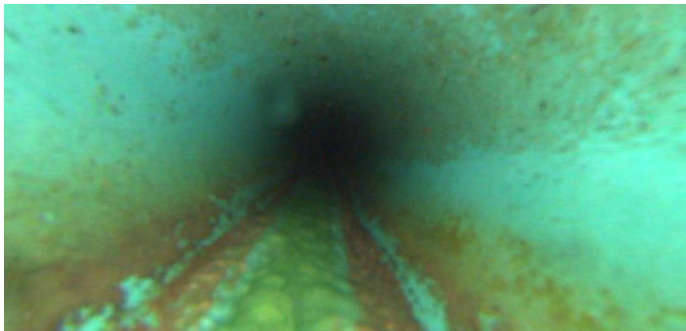
Code: **AMH**
Description: **Manhole**

Distance (ft): **.0**
Structural Grade: **0**
O&M Grade: **0**
Clock Start/From:
Clock To:
1st Value:
2nd Value:
Value Percent:
Continuous Index:
Within 8" of Joint: **NO**
Remarks: **M-907-020**

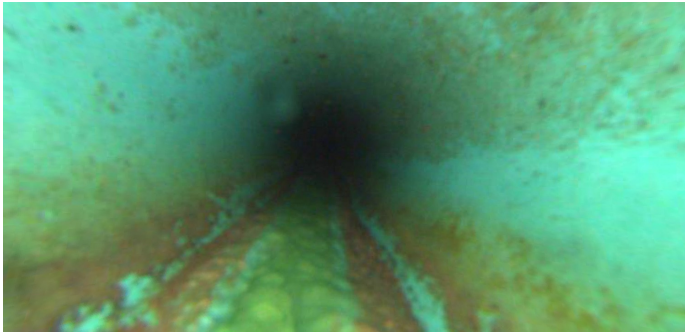
Code:	MWL
Description:	Water Level

Distance (ft):	.0
Structural Grade:	0
O&M Grade:	0
Clock Start/From:	
Clock To:	
1st Value:	
2nd Value:	
Value Percent:	5.000
Continuous Index:	
Within 8" of Joint:	NO
Remarks:

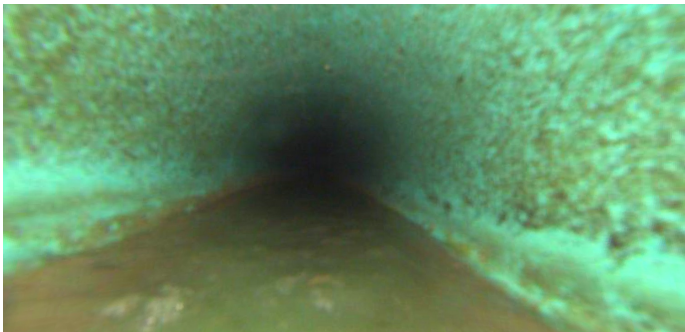
Code:	MWL
Description:	Water Level

Distance (ft):	21.1
Structural Grade:	0
O&M Grade:	0
Clock Start/From:	
Clock To:	
1st Value:	
2nd Value:	
Value Percent:	30.000
Continuous Index:	
Within 8" of Joint:	NO
Remarks:

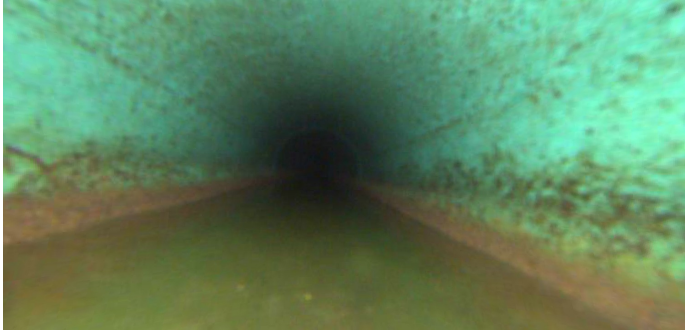
Code: **MWL**
Description: **Water Level**

Distance (ft): **65.1**
Structural Grade: **0**
O&M Grade: **0**
Clock Start/From:
Clock To:
1st Value:
2nd Value:
Value Percent: **40.000**
Continuous Index:
Within 8" of Joint: **NO**
Remarks:

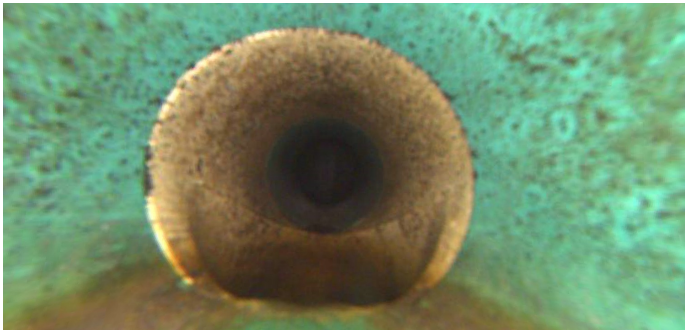
Code: **TF**
Description: **Tap Factory**

Distance (ft): **136.3**
Structural Grade: **0**
O&M Grade: **0**
Clock Start/From: **6**
Clock To:
1st Value: **6.000**
2nd Value:
Value Percent:
Continuous Index:
Within 8" of Joint:
Remarks: **drop connetion**

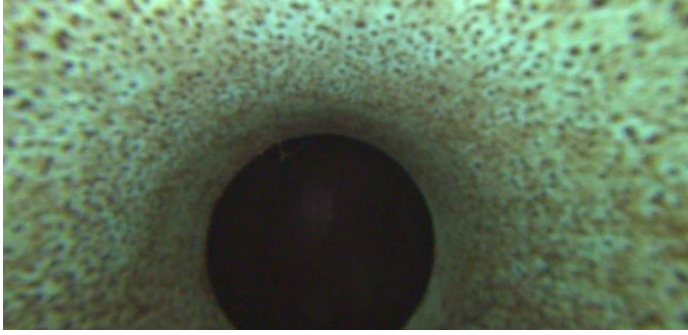
Code:	AMH
Description:	Manhole
Distance (ft):	138.6
Structural Grade:	0
O&M Grade:	0
Clock Start/From:	
Clock To:	
1st Value:	
2nd Value:	
Value Percent:	
Continuous Index:	
Within 8" of Joint:	NO
Remarks:	M-907-021 in drop
