## Profile/Photo Observation Report

Street:	<b>Capitol</b>	Flow Control:	<b>Not Controlled</b>
City:	<b>Hobart, IN</b>	Year Renewed:	
Location:	<b>Parking Lot</b>	Tape/Media #:	
Purpose:	<b>Maintenance Related</b>	Dia/Height:	<b>8"</b>
Use:	<b>Sanitary</b>	Material:	<b>PVC</b>
Drain Area:	<b>NA</b>	Lining:	<b>Cured in Place</b>
Category:	<b>NA</b>		
Comment:	<b>unknown pipe change at 137'.</b>

Location Details:		Direction of Survey:	<b>Downstream</b>
US MH:	<b>M-907-020</b>	DS MH:	<b>M-907-021</b>
		Total Length Surveyed (ft):	<b>138.6</b>

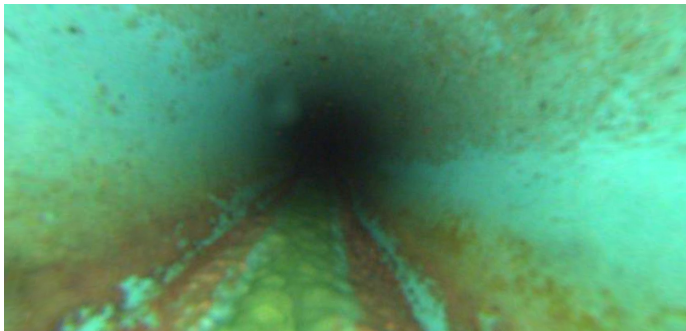
Code: **AMH**  
Description: **Manhole**

Distance (ft): **.0**  
Structural Grade: **0**  
O&M Grade: **0**  
Clock Start/From:  
Clock To:  
1st Value:  
2nd Value:  
Value Percent:  
Continuous Index:  
Within 8" of Joint: **NO**  
Remarks: **M-907-020**

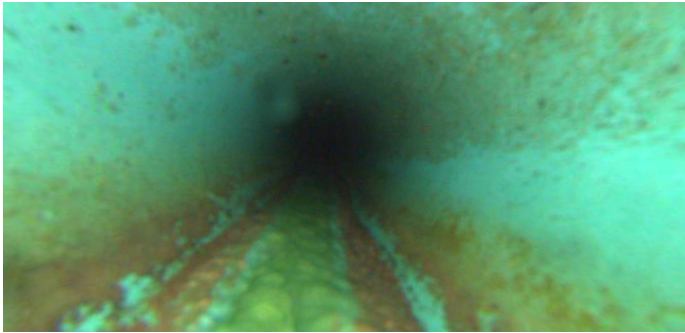
Code:	<b>MWL</b>
Description:	<b>Water Level</b>

Distance (ft):	<b>.0</b>
Structural Grade:	<b>0</b>
O&M Grade:	<b>0</b>
Clock Start/From:	
Clock To:	
1st Value:	
2nd Value:	
Value Percent:	<b>5.000</b>
Continuous Index:	
Within 8" of Joint:	<b>NO</b>
Remarks:

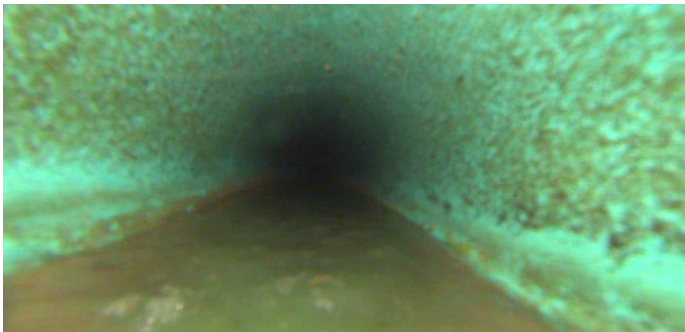
Code:	<b>MWL</b>
Description:	<b>Water Level</b>

Distance (ft):	<b>21.1</b>
Structural Grade:	<b>0</b>
O&M Grade:	<b>0</b>
Clock Start/From:	
Clock To:	
1st Value:	
2nd Value:	
Value Percent:	<b>30.000</b>
Continuous Index:	
Within 8" of Joint:	<b>NO</b>
Remarks:

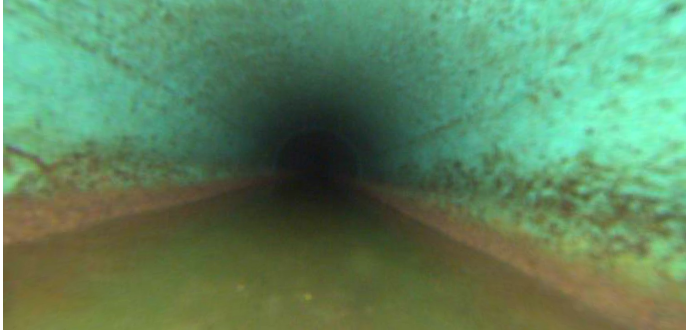
Code: **MWL**  
Description: **Water Level**

Distance (ft): **65.1**  
Structural Grade: **0**  
O&M Grade: **0**  
Clock Start/From:  
Clock To:  
1st Value:  
2nd Value:  
Value Percent: **40.000**  
Continuous Index:  
Within 8" of Joint: **NO**  
Remarks:

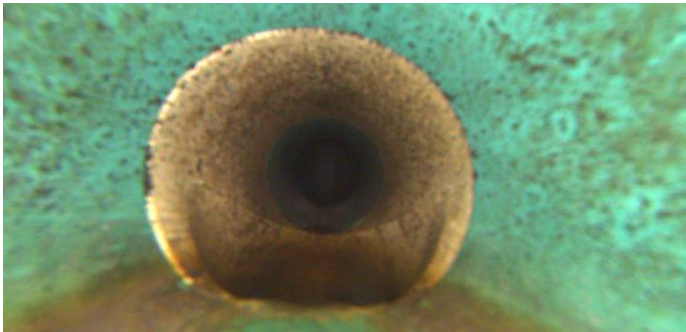
Code: **TF**  
Description: **Tap Factory**

Distance (ft): **136.3**  
Structural Grade: **0**  
O&M Grade: **0**  
Clock Start/From: **6**  
Clock To:  
1st Value: **6.000**  
2nd Value:  
Value Percent:  
Continuous Index:  
Within 8" of Joint:  
Remarks: **drop connetion**

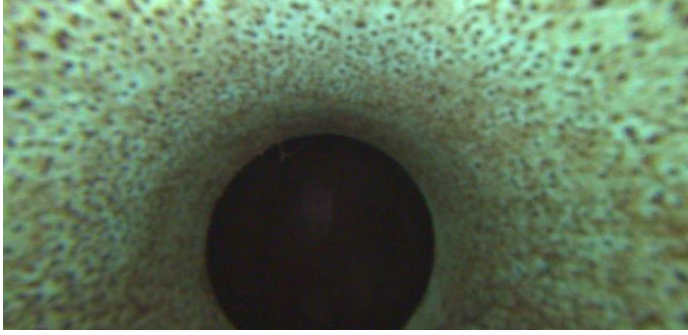
Code:	AMH
Description:	Manhole
Distance (ft):	138.6
Structural Grade:	0
O&M Grade:	0
Clock Start/From:	
Clock To:	
1st Value:	
2nd Value:	
Value Percent:	
Continuous Index:	
Within 8" of Joint:	NO
Remarks:	M-907-021 in drop
