Profile/Photo Observation Report

Street:	Capitol	Flow Control:	Not Controlled
City:	Hobart, IN	Year Renewed:	
Location:	Yard	Tape/Media #:	
Purpose:	Maintenance Related	Dia/Height:	10"
Use:	Sanitary	Material:	PVC
Drain Area:	NA	Lining:	Cured in Place
Category:	NA		
Comment:	mh confirmed by wheel at 60'.

Location Details:		Direction of Survey:	Downstream
US MH:	M-907-022	DS MH:	M-907-021
		Total Length Surveyed (ft):	61.3

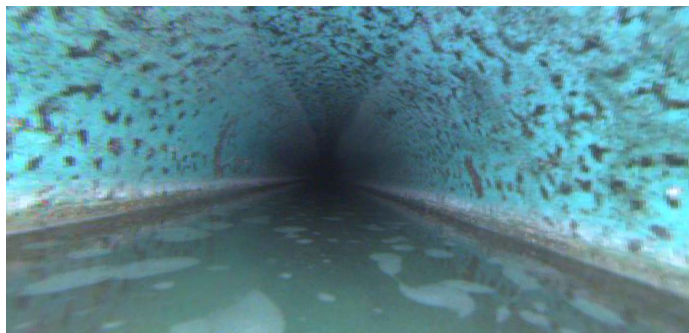
Code: **AMH**
Description: **Manhole**

Distance (ft): **.0**
Structural Grade: **0**
O&M Grade: **0**
Clock Start/From:
Clock To:
1st Value:
2nd Value:
Value Percent:
Continuous Index:
Within 8" of Joint: **NO**
Remarks: **M-907-022**

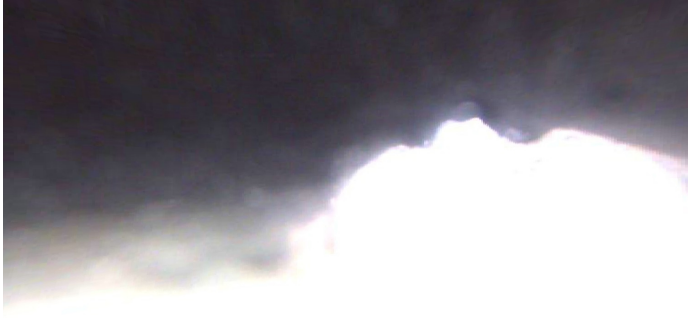
Code:	AMH
Description:	Manhole
Distance (ft):	61.3
Structural Grade:	0
O&M Grade:	0
Clock Start/From:	
Clock To:	
1st Value:	
2nd Value:	
Value Percent:	
Continuous Index:	
Within 8" of Joint:	NO
Remarks:	M-907-021
