Profile/Photo Observation Report

Street:	NORRIS DR	Flow Control:	Not Controlled
City:	Hobart, IN	Year Renewed:	
Location:	Sidewalk	Tape/Media #:	
Purpose:	Maintenance Related	Dia/Height:	8"
Use:	Sanitary	Material:	PVC
Drain Area:	NA	Lining:	
Category:	NA		
Comment:	Flow direction wrong.

Location Details:		Direction of Survey:	Upstream
US MH:	M-910-001	DS MH:	M-910-002
		Total Length Surveyed (ft):	90.4

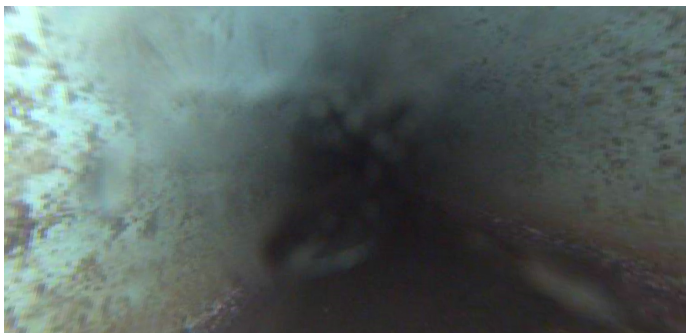
Code: **AMH**
Description: **Manhole**

Distance (ft): **.0**
Structural Grade: **0**
O&M Grade: **0**
Clock Start/From:
Clock To:
1st Value:
2nd Value:
Value Percent:
Continuous Index:
Within 8" of Joint: **NO**
Remarks: **M-910-002**

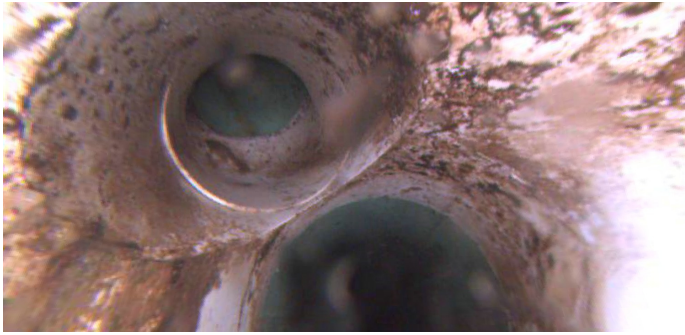
Code: **TF**
Description: **Tap Factory**

Distance (ft): **20.1**
Structural Grade: **0**
O&M Grade: **0**
Clock Start/From: **1**
Clock To:
1st Value: **4.000**
2nd Value:
Value Percent:
Continuous Index:
Within 8" of Joint:
Remarks:

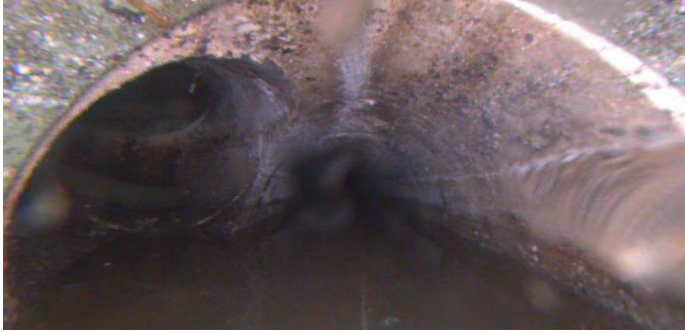
Code: **TF**
Description: **Tap Factory**

Distance (ft): **86.8**
Structural Grade: **0**
O&M Grade: **0**
Clock Start/From: **9**
Clock To:
1st Value: **4.000**
2nd Value:
Value Percent:
Continuous Index:
Within 8" of Joint:
Remarks:

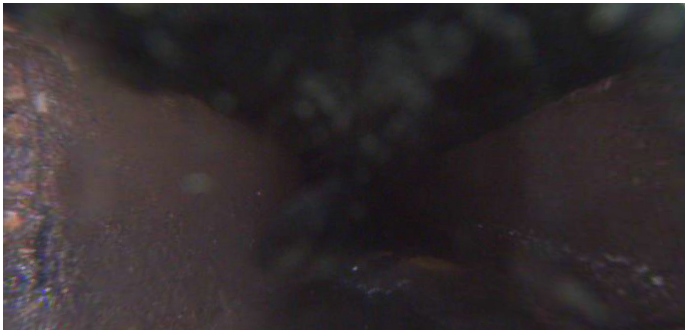
Code: **DAGS**
Description: **Deposits Attached Grease**

Distance (ft): **88.4**
Structural Grade: **0**
O&M Grade: **2**
Clock Start/From: **8**
Clock To: **4**
1st Value:
2nd Value:
Value Percent: **5.000**
Continuous Index: **F01**
Within 8" of Joint: **NO**
Remarks:

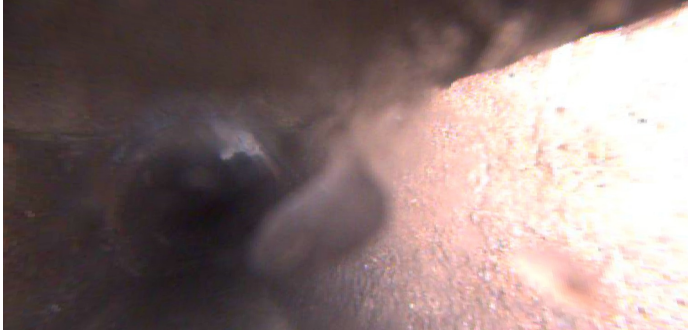
Code:	AMH
Description:	Manhole
Distance (ft):	90.4
Structural Grade:	0
O&M Grade:	0
Clock Start/From:	
Clock To:	
1st Value:	
2nd Value:	
Value Percent:	
Continuous Index:	
Within 8" of Joint:	NO
Remarks:	M-910-001
