Profile/Photo Observation Report

Street:	Norris	Flow Control:	Not Controlled
City:	Hobart, IN	Year Renewed:	
Location:	Sidewalk	Tape/Media #:	
Purpose:	Maintenance Related	Dia/Height:	8"
Use:	Sanitary	Material:	PVC
Drain Area:	NA	Lining:	
Category:	NA		
Comment:	Flow direction wrong.

Location Details:		Direction of Survey:	Upstream
US MH:	M-910-001	DS MH:	M-910-002
		Total Length Surveyed (ft):	90.4

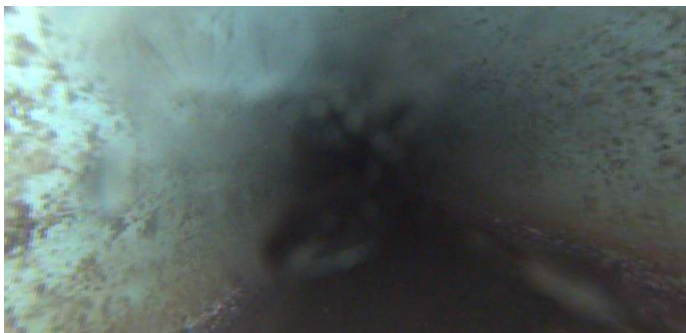
Code: **AMH**
Description: **Manhole**

Distance (ft): **.0**
Structural Grade: **0**
O&M Grade: **0**
Clock Start/From:
Clock To:
1st Value:
2nd Value:
Value Percent:
Continuous Index:
Within 8" of Joint: **NO**
Remarks: **M-910-002**

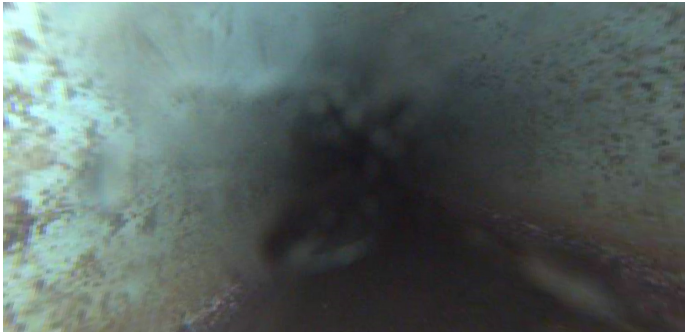
Code:	MWL
Description:	Water Level

Distance (ft):	.0
Structural Grade:	0
O&M Grade:	0
Clock Start/From:	
Clock To:	
1st Value:	
2nd Value:	
Value Percent:	5.000
Continuous Index:	
Within 8" of Joint:	NO
Remarks:

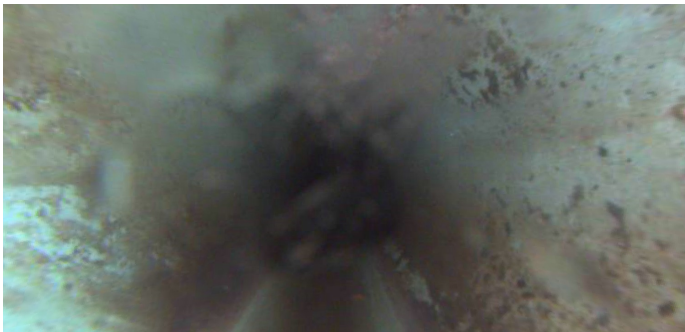
Code:	DAGS
Description:	Deposits Attached Grease

Distance (ft):	19.9
Structural Grade:	0
O&M Grade:	2
Clock Start/From:	8
Clock To:	4
1st Value:	
2nd Value:	
Value Percent:	5.000
Continuous Index:	S01
Within 8" of Joint:	NO
Remarks:

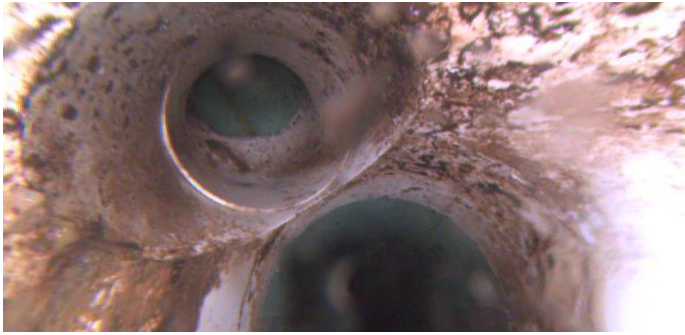
Code: **TF**
Description: **Tap Factory**

Distance (ft): **20.1**
Structural Grade: **0**
O&M Grade: **0**
Clock Start/From: **1**
Clock To:
1st Value: **4.000**
2nd Value:
Value Percent:
Continuous Index:
Within 8" of Joint:
Remarks:

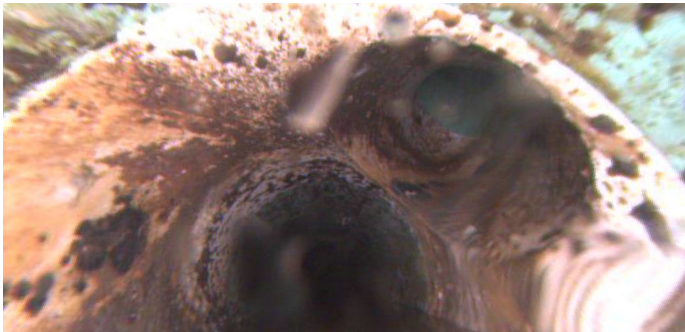
Code: **TF**
Description: **Tap Factory**

Distance (ft): **60.8**
Structural Grade: **0**
O&M Grade: **0**
Clock Start/From: **10**
Clock To:
1st Value: **4.000**
2nd Value:
Value Percent:
Continuous Index:
Within 8" of Joint:
Remarks:

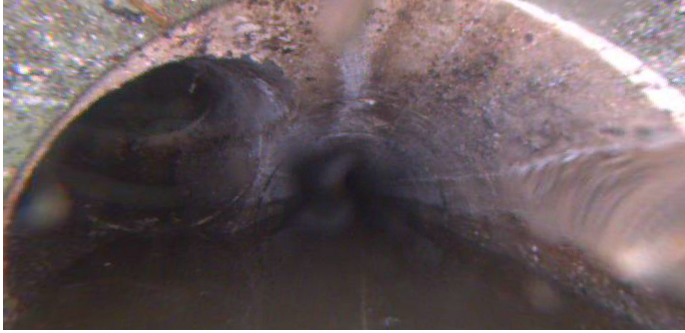
Code: **TF**
Description: **Tap Factory**

Distance (ft): **86.8**
Structural Grade: **0**
O&M Grade: **0**
Clock Start/From: **9**
Clock To:
1st Value: **4.000**
2nd Value:
Value Percent:
Continuous Index:
Within 8" of Joint:
Remarks:

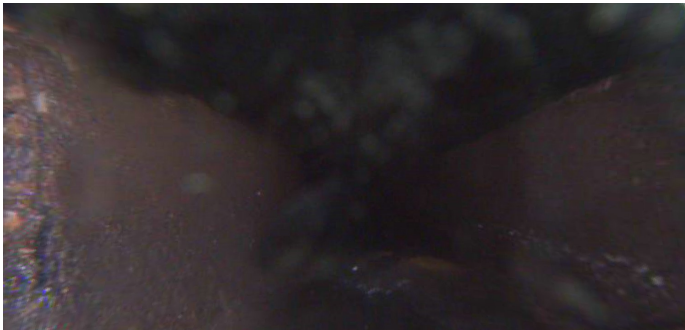
Code: **DAGS**
Description: **Deposits Attached Grease**

Distance (ft): **88.4**
Structural Grade: **0**
O&M Grade: **2**
Clock Start/From: **8**
Clock To: **4**
1st Value:
2nd Value:
Value Percent: **5.000**
Continuous Index: **F01**
Within 8" of Joint: **NO**
Remarks:

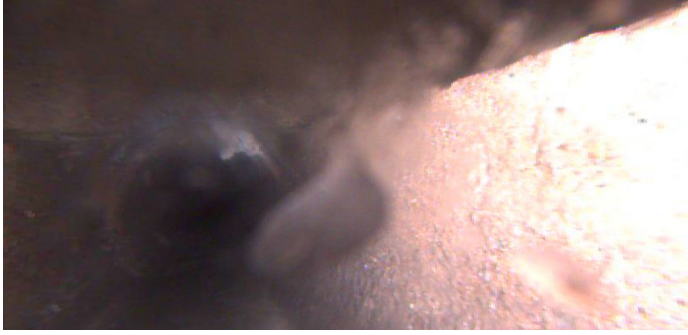
Code:	AMH
Description:	Manhole
Distance (ft):	90.4
Structural Grade:	0
O&M Grade:	0
Clock Start/From:	
Clock To:	
1st Value:	
2nd Value:	
Value Percent:	
Continuous Index:	
Within 8" of Joint:	NO
Remarks:	M-910-001
