Profile/Photo Observation Report

Date:	03/27/2018	Weather:		Coding:	PACP 6.0
Pipe Length (ft):	217.8	Owner:	NA	Pre Clean:	Not Known
P.O.#:		Surveyor:	Byrd Fitzgerald	PSR:	P-910-003-002
Customer:		Clean Date:	01/01/1900	Shape:	C

Street:	NORRIS DR	Flow Control:	Not Controlled
City:	Hobart, IN	Year Renewed:	
Location:	Sidewalk	Tape/Media #:	
Purpose:	Maintenance Related	Dia/Height:	8"
Use:	Sanitary	Material:	PVC
Drain Area:	NA	Lining:	
Category:	NA		
Comment:	Flow direction wrong. Reverse setup.		
Location Details:		Direction of Survey:	Upstream
US MH:	M-910-002	DS MH:	M-910-003
		Total Length Surveyed (ft):	197.3

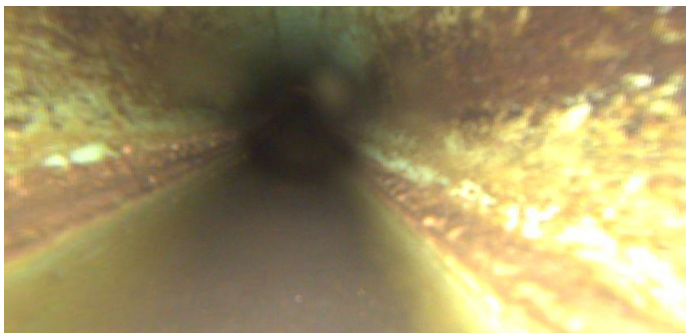
Code: **AMH**
Description: **Manhole**

Distance (ft): **.0**
Structural Grade: **0**
O&M Grade: **0**
Clock Start/From:
Clock To:
1st Value:
2nd Value:
Value Percent:
Continuous Index:
Within 8" of Joint: **NO**
Remarks: **M-910-003**

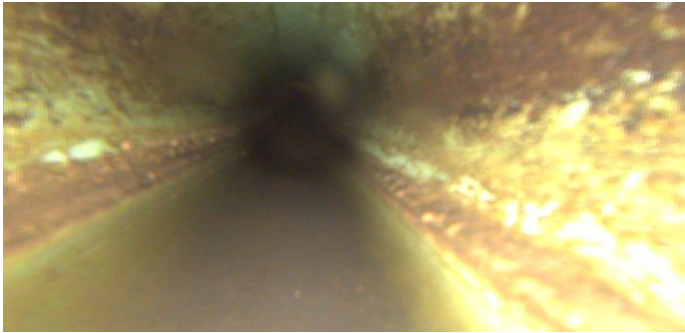
Code:	MWL
Description:	Water Level

Distance (ft):	.0
Structural Grade:	0
O&M Grade:	0
Clock Start/From:	
Clock To:	
1st Value:	
2nd Value:	
Value Percent:	5.000
Continuous Index:	
Within 8" of Joint:	NO
Remarks:

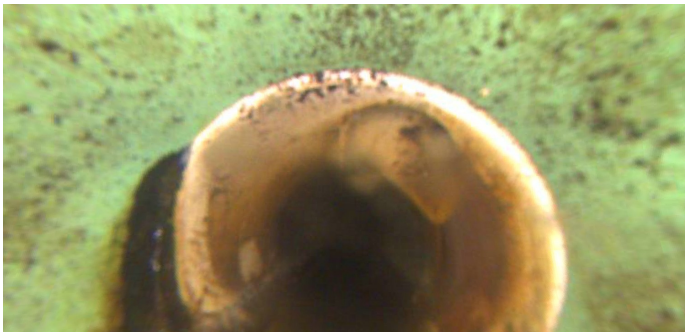
Code:	IW
Description:	Infil Weeper

Distance (ft):	5.8
Structural Grade:	0
O&M Grade:	2
Clock Start/From:	8
Clock To:	9
1st Value:	
2nd Value:	
Value Percent:	
Continuous Index:	
Within 8" of Joint:	YES
Remarks:

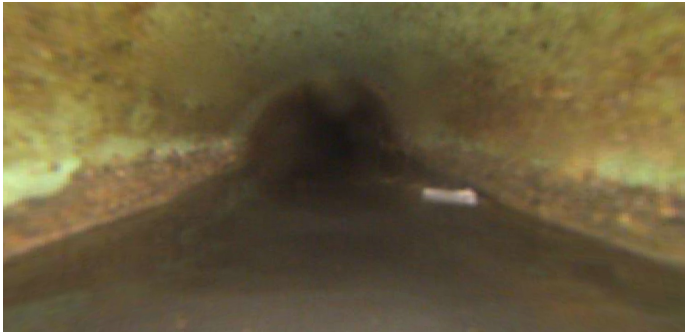
Code: **MWL**
Description: **Water Level**

Distance (ft): **8.1**
Structural Grade: **0**
O&M Grade: **0**
Clock Start/From:
Clock To:
1st Value:
2nd Value:
Value Percent: **25.000**
Continuous Index:
Within 8" of Joint: **NO**
Remarks:

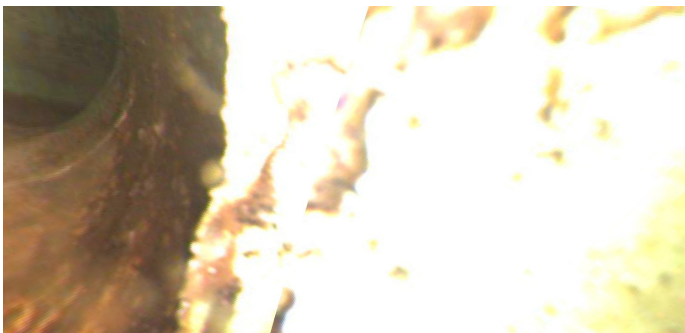
Code: **TF**
Description: **Tap Factory**

Distance (ft): **10.2**
Structural Grade: **0**
O&M Grade: **0**
Clock Start/From: **11**
Clock To:
1st Value: **4.000**
2nd Value:
Value Percent:
Continuous Index:
Within 8" of Joint: **YES**
Remarks:

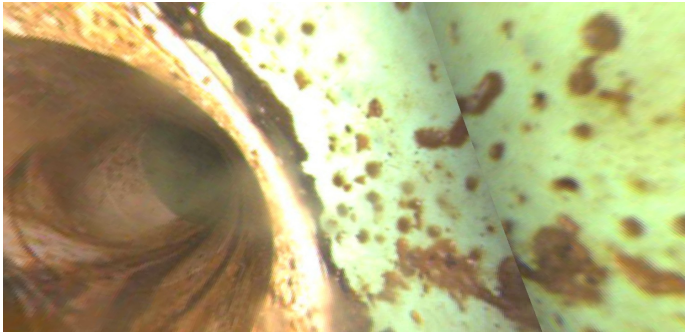
Code: **TF**
Description: **Tap Factory**

Distance (ft): **96.1**
Structural Grade: **0**
O&M Grade: **0**
Clock Start/From: **10**
Clock To:
1st Value: **4.000**
2nd Value:
Value Percent:
Continuous Index:
Within 8" of Joint: **YES**
Remarks:

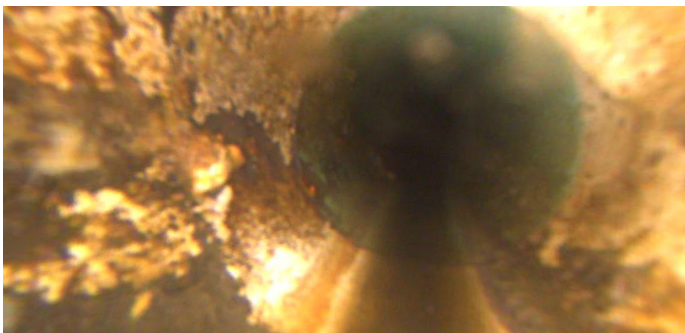
Code: **DAGS**
Description: **Deposits Attached Grease**

Distance (ft): **98.4**
Structural Grade: **0**
O&M Grade: **2**
Clock Start/From: **8**
Clock To: **4**
1st Value:
2nd Value:
Value Percent: **5.000**
Continuous Index:
Within 8" of Joint: **NO**
Remarks:

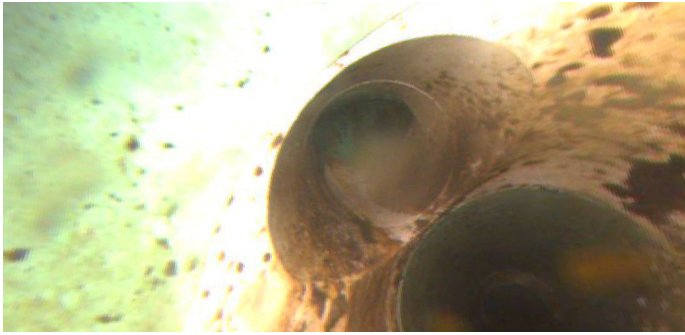
Code: **TF**
Description: **Tap Factory**

Distance (ft): **99.3**
Structural Grade: **0**
O&M Grade: **0**
Clock Start/From: **1**
Clock To:
1st Value: **4.000**
2nd Value:
Value Percent:
Continuous Index:
Within 8" of Joint: **YES**
Remarks:

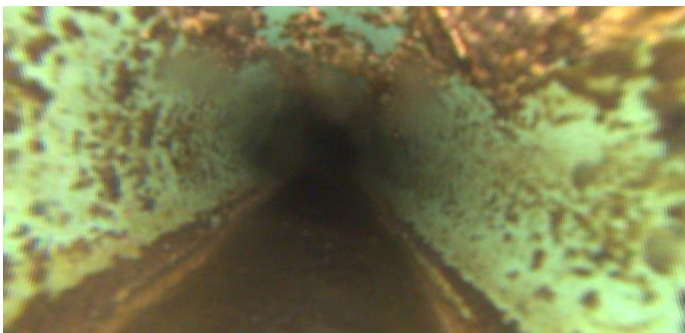
Code: **DAGS**
Description: **Deposits Attached Grease**

Distance (ft): **110.8**
Structural Grade: **0**
O&M Grade: **2**
Clock Start/From: **11**
Clock To: **2**
1st Value:
2nd Value:
Value Percent: **5.000**
Continuous Index: **S01**
Within 8" of Joint: **NO**
Remarks:

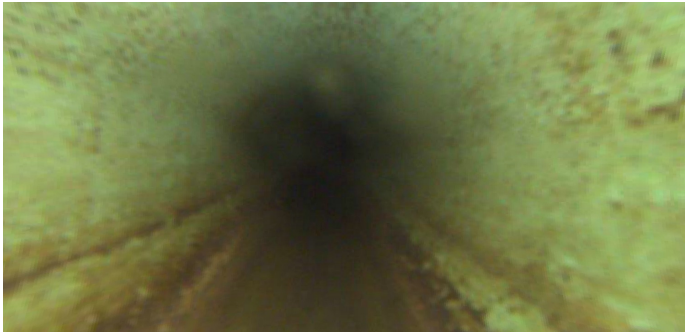
Code: **DAGS**
Description: **Deposits Attached Grease**

Distance (ft): **135.4**
Structural Grade: **0**
O&M Grade: **2**
Clock Start/From: **11**
Clock To: **2**
1st Value:
2nd Value:
Value Percent: **5.000**
Continuous Index: **F01**
Within 8" of Joint: **NO**
Remarks:

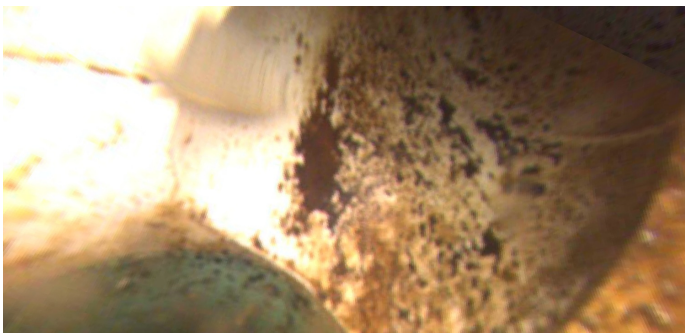
Code: **TF**
Description: **Tap Factory**

Distance (ft): **151.8**
Structural Grade: **0**
O&M Grade: **0**
Clock Start/From: **1**
Clock To:
1st Value: **4.000**
2nd Value:
Value Percent:
Continuous Index:
Within 8" of Joint: **YES**
Remarks:

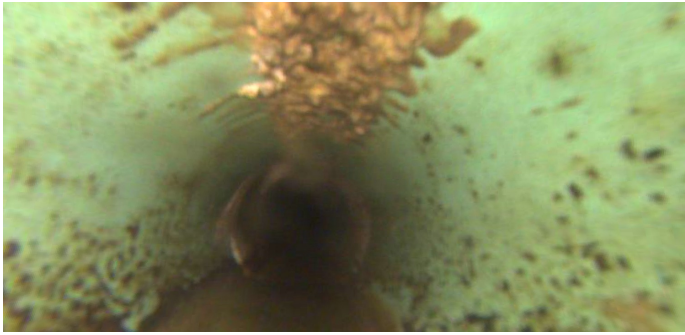
Code: **DAGS**
Description: **Deposits Attached Grease**

Distance (ft): **153.5**
Structural Grade: **0**
O&M Grade: **2**
Clock Start/From: **12**
Clock To:
1st Value:
2nd Value:
Value Percent: **5.000**
Continuous Index:
Within 8" of Joint: **NO**
Remarks:

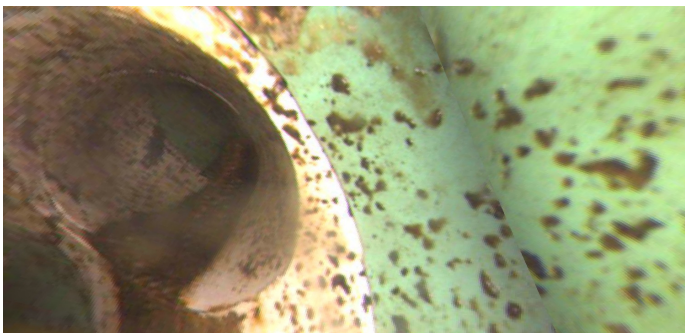
Code: **TF**
Description: **Tap Factory**

Distance (ft): **155.9**
Structural Grade: **0**
O&M Grade: **0**
Clock Start/From: **10**
Clock To:
1st Value: **4.000**
2nd Value:
Value Percent:
Continuous Index:
Within 8" of Joint: **YES**
Remarks:

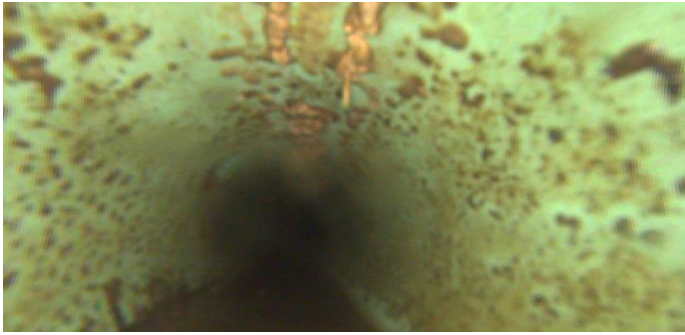
Code: **DAGS**
Description: **Deposits Attached Grease**

Distance (ft): **155.9**
Structural Grade: **0**
O&M Grade: **2**
Clock Start/From: **12**
Clock To:
1st Value:
2nd Value:
Value Percent: **5.000**
Continuous Index: **S02**
Within 8" of Joint: **NO**
Remarks:

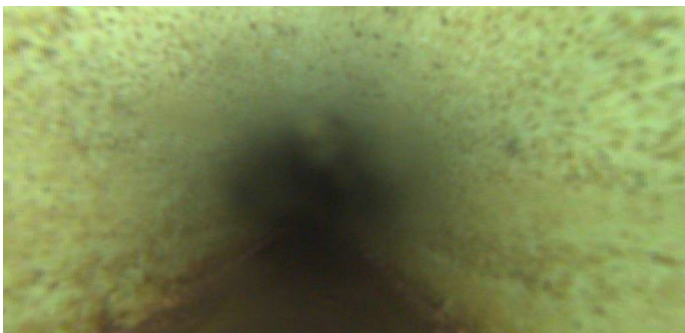
Code: **DAGS**
Description: **Deposits Attached Grease**

Distance (ft): **160.6**
Structural Grade: **0**
O&M Grade: **2**
Clock Start/From: **12**
Clock To:
1st Value:
2nd Value:
Value Percent: **5.000**
Continuous Index: **F02**
Within 8" of Joint: **NO**
Remarks:

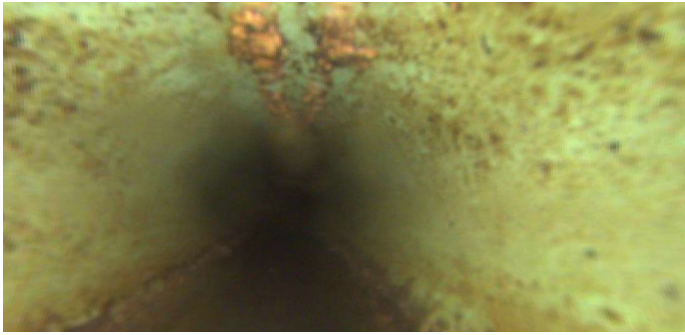
Code: **DAGS**
Description: **Deposits Attached Grease**

Distance (ft): **181.2**
Structural Grade: **0**
O&M Grade: **2**
Clock Start/From: **12**
Clock To:
1st Value:
2nd Value:
Value Percent: **5.000**
Continuous Index: **S03**
Within 8" of Joint: **NO**
Remarks:

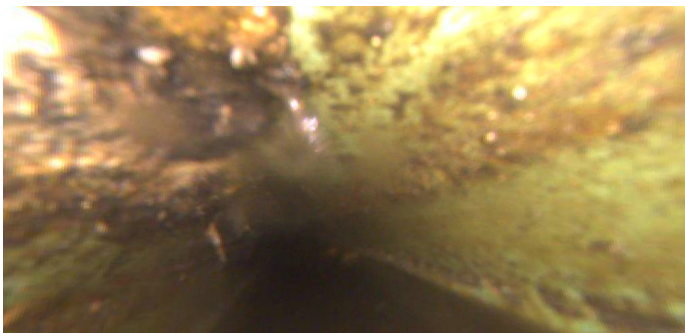
Code: **MSA**
Description: **Abandoned Survey**

Distance (ft): **197.3**
Structural Grade: **0**
O&M Grade: **0**
Clock Start/From:
Clock To:
1st Value:
2nd Value:
Value Percent:
Continuous Index:
Within 8" of Joint: **NO**
Remarks: **no blockage**

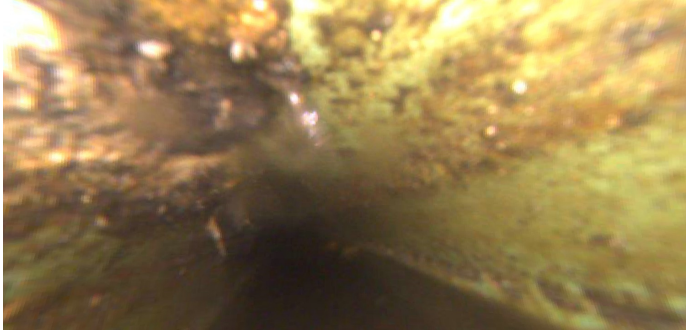
Code:	DAGS
Description:	Deposits Attached Grease
Distance (ft):	197.3
Structural Grade:	0
O&M Grade:	2
Clock Start/From:	12
Clock To:	
1st Value:	
2nd Value:	
Value Percent:	5.000
Continuous Index:	F03
Within 8" of Joint:	NO
Remarks:
