Profile/Photo Observation Report

Date:	03/27/2018	Weather:		Coding:	PACP 6.0
Pipe Length (ft):	217.8	Owner:	NA	Pre Clean:	Not Known
P.O.#:		Surveyor:	Byrd Fitzgerald	PSR:	P-910-003-002
Customer:		Clean Date:	01/01/1900	Shape:	C

Street:	Norris	Flow Control:	Not Controlled
City:	Hobart, IN	Year Renewed:	
Location:	Sidewalk	Tape/Media #:	
Purpose:	Maintenance Related	Dia/Height:	8"
Use:	Sanitary	Material:	PVC
Drain Area:	NA	Lining:	
Category:	NA		
Comment:	Flow direction wrong. Reverse setup.

Location Details:		Direction of Survey:	Upstream
US MH:	M-910-002	DS MH:	M-910-003
		Total Length Surveyed (ft):	197.3

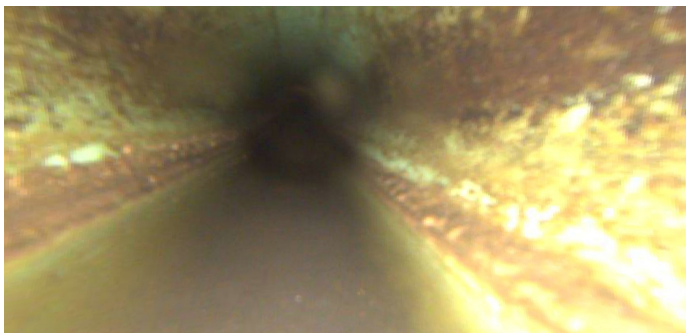
Code: **AMH**
Description: **Manhole**

Distance (ft): **.0**
Structural Grade: **0**
O&M Grade: **0**
Clock Start/From:
Clock To:
1st Value:
2nd Value:
Value Percent:
Continuous Index:
Within 8" of Joint: **NO**
Remarks: **M-910-003**

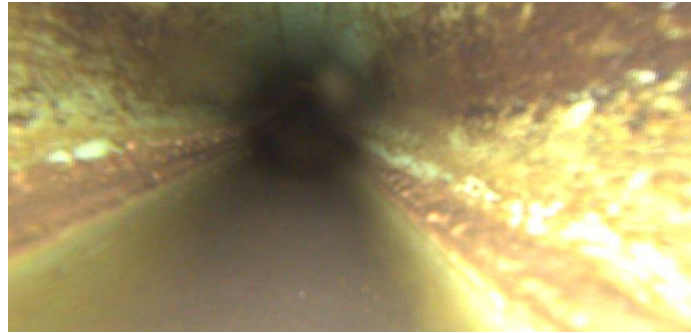
Code: **MWL**
Description: **Water Level**

Distance (ft): **.0**
Structural Grade: **0**
O&M Grade: **0**
Clock Start/From:
Clock To:
1st Value:
2nd Value:
Value Percent: **5.000**
Continuous Index:
Within 8" of Joint: **NO**
Remarks:

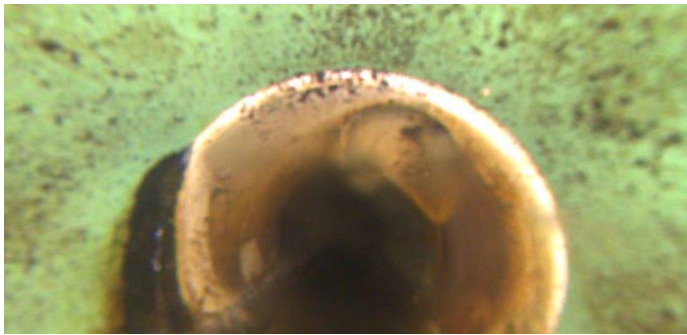
Code: **IW**
Description: **Infil Weeper**

Distance (ft): **5.8**
Structural Grade: **0**
O&M Grade: **2**
Clock Start/From: **8**
Clock To: **9**
1st Value:
2nd Value:
Value Percent:
Continuous Index:
Within 8" of Joint: **YES**
Remarks:

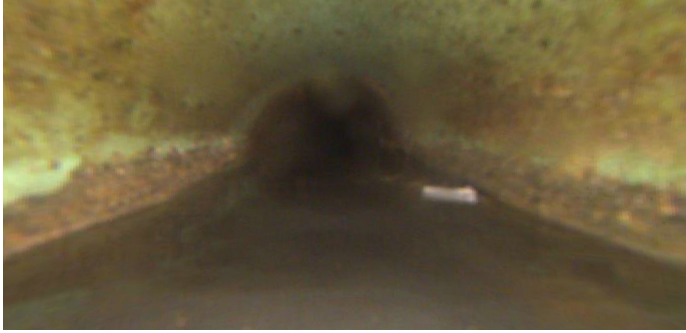
Code: **MWL**
Description: **Water Level**

Distance (ft): **8.1**
Structural Grade: **0**
O&M Grade: **0**
Clock Start/From:
Clock To:
1st Value:
2nd Value:
Value Percent: **25.000**
Continuous Index:
Within 8" of Joint: **NO**
Remarks:

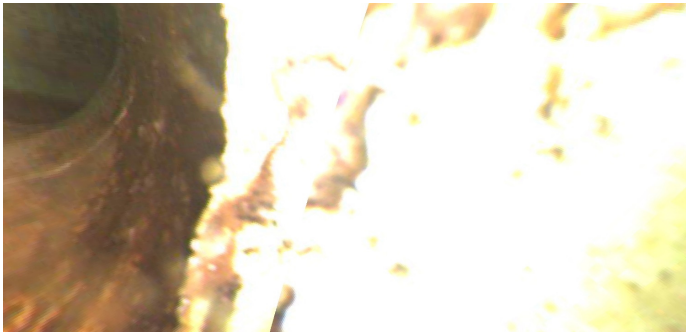
Code: **TF**
Description: **Tap Factory**

Distance (ft): **10.2**
Structural Grade: **0**
O&M Grade: **0**
Clock Start/From: **11**
Clock To:
1st Value: **4.000**
2nd Value:
Value Percent:
Continuous Index:
Within 8" of Joint: **YES**
Remarks:

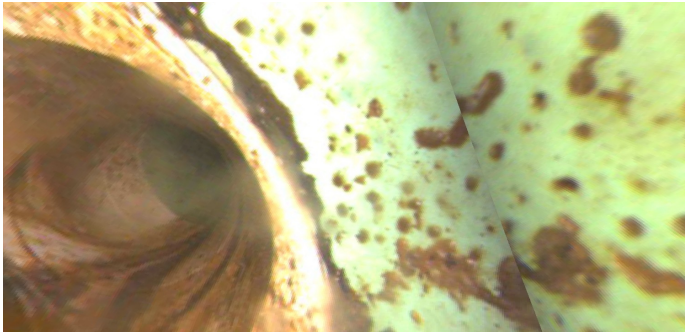
Code: **TF**
Description: **Tap Factory**

Distance (ft): **96.1**
Structural Grade: **0**
O&M Grade: **0**
Clock Start/From: **10**
Clock To:
1st Value: **4.000**
2nd Value:
Value Percent:
Continuous Index:
Within 8" of Joint: **YES**
Remarks:

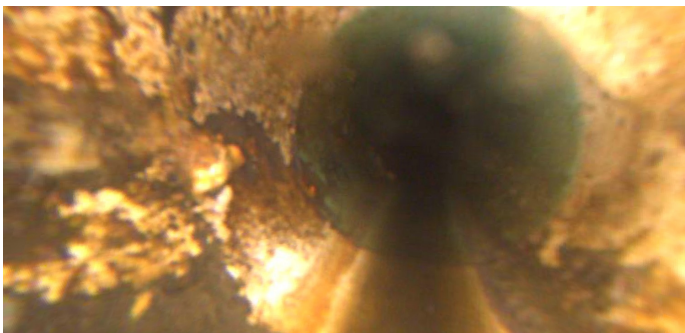
Code: **DAGS**
Description: **Deposits Attached Grease**

Distance (ft): **98.4**
Structural Grade: **0**
O&M Grade: **2**
Clock Start/From: **8**
Clock To: **4**
1st Value:
2nd Value:
Value Percent: **5.000**
Continuous Index:
Within 8" of Joint: **NO**
Remarks:

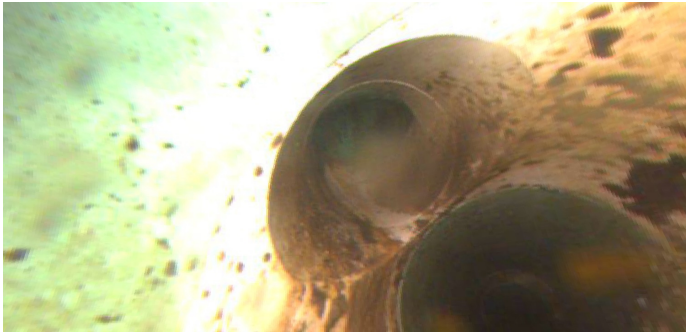
Code: **TF**
Description: **Tap Factory**

Distance (ft): **99.3**
Structural Grade: **0**
O&M Grade: **0**
Clock Start/From: **1**
Clock To:
1st Value: **4.000**
2nd Value:
Value Percent:
Continuous Index:
Within 8" of Joint: **YES**
Remarks:

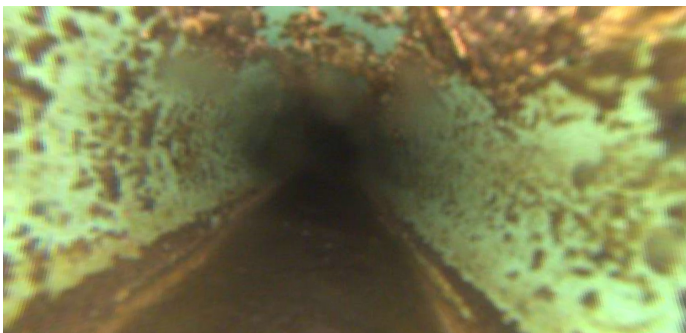
Code: **DAGS**
Description: **Deposits Attached Grease**

Distance (ft): **110.8**
Structural Grade: **0**
O&M Grade: **2**
Clock Start/From: **11**
Clock To: **2**
1st Value:
2nd Value:
Value Percent: **5.000**
Continuous Index: **S01**
Within 8" of Joint: **NO**
Remarks:

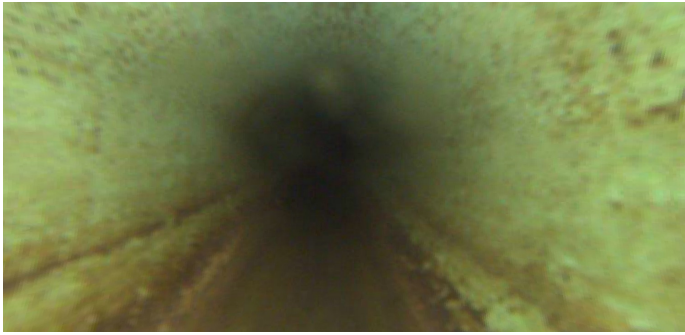
Code: **DAGS**
Description: **Deposits Attached Grease**

Distance (ft): **135.4**
Structural Grade: **0**
O&M Grade: **2**
Clock Start/From: **11**
Clock To: **2**
1st Value:
2nd Value:
Value Percent: **5.000**
Continuous Index: **F01**
Within 8" of Joint: **NO**
Remarks:

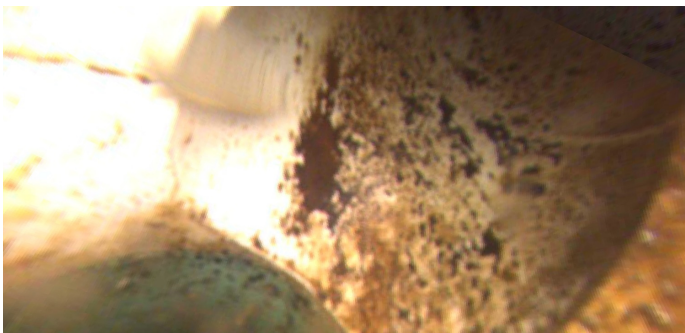
Code: **TF**
Description: **Tap Factory**

Distance (ft): **151.8**
Structural Grade: **0**
O&M Grade: **0**
Clock Start/From: **1**
Clock To:
1st Value: **4.000**
2nd Value:
Value Percent:
Continuous Index:
Within 8" of Joint: **YES**
Remarks:

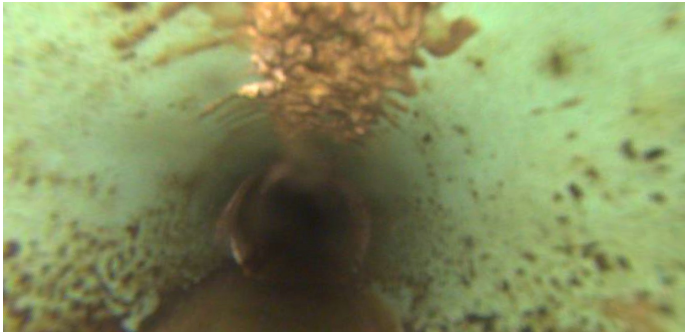
Code: **DAGS**
Description: **Deposits Attached Grease**

Distance (ft): **153.5**
Structural Grade: **0**
O&M Grade: **2**
Clock Start/From: **12**
Clock To:
1st Value:
2nd Value:
Value Percent: **5.000**
Continuous Index:
Within 8" of Joint: **NO**
Remarks:

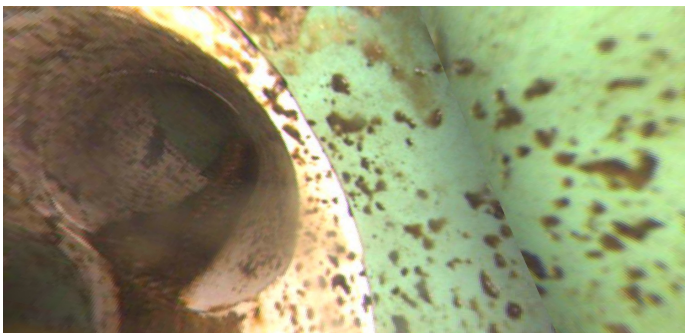
Code: **TF**
Description: **Tap Factory**

Distance (ft): **155.9**
Structural Grade: **0**
O&M Grade: **0**
Clock Start/From: **10**
Clock To:
1st Value: **4.000**
2nd Value:
Value Percent:
Continuous Index:
Within 8" of Joint: **YES**
Remarks:

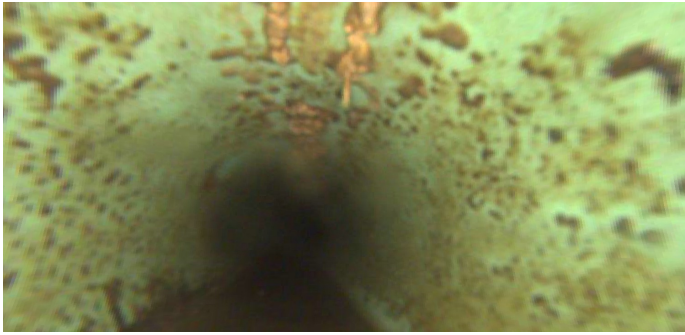
Code: **DAGS**
Description: **Deposits Attached Grease**

Distance (ft): **155.9**
Structural Grade: **0**
O&M Grade: **2**
Clock Start/From: **12**
Clock To:
1st Value:
2nd Value:
Value Percent: **5.000**
Continuous Index: **S02**
Within 8" of Joint: **NO**
Remarks:

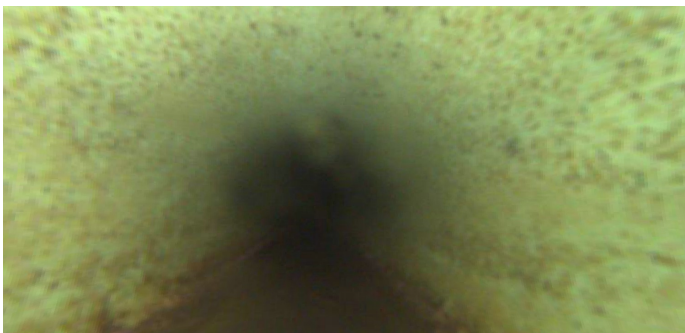
Code: **DAGS**
Description: **Deposits Attached Grease**

Distance (ft): **160.6**
Structural Grade: **0**
O&M Grade: **2**
Clock Start/From: **12**
Clock To:
1st Value:
2nd Value:
Value Percent: **5.000**
Continuous Index: **F02**
Within 8" of Joint: **NO**
Remarks:

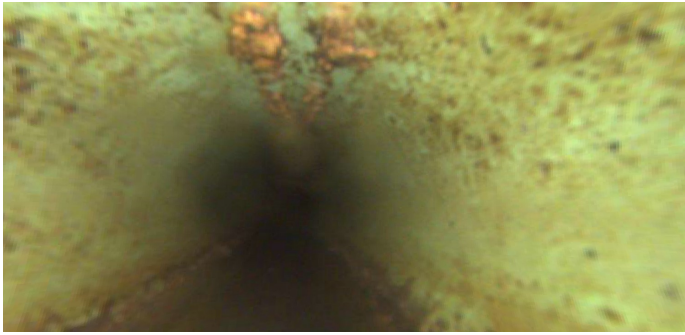
Code: **DAGS**
Description: **Deposits Attached Grease**

Distance (ft): **181.2**
Structural Grade: **0**
O&M Grade: **2**
Clock Start/From: **12**
Clock To:
1st Value:
2nd Value:
Value Percent: **5.000**
Continuous Index: **S03**
Within 8" of Joint: **NO**
Remarks:

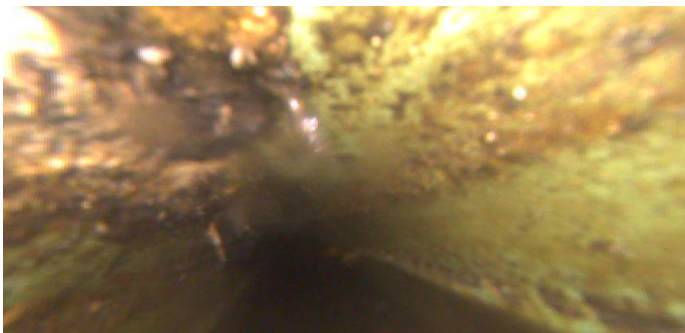
Code: **MSA**
Description: **Abandoned Survey**

Distance (ft): **197.3**
Structural Grade: **0**
O&M Grade: **0**
Clock Start/From:
Clock To:
1st Value:
2nd Value:
Value Percent:
Continuous Index:
Within 8" of Joint: **NO**
Remarks: **no blockage**

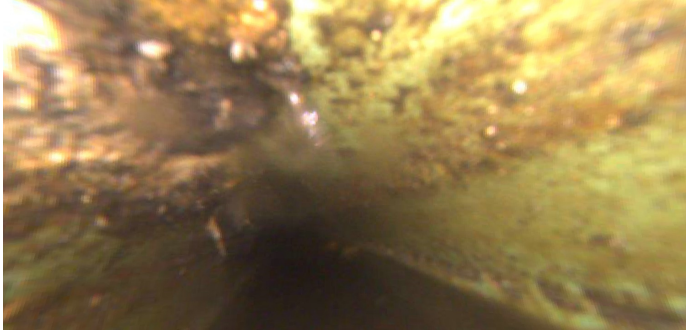
Code:	DAGS
Description:	Deposits Attached Grease
Distance (ft):	197.3
Structural Grade:	0
O&M Grade:	2
Clock Start/From:	12
Clock To:	
1st Value:	
2nd Value:	
Value Percent:	5.000
Continuous Index:	F03
Within 8" of Joint:	NO
Remarks:
