## Profile/Photo Observation Report

Street:	<b>NORRIS DR</b>	Flow Control:	<b>Not Controlled</b>
City:	<b>Hobart, IN</b>	Year Renewed:	
Location:	<b>Sidewalk</b>	Tape/Media #:	
Purpose:	<b>Maintenance Related</b>	Dia/Height:	<b>8"</b>
Use:	<b>Sanitary</b>	Material:	<b>PVC</b>
Drain Area:	<b>NA</b>	Lining:	
Category:	<b>NA</b>		
Comment:	<b>Flow direction wrong. Debris at 2'.</b>		
Location Details:		Direction of Survey:	<b>Downstream</b>
US MH:	<b>M-910-003</b>	DS MH:	<b>M-910-004</b>
		Total Length Surveyed (ft):	<b>3.4</b>

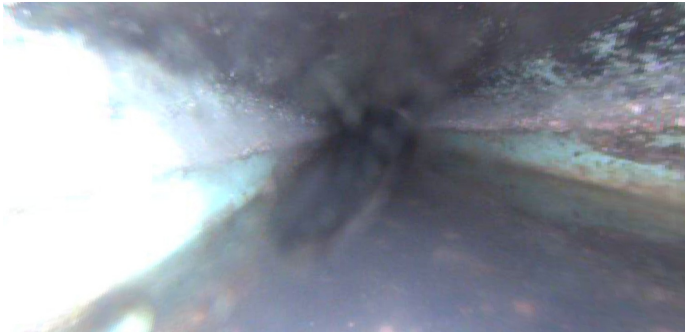
Code:	<b>MWL</b>
Description:	<b>Water Level</b>

Distance (ft):	<b>.0</b>
Structural Grade:	<b>0</b>
O&M Grade:	<b>0</b>
Clock Start/From:	
Clock To:	
1st Value:	
2nd Value:	
Value Percent:	<b>50.000</b>
Continuous Index:	
Within 8" of Joint:	<b>NO</b>
Remarks:

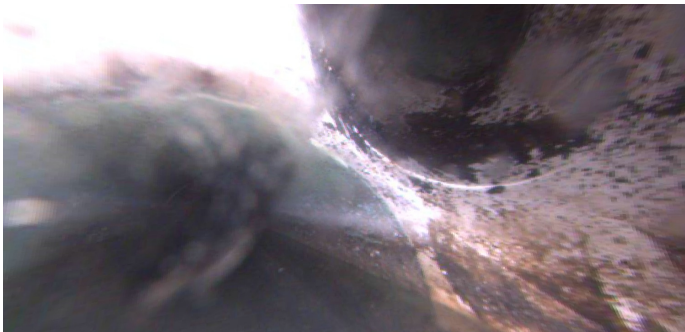
Code:	<b>TF</b>
Description:	<b>Tap Factory</b>

Distance (ft):	<b>3.4</b>
Structural Grade:	<b>0</b>
O&M Grade:	<b>0</b>
Clock Start/From:	<b>1</b>
Clock To:	
1st Value:	<b>4.000</b>
2nd Value:	
Value Percent:	
Continuous Index:	
Within 8" of Joint:	<b>YES</b>
Remarks:

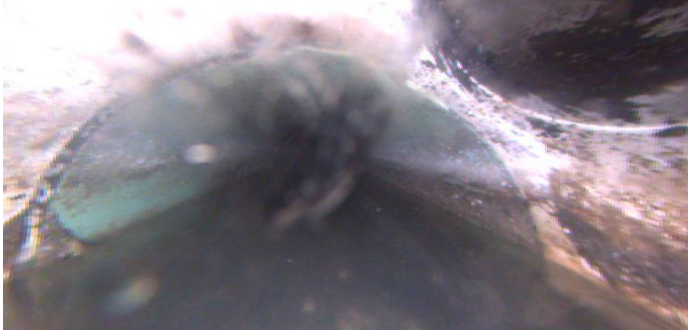
Code:	<b>MSA</b>
Description:	<b>Abandoned Survey</b>
Distance (ft):	<b>3.4</b>
Structural Grade:	<b>0</b>
O&M Grade:	<b>0</b>
Clock Start/From:	
Clock To:	
1st Value:	
2nd Value:	
Value Percent:	
Continuous Index:	
Within 8" of Joint:	<b>NO</b>
Remarks:	<b>debris</b>
