## Profile/Photo Observation Report

Street:	<b>NORRIS DR</b>	Flow Control:	<b>Not Controlled</b>
City:	<b>Hobart, IN</b>	Year Renewed:	
Location:	<b>Sidewalk</b>	Tape/Media #:	
Purpose:	<b>Maintenance Related</b>	Dia/Height:	<b>8"</b>
Use:	<b>Sanitary</b>	Material:	<b>PVC</b>
Drain Area:	<b>NA</b>	Lining:	
Category:	<b>NA</b>		
Comment:	<b>Flow direction wrong.</b>

Location Details:		Direction of Survey:	<b>Upstream</b>
US MH:	<b>M-910-005</b>	DS MH:	<b>M-910-006</b>
		Total Length Surveyed (ft):	<b>104.1</b>

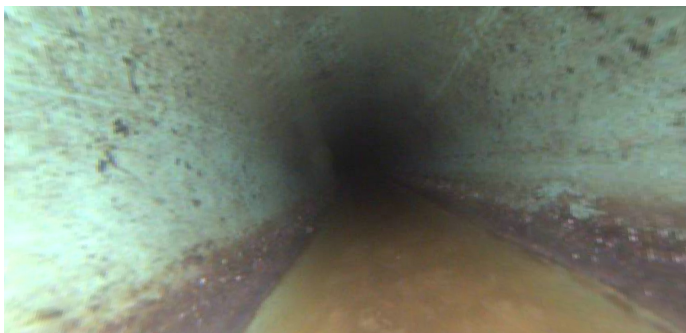
Code: **AMH**  
Description: **Manhole**

Distance (ft): **.0**  
Structural Grade: **0**  
O&M Grade: **0**  
Clock Start/From:  
Clock To:  
1st Value:  
2nd Value:  
Value Percent:  
Continuous Index:  
Within 8" of Joint: **NO**  
Remarks: **M-910-006**

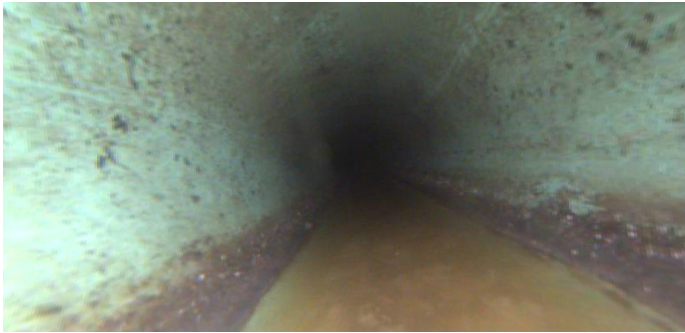
Code:	<b>MWL</b>
Description:	<b>Water Level</b>

Distance (ft):	<b>.0</b>
Structural Grade:	<b>0</b>
O&M Grade:	<b>0</b>
Clock Start/From:	
Clock To:	
1st Value:	
2nd Value:	
Value Percent:	<b>5.000</b>
Continuous Index:	
Within 8" of Joint:	<b>NO</b>
Remarks:

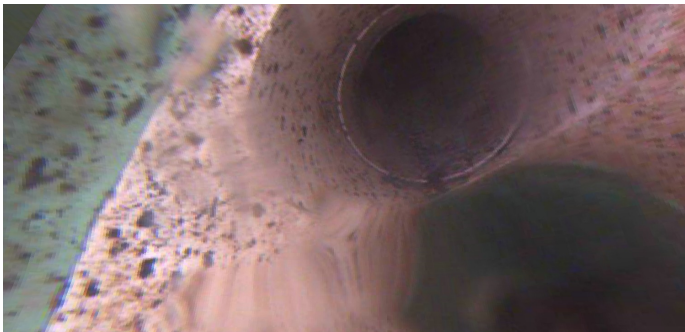
Code:	<b>TF</b>
Description:	<b>Tap Factory</b>

Distance (ft):	<b>37.2</b>
Structural Grade:	<b>0</b>
O&M Grade:	<b>0</b>
Clock Start/From:	<b>1</b>
Clock To:	
1st Value:	<b>4.000</b>
2nd Value:	
Value Percent:	
Continuous Index:	
Within 8" of Joint:	<b>YES</b>
Remarks:

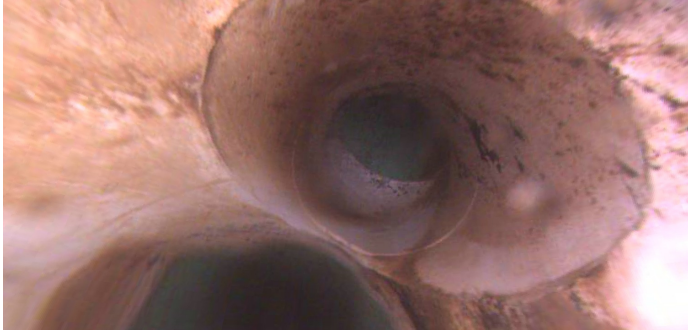
Code: **TF**  
Description: **Tap Factory**

Distance (ft): **39.1**  
Structural Grade: **0**  
O&M Grade: **0**  
Clock Start/From: **11**  
Clock To:  
1st Value: **4.000**  
2nd Value:  
Value Percent:  
Continuous Index:  
Within 8" of Joint:  
Remarks:

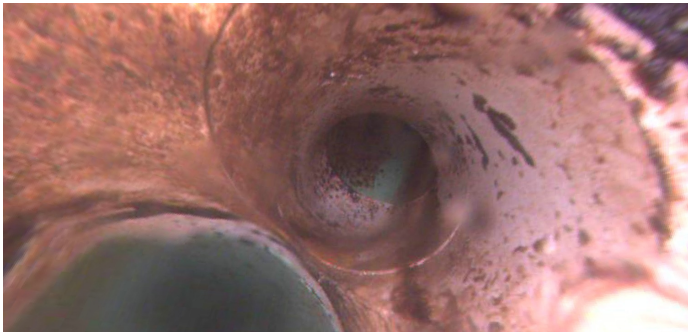
Code: **TF**  
Description: **Tap Factory**

Distance (ft): **72.4**  
Structural Grade: **0**  
O&M Grade: **0**  
Clock Start/From: **10**  
Clock To:  
1st Value: **4.000**  
2nd Value:  
Value Percent:  
Continuous Index:  
Within 8" of Joint:  
Remarks:

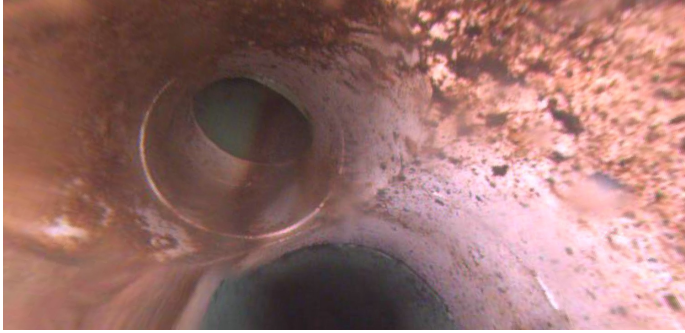
Code: **TF**  
Description: **Tap Factory**

Distance (ft): **100.5**  
Structural Grade: **0**  
O&M Grade: **0**  
Clock Start/From: **11**  
Clock To:  
1st Value: **4.000**  
2nd Value:  
Value Percent:  
Continuous Index:  
Within 8" of Joint:  
Remarks:

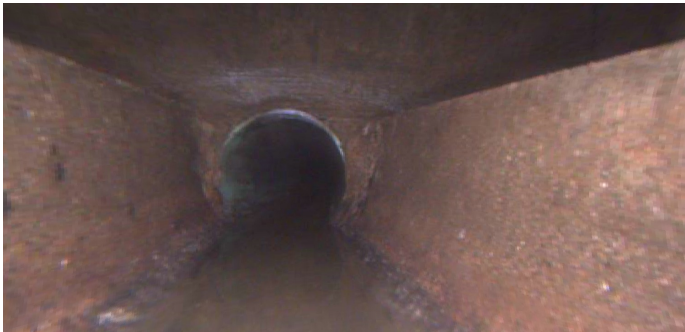
Code: **AMH**  
Description: **Manhole**

Distance (ft): **104.1**  
Structural Grade: **0**  
O&M Grade: **0**  
Clock Start/From:  
Clock To:  
1st Value:  
2nd Value:  
Value Percent:  
Continuous Index:  
Within 8" of Joint: **NO**  
Remarks: **M-910-005**
