Profile/Photo Observation Report

Date:	03/27/2018	Weather:		Coding:	PACP 6.0
Pipe Length (ft):	109.0	Owner:	NA	Pre Clean:	Not Known
P.O.#:		Surveyor:	Byrd Fitzgerald	PSR:	P-910-006-005
Customer:		Clean Date:	01/01/1900	Shape:	C

Street:	Norris	Flow Control:	Not Controlled
City:	Hobart, IN	Year Renewed:	
Location:	Sidewalk	Tape/Media #:	
Purpose:	Maintenance Related	Dia/Height:	8"
Use:	Sanitary	Material:	PVC
Drain Area:	NA	Lining:	
Category:	NA		
Comment:	Flow direction wrong.

Location Details:		Direction of Survey:	Upstream
US MH:	M-910-005	DS MH:	M-910-006
		Total Length Surveyed (ft):	104.1

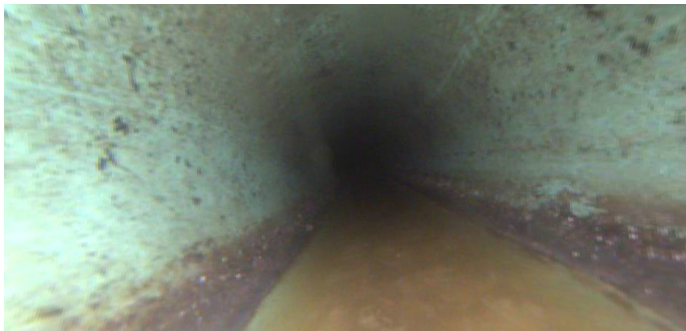
Code: **AMH**
Description: **Manhole**

Distance (ft): **.0**
Structural Grade: **0**
O&M Grade: **0**
Clock Start/From:
Clock To:
1st Value:
2nd Value:
Value Percent:
Continuous Index:
Within 8" of Joint: **NO**
Remarks: **M-910-006**

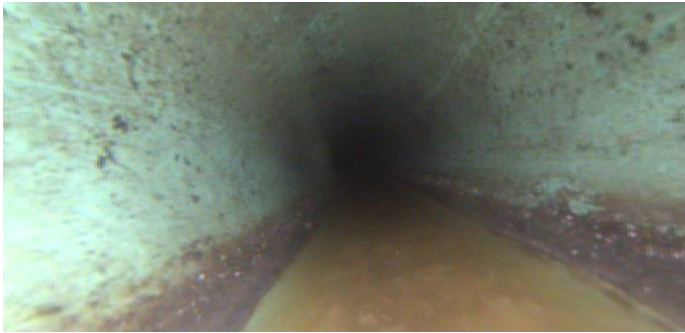
Code:	MWL
Description:	Water Level

Distance (ft):	.0
Structural Grade:	0
O&M Grade:	0
Clock Start/From:	
Clock To:	
1st Value:	
2nd Value:	
Value Percent:	5.000
Continuous Index:	
Within 8" of Joint:	NO
Remarks:

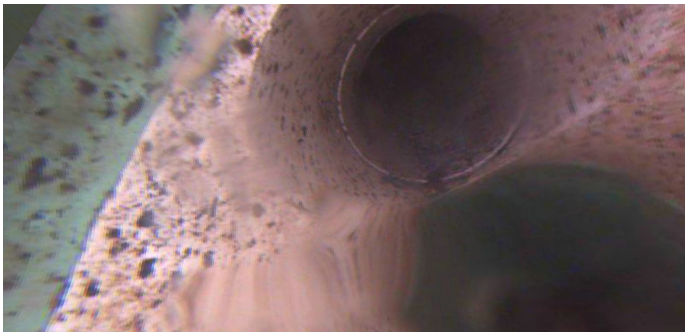
Code:	TF
Description:	Tap Factory

Distance (ft):	37.2
Structural Grade:	0
O&M Grade:	0
Clock Start/From:	1
Clock To:	
1st Value:	4.000
2nd Value:	
Value Percent:	
Continuous Index:	
Within 8" of Joint:	YES
Remarks:

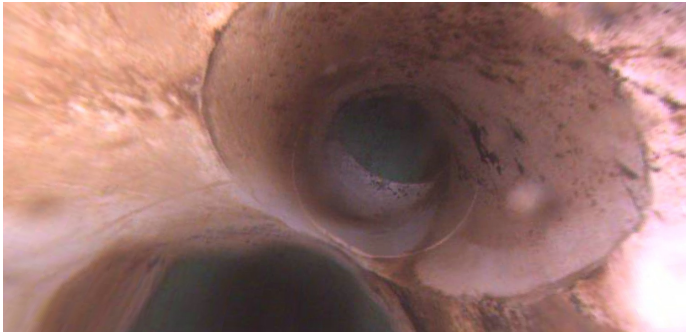
Code: **TF**
Description: **Tap Factory**

Distance (ft): **39.1**
Structural Grade: **0**
O&M Grade: **0**
Clock Start/From: **11**
Clock To:
1st Value: **4.000**
2nd Value:
Value Percent:
Continuous Index:
Within 8" of Joint:
Remarks:

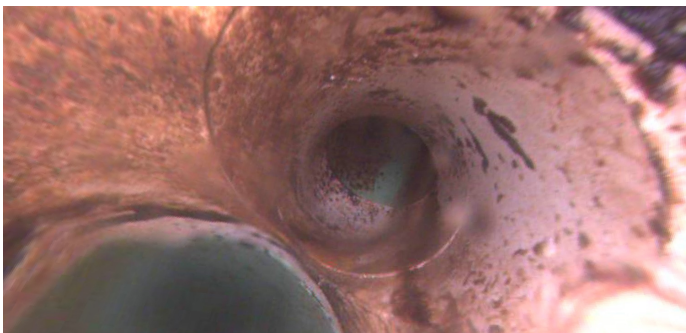
Code: **TF**
Description: **Tap Factory**

Distance (ft): **72.4**
Structural Grade: **0**
O&M Grade: **0**
Clock Start/From: **10**
Clock To:
1st Value: **4.000**
2nd Value:
Value Percent:
Continuous Index:
Within 8" of Joint:
Remarks:

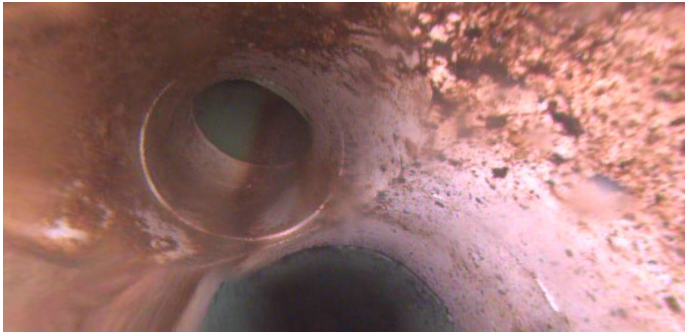
Code: **TF**
Description: **Tap Factory**

Distance (ft): **100.5**
Structural Grade: **0**
O&M Grade: **0**
Clock Start/From: **11**
Clock To:
1st Value: **4.000**
2nd Value:
Value Percent:
Continuous Index:
Within 8" of Joint:
Remarks:

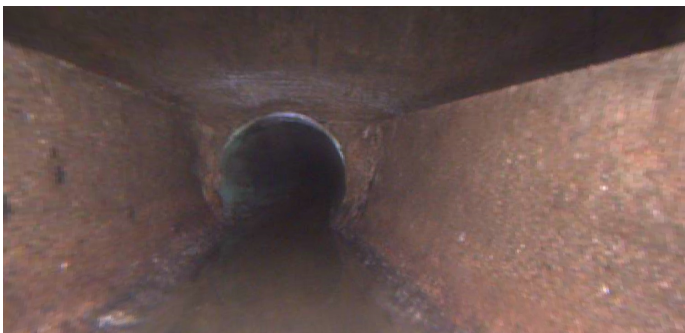
Code: **AMH**
Description: **Manhole**

Distance (ft): **104.1**
Structural Grade: **0**
O&M Grade: **0**
Clock Start/From:
Clock To:
1st Value:
2nd Value:
Value Percent:
Continuous Index:
Within 8" of Joint: **NO**
Remarks: **M-910-005**
