Profile/Photo Observation Report

Street:	NORRIS DR	Flow Control:	Not Controlled
City:	Hobart, IN	Year Renewed:	
Location:	Sidewalk	Tape/Media #:	
Purpose:	Maintenance Related	Dia/Height:	8"
Use:	Sanitary	Material:	PVC
Drain Area:	NA	Lining:	
Category:	NA		
Comment:

Location Details:		Direction of Survey:	Downstream
US MH:	M-910-006	DS MH:	M-910-007
		Total Length Surveyed (ft):	97.4

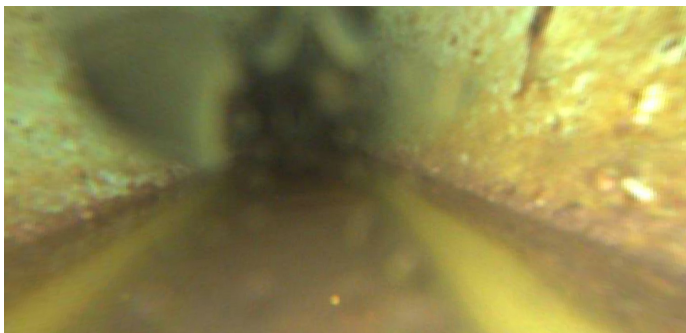
Code: **AMH**
Description: **Manhole**

Distance (ft): **.0**
Structural Grade: **0**
O&M Grade: **0**
Clock Start/From:
Clock To:
1st Value:
2nd Value:
Value Percent:
Continuous Index:
Within 8" of Joint: **NO**
Remarks: **M-910-006**

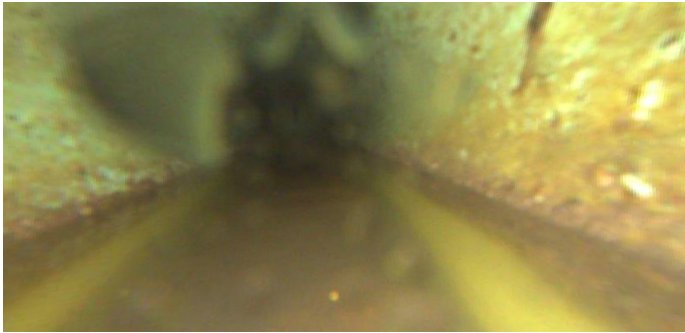
Code:	MWL
Description:	Water Level

Distance (ft):	.0
Structural Grade:	0
O&M Grade:	0
Clock Start/From:	
Clock To:	
1st Value:	
2nd Value:	
Value Percent:	5.000
Continuous Index:	
Within 8" of Joint:	NO
Remarks:

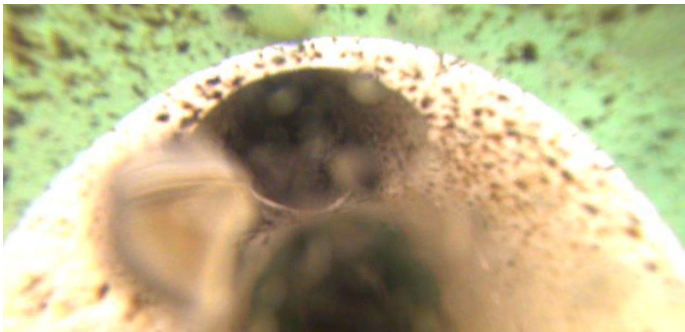
Code:	TF
Description:	Tap Factory

Distance (ft):	14.4
Structural Grade:	0
O&M Grade:	0
Clock Start/From:	12
Clock To:	
1st Value:	4.000
2nd Value:	
Value Percent:	
Continuous Index:	
Within 8" of Joint:	
Remarks:

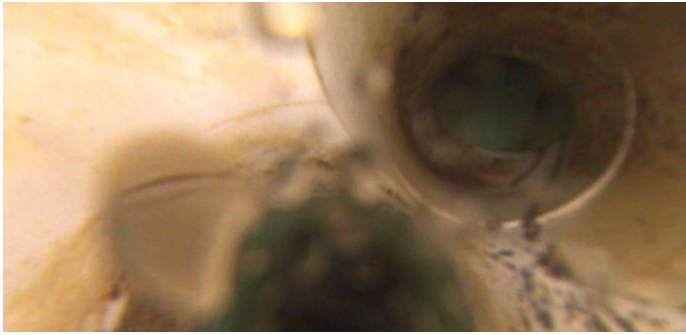
Code: **TF**
Description: **Tap Factory**

Distance (ft): **16.8**
Structural Grade: **0**
O&M Grade: **0**
Clock Start/From: **2**
Clock To:
1st Value: **4.000**
2nd Value:
Value Percent:
Continuous Index:
Within 8" of Joint:
Remarks:

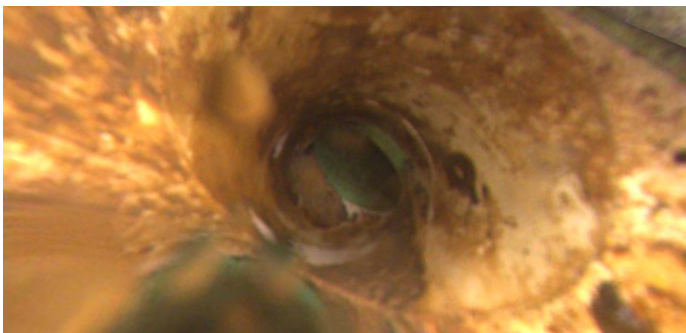
Code: **TB**
Description: **Tap Break-in**

Distance (ft): **55.3**
Structural Grade: **0**
O&M Grade: **0**
Clock Start/From: **1**
Clock To:
1st Value: **4.000**
2nd Value:
Value Percent:
Continuous Index:
Within 8" of Joint:
Remarks:

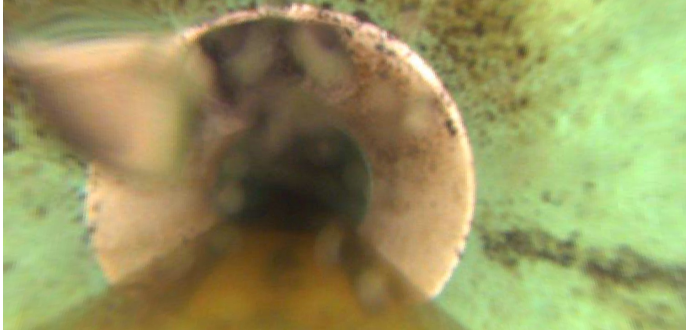
Code: **TF**
Description: **Tap Factory**

Distance (ft): **56.9**
Structural Grade: **0**
O&M Grade: **0**
Clock Start/From: **11**
Clock To:
1st Value: **4.000**
2nd Value:
Value Percent:
Continuous Index:
Within 8" of Joint: **YES**
Remarks:

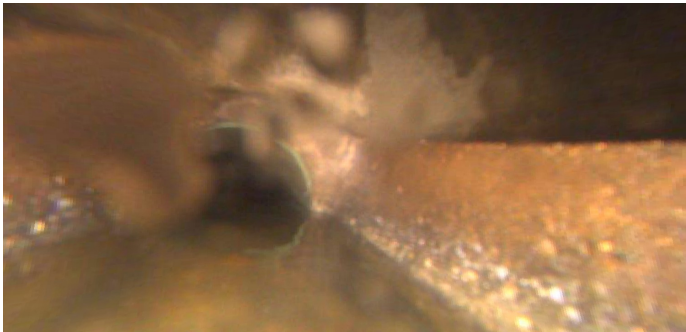
Code: **AMH**
Description: **Manhole**

Distance (ft): **97.4**
Structural Grade: **0**
O&M Grade: **0**
Clock Start/From:
Clock To:
1st Value:
2nd Value:
Value Percent:
Continuous Index:
Within 8" of Joint: **NO**
Remarks: **M-910-007**
