## Profile/Photo Observation Report

Street:	<b>Norris</b>	Flow Control:	<b>Not Controlled</b>
City:	<b>Hobart, IN</b>	Year Renewed:	
Location:	<b>Sidewalk</b>	Tape/Media #:	
Purpose:	<b>Maintenance Related</b>	Dia/Height:	<b>8"</b>
Use:	<b>Sanitary</b>	Material:	<b>PVC</b>
Drain Area:	<b>NA</b>	Lining:	
Category:	<b>NA</b>		
Comment:

Location Details:		Direction of Survey:	<b>Downstream</b>
US MH:	<b>M-910-006</b>	DS MH:	<b>M-910-007</b>
		Total Length Surveyed (ft):	<b>97.4</b>

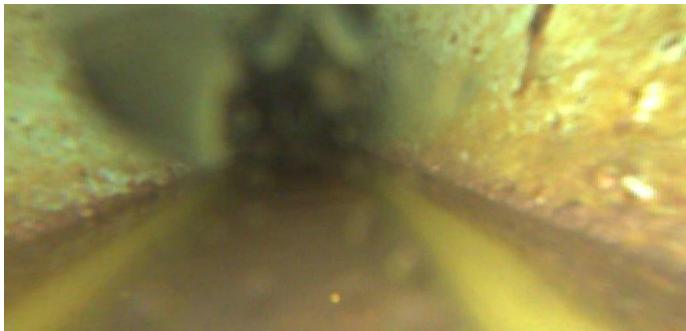
Code: **AMH**  
Description: **Manhole**

Distance (ft): **.0**  
Structural Grade: **0**  
O&M Grade: **0**  
Clock Start/From:  
Clock To:  
1st Value:  
2nd Value:  
Value Percent:  
Continuous Index:  
Within 8" of Joint: **NO**  
Remarks: **M-910-006**

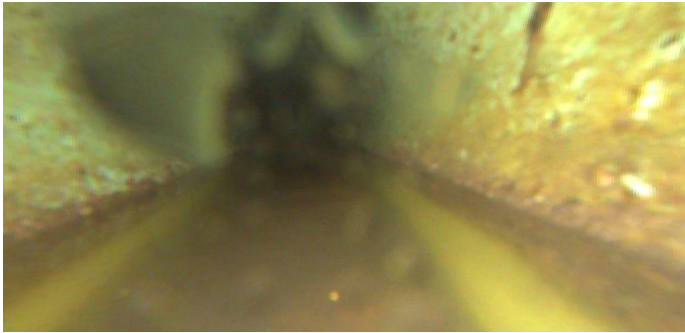
Code:	<b>MWL</b>
Description:	<b>Water Level</b>

Distance (ft):	<b>.0</b>
Structural Grade:	<b>0</b>
O&M Grade:	<b>0</b>
Clock Start/From:	
Clock To:	
1st Value:	
2nd Value:	
Value Percent:	<b>5.000</b>
Continuous Index:	
Within 8" of Joint:	<b>NO</b>
Remarks:

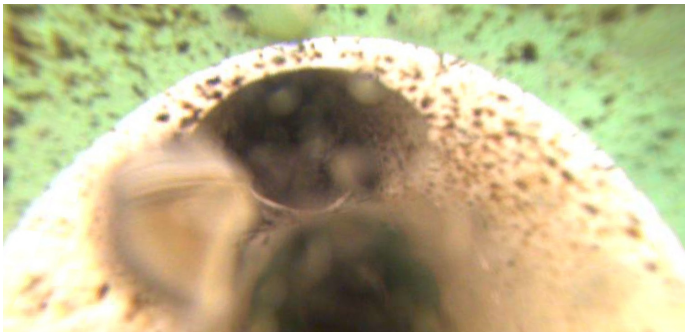
Code:	<b>TF</b>
Description:	<b>Tap Factory</b>

Distance (ft):	<b>14.4</b>
Structural Grade:	<b>0</b>
O&M Grade:	<b>0</b>
Clock Start/From:	<b>12</b>
Clock To:	
1st Value:	<b>4.000</b>
2nd Value:	
Value Percent:	
Continuous Index:	
Within 8" of Joint:	
Remarks:

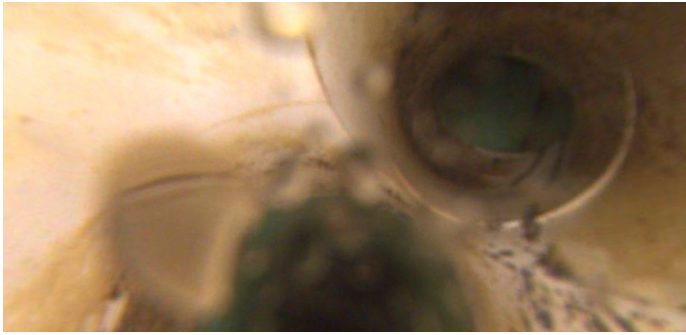
Code: **TF**  
Description: **Tap Factory**

Distance (ft): **16.8**  
Structural Grade: **0**  
O&M Grade: **0**  
Clock Start/From: **2**  
Clock To:  
1st Value: **4.000**  
2nd Value:  
Value Percent:  
Continuous Index:  
Within 8" of Joint:  
Remarks:

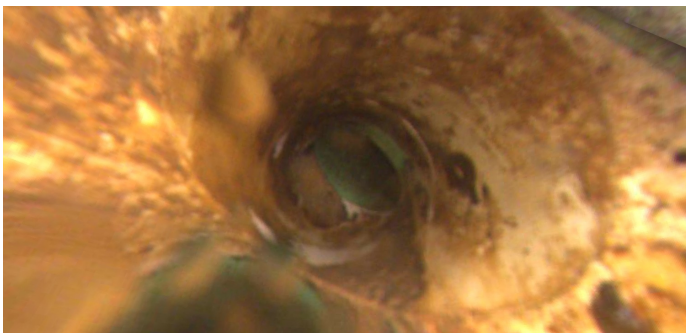
Code: **TB**  
Description: **Tap Break-in**

Distance (ft): **55.3**  
Structural Grade: **0**  
O&M Grade: **0**  
Clock Start/From: **1**  
Clock To:  
1st Value: **4.000**  
2nd Value:  
Value Percent:  
Continuous Index:  
Within 8" of Joint:  
Remarks:

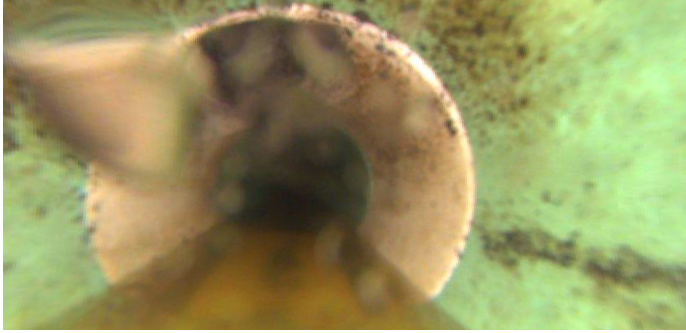
Code: **TF**  
Description: **Tap Factory**

Distance (ft): **56.9**  
Structural Grade: **0**  
O&M Grade: **0**  
Clock Start/From: **11**  
Clock To:  
1st Value: **4.000**  
2nd Value:  
Value Percent:  
Continuous Index:  
Within 8" of Joint: **YES**  
Remarks:

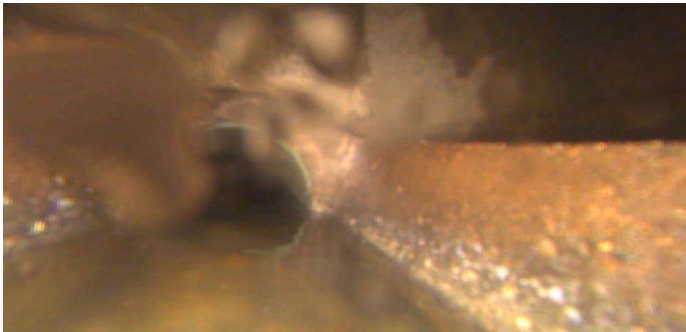
Code: **AMH**  
Description: **Manhole**

Distance (ft): **97.4**  
Structural Grade: **0**  
O&M Grade: **0**  
Clock Start/From:  
Clock To:  
1st Value:  
2nd Value:  
Value Percent:  
Continuous Index:  
Within 8" of Joint: **NO**  
Remarks: **M-910-007**
