Profile/Photo Observation Report

Street:	Norris Dr.	Flow Control:	Not Controlled
City:	Hobart, IN	Year Renewed:	
Location:	Light Highway	Tape/Media #:	
Purpose:	Routine Assessment	Dia/Height:	8"
Use:	Sanitary	Material:	PVC
Drain Area:	NA	Lining:	
Category:	NA		
Comment:

Location Details:		Direction of Survey:	Upstream
US MH:	M-910-007	DS MH:	M-910-008
		Total Length Surveyed (ft):	186.0

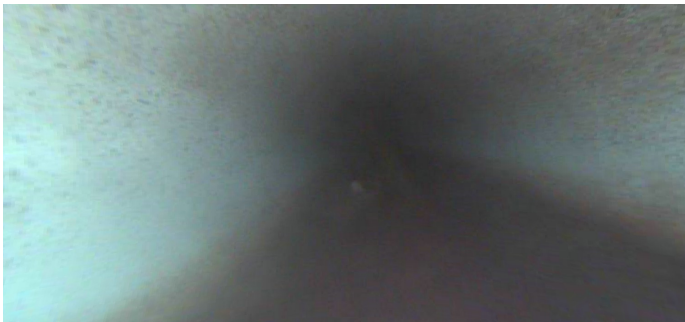
Code: **AMH**
Description: **Manhole**

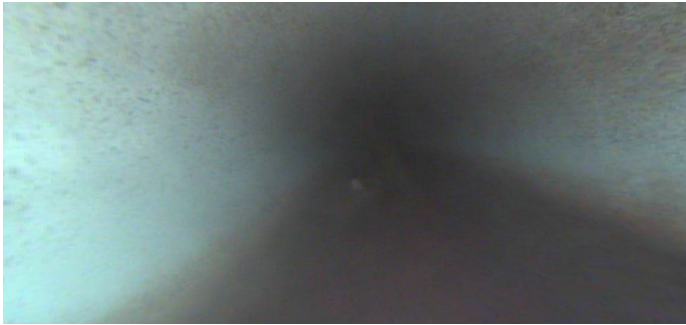
Code:	MWL
Description:	Water Level

Distance (ft):	.0
Structural Grade:	0
O&M Grade:	0
Clock Start/From:	
Clock To:	
1st Value:	
2nd Value:	
Value Percent:	5.000
Continuous Index:	
Within 8" of Joint:	NO
Remarks:

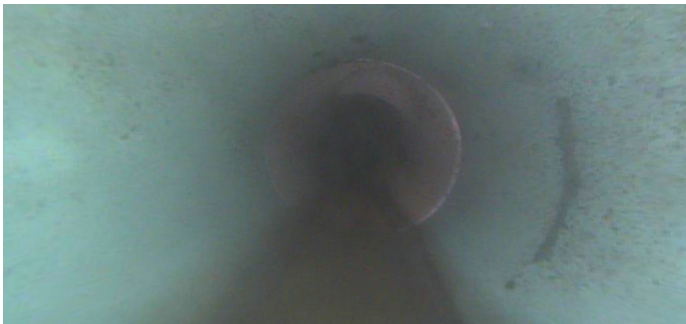
Code:	TF
Description:	Tap Factory

Distance (ft):	47.5
Structural Grade:	0
O&M Grade:	0
Clock Start/From:	1
Clock To:	
1st Value:	4.000
2nd Value:	
Value Percent:	
Continuous Index:	
Within 8" of Joint:	
Remarks:

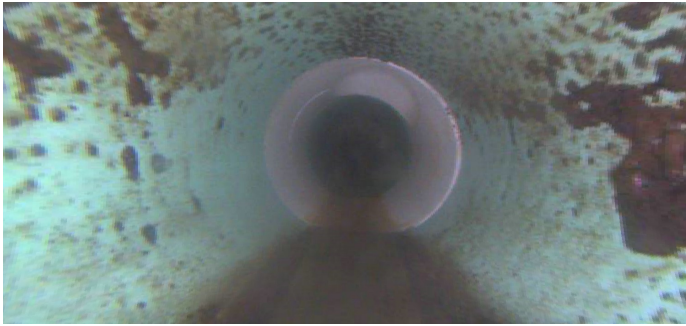
Code: **TF**
Description: **Tap Factory**

Distance (ft): **114.0**
Structural Grade: **0**
O&M Grade: **0**
Clock Start/From: **1**
Clock To:
1st Value: **4.000**
2nd Value:
Value Percent:
Continuous Index:
Within 8" of Joint:
Remarks:

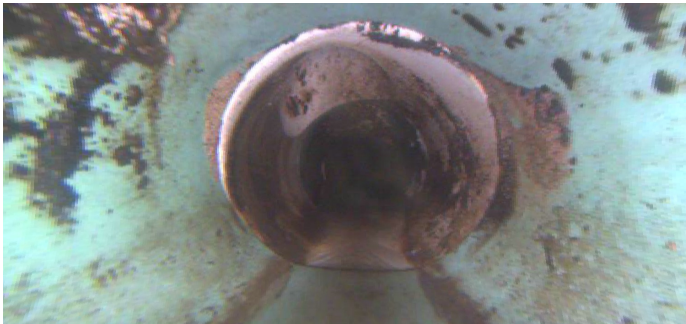
Code: **TF**
Description: **Tap Factory**

Distance (ft): **141.1**
Structural Grade: **0**
O&M Grade: **0**
Clock Start/From: **11**
Clock To:
1st Value: **4.000**
2nd Value:
Value Percent:
Continuous Index:
Within 8" of Joint:
Remarks:

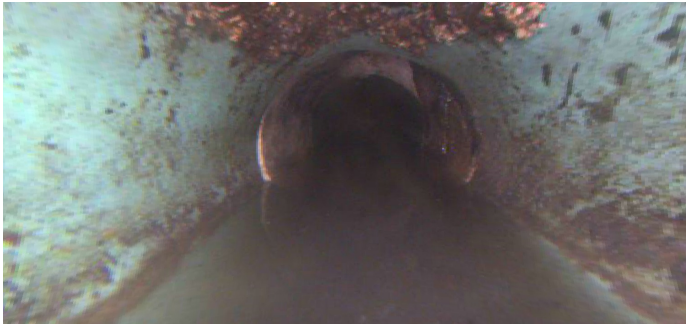
Code: **TF**
Description: **Tap Factory**

Distance (ft): **142.8**
Structural Grade: **0**
O&M Grade: **0**
Clock Start/From: **12**
Clock To:
1st Value: **4.000**
2nd Value:
Value Percent:
Continuous Index:
Within 8" of Joint:
Remarks:

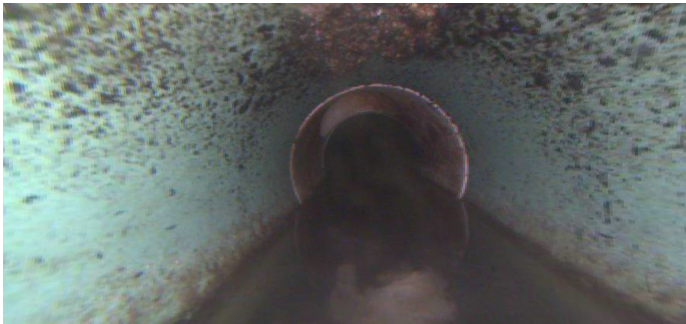
Code: **TF**
Description: **Tap Factory**

Distance (ft): **180.0**
Structural Grade: **0**
O&M Grade: **0**
Clock Start/From: **11**
Clock To:
1st Value: **4.000**
2nd Value:
Value Percent:
Continuous Index:
Within 8" of Joint:
Remarks:

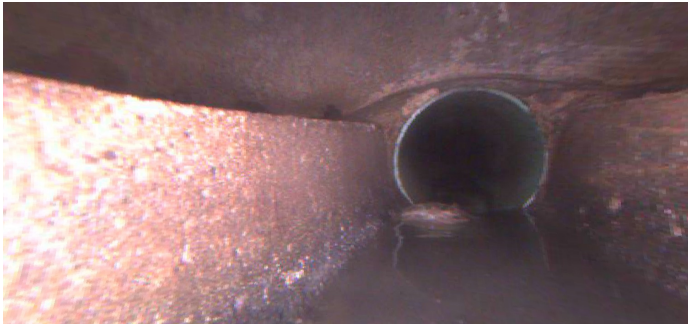
Code:	AMH
Description:	Manhole
Distance (ft):	186.0
Structural Grade:	0
O&M Grade:	0
Clock Start/From:	
Clock To:	
1st Value:	
2nd Value:	
Value Percent:	
Continuous Index:	
Within 8" of Joint:	NO
Remarks:	M-910-007
