Profile/Photo Observation Report

Street:	NORRIS DR	Flow Control:	Not Controlled
City:	Hobart, IN	Year Renewed:	
Location:	Light Highway	Tape/Media #:	
Purpose:	Routine Assessment	Dia/Height:	8"
Use:	Sanitary	Material:	PVC
Drain Area:	NA	Lining:	
Category:	NA		
Comment:

Location Details:		Direction of Survey:	Downstream
US MH:	M-910-008	DS MH:	M-910-009
		Total Length Surveyed (ft):	242.3

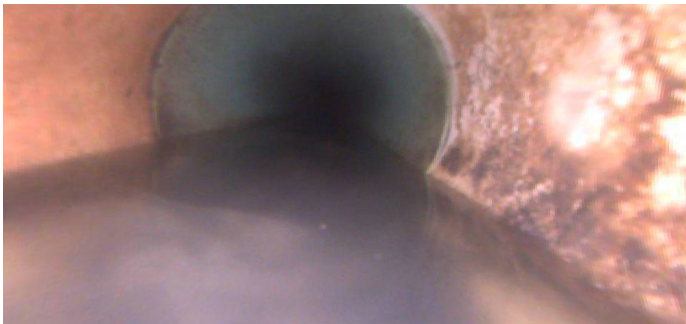
The diagram shows a vertical pipe section. At the top, a circle is labeled **M-910-008**. At the bottom, a circle is labeled **M-910-009**. A red arrow points downwards along the left side of the pipe, labeled **Camera Direction**. A table is positioned to the right of the pipe, with lines connecting its rows to specific points on the pipe. The table has five columns: Position, Code, Observation, Video (sec), and Grade.

Position	Code	Observation	Video (sec)	Grade
.0	AMH	Manhole	10	NA
.0	MWL	Water Level	21	NA
71.5	TF	Tap Factory	175	NA
87.8	RFB	Roots Fine Barrel	219	M 2
222.1	TF	Tap Factory	500	NA
242.3	AMH	Manhole	552	NA

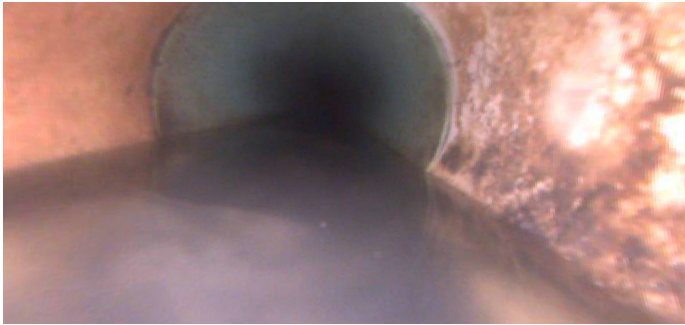
Code:	MWL
Description:	Water Level

Distance (ft):	.0
Structural Grade:	0
O&M Grade:	0
Clock Start/From:	
Clock To:	
1st Value:	
2nd Value:	
Value Percent:	5.000
Continuous Index:	
Within 8" of Joint:	NO
Remarks:

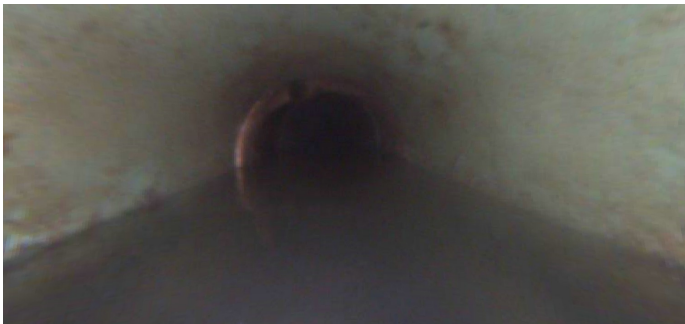
Code:	TF
Description:	Tap Factory

Distance (ft):	71.5
Structural Grade:	0
O&M Grade:	0
Clock Start/From:	11
Clock To:	
1st Value:	4.000
2nd Value:	
Value Percent:	
Continuous Index:	
Within 8" of Joint:	
Remarks:

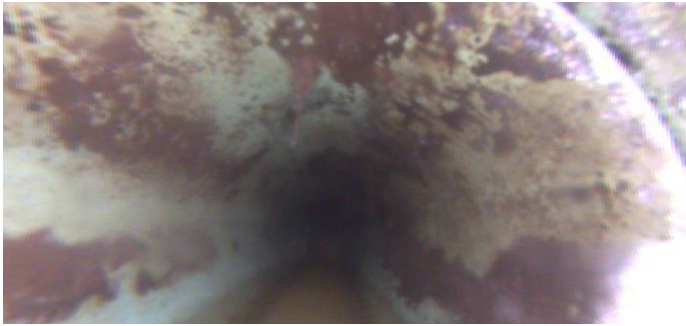
Code: **RFB**
Description: **Roots Fine Barrel**

Distance (ft): **87.8**
Structural Grade: **0**
O&M Grade: **2**
Clock Start/From: **12**
Clock To:
1st Value:
2nd Value:
Value Percent:
Continuous Index:
Within 8" of Joint: **NO**
Remarks:

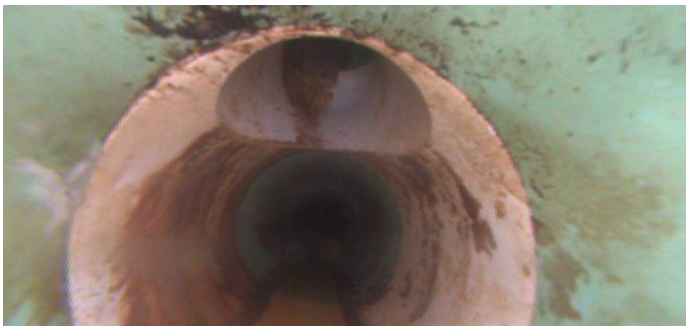
Code: **TF**
Description: **Tap Factory**

Distance (ft): **222.1**
Structural Grade: **0**
O&M Grade: **0**
Clock Start/From: **12**
Clock To:
1st Value: **4.000**
2nd Value:
Value Percent:
Continuous Index:
Within 8" of Joint:
Remarks:

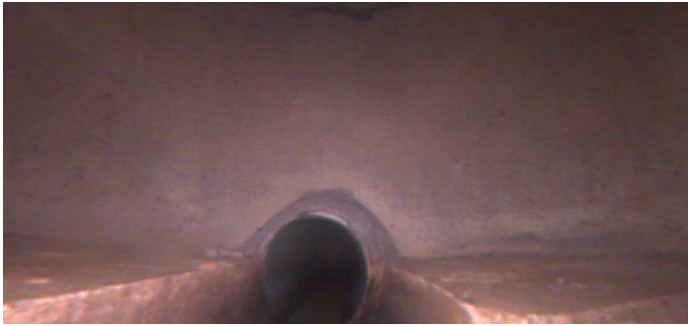
Code:	AMH
Description:	Manhole
Distance (ft):	242.3
Structural Grade:	0
O&M Grade:	0
Clock Start/From:	
Clock To:	
1st Value:	
2nd Value:	
Value Percent:	
Continuous Index:	
Within 8" of Joint:	NO
Remarks:	M-910-009
