Profile/Photo Observation Report

Street:	NORRIS DR	Flow Control:	Not Controlled
City:	Hobart, IN	Year Renewed:	
Location:	Sidewalk	Tape/Media #:	
Purpose:	Maintenance Related	Dia/Height:	8"
Use:	Sanitary	Material:	PVC
Drain Area:	NA	Lining:	
Category:	NA		
Comment:

Location Details:		Direction of Survey:	Upstream
US MH:	M-910-008	DS MH:	M-910-022
		Total Length Surveyed (ft):	155.8

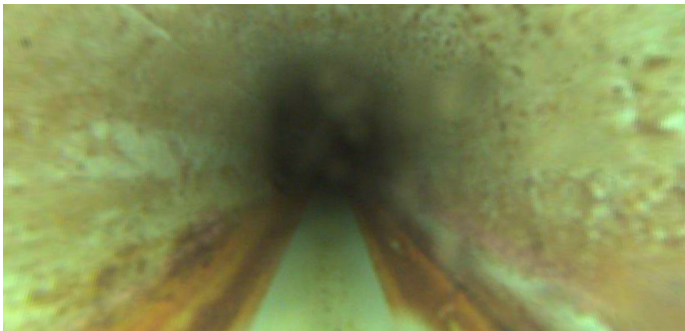
Code: **AMH**
Description: **Manhole**

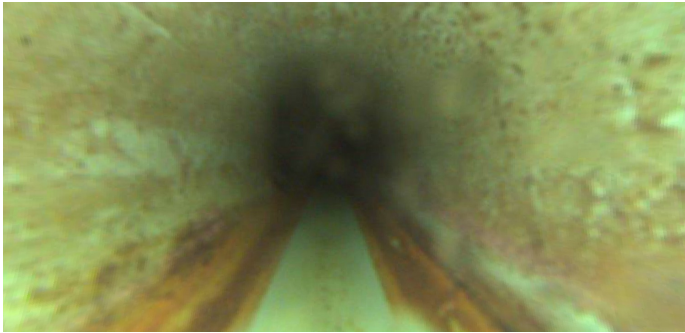
Code:	MWL
Description:	Water Level

Distance (ft):	.0
Structural Grade:	0
O&M Grade:	0
Clock Start/From:	
Clock To:	
1st Value:	
2nd Value:	
Value Percent:	5.000
Continuous Index:	
Within 8" of Joint:	NO
Remarks:

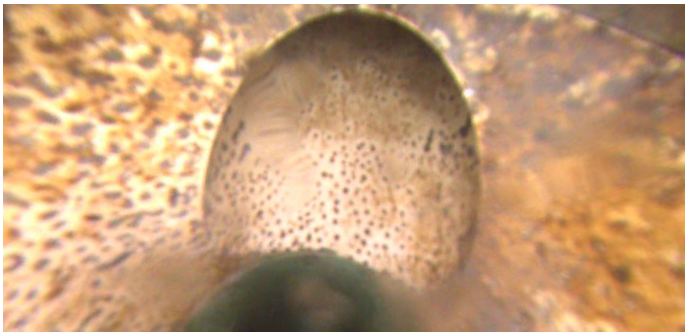
Code:	TF
Description:	Tap Factory

Distance (ft):	16.7
Structural Grade:	0
O&M Grade:	0
Clock Start/From:	12
Clock To:	
1st Value:	4.000
2nd Value:	
Value Percent:	
Continuous Index:	
Within 8" of Joint:	
Remarks:

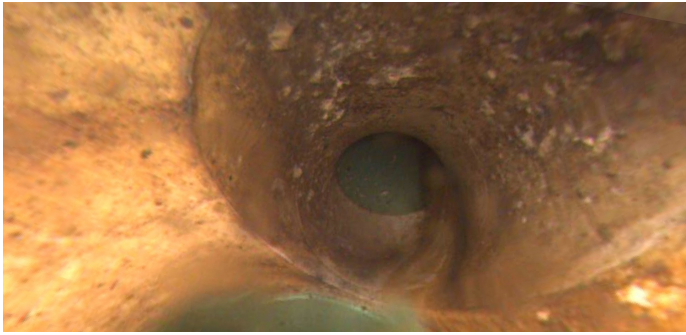
Code: **TF**
Description: **Tap Factory**

Distance (ft): **39.4**
Structural Grade: **0**
O&M Grade: **0**
Clock Start/From: **12**
Clock To:
1st Value: **4.000**
2nd Value:
Value Percent:
Continuous Index:
Within 8" of Joint:
Remarks:

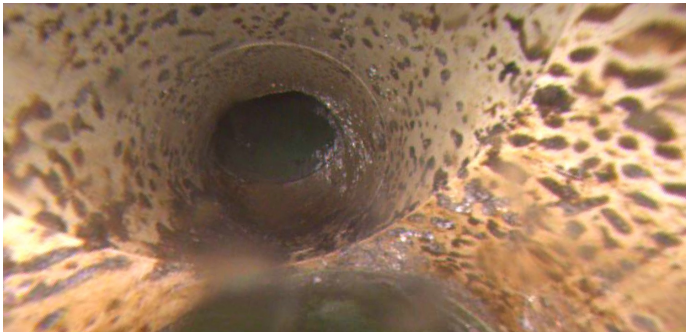
Code: **TF**
Description: **Tap Factory**

Distance (ft): **56.7**
Structural Grade: **0**
O&M Grade: **0**
Clock Start/From: **12**
Clock To:
1st Value: **4.000**
2nd Value:
Value Percent:
Continuous Index:
Within 8" of Joint:
Remarks:

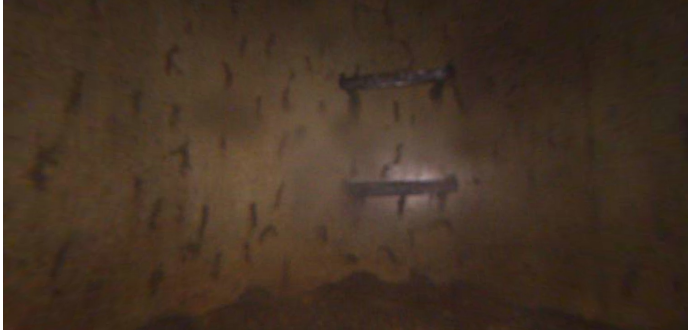
Code:	AMH
Description:	Manhole
Distance (ft):	155.8
Structural Grade:	0
O&M Grade:	0
Clock Start/From:	
Clock To:	
1st Value:	
2nd Value:	
Value Percent:	
Continuous Index:	
Within 8" of Joint:	NO
Remarks:	M-910-008
