Profile/Photo Observation Report

Location Details:		Direction of Survey:	Upstream
US MH:	M-910-008	DS MH:	M-910-022
		Total Length Surveyed (ft):	155.8

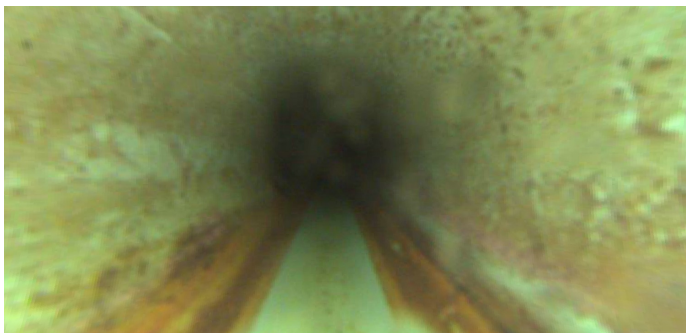
Code: **AMH**
Description: **Manhole**

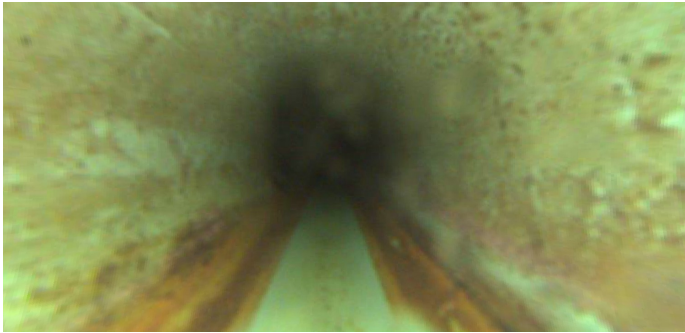
Code:	MWL
Description:	Water Level

Distance (ft):	.0
Structural Grade:	0
O&M Grade:	0
Clock Start/From:	
Clock To:	
1st Value:	
2nd Value:	
Value Percent:	5.000
Continuous Index:	
Within 8" of Joint:	NO
Remarks:

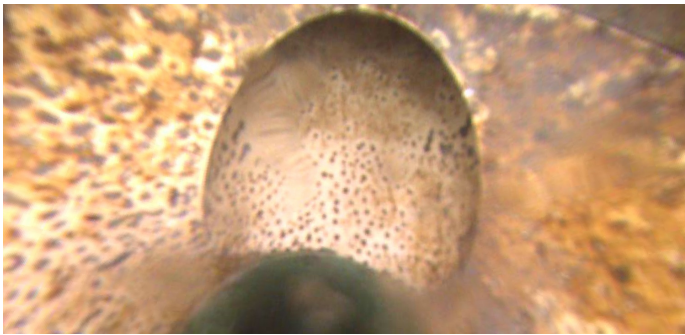
Code:	TF
Description:	Tap Factory

Distance (ft):	16.7
Structural Grade:	0
O&M Grade:	0
Clock Start/From:	12
Clock To:	
1st Value:	4.000
2nd Value:	
Value Percent:	
Continuous Index:	
Within 8" of Joint:	
Remarks:

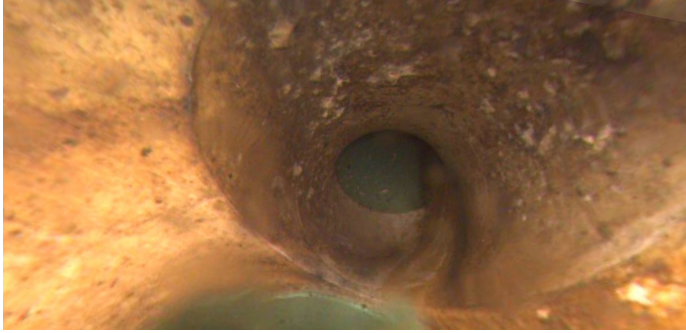
Code: **TF**
Description: **Tap Factory**

Distance (ft): **39.4**
Structural Grade: **0**
O&M Grade: **0**
Clock Start/From: **12**
Clock To:
1st Value: **4.000**
2nd Value:
Value Percent:
Continuous Index:
Within 8" of Joint:
Remarks:

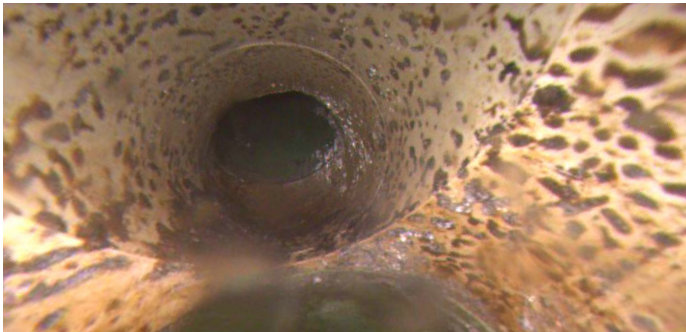
Code: **TF**
Description: **Tap Factory**

Distance (ft): **56.7**
Structural Grade: **0**
O&M Grade: **0**
Clock Start/From: **12**
Clock To:
1st Value: **4.000**
2nd Value:
Value Percent:
Continuous Index:
Within 8" of Joint:
Remarks:

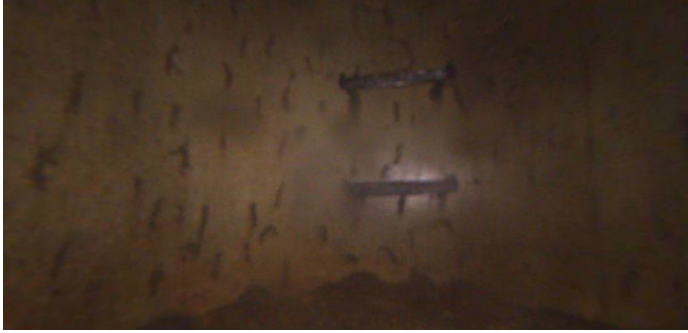
Code:	AMH
Description:	Manhole
Distance (ft):	155.8
Structural Grade:	0
O&M Grade:	0
Clock Start/From:	
Clock To:	
1st Value:	
2nd Value:	
Value Percent:	
Continuous Index:	
Within 8" of Joint:	NO
Remarks:	M-910-008
