## Profile/Photo Observation Report

Street:	<b>Norris</b>	Flow Control:	<b>Not Controlled</b>
City:	<b>Hobart, IN</b>	Year Renewed:	
Location:	<b>Sidewalk</b>	Tape/Media #:	
Purpose:	<b>Maintenance Related</b>	Dia/Height:	<b>8"</b>
Use:	<b>Sanitary</b>	Material:	<b>PVC</b>
Drain Area:	<b>NA</b>	Lining:	
Category:	<b>NA</b>		
Comment:	<b>Flow direction wrong.</b>

Location Details:		Direction of Survey:	<b>Upstream</b>
US MH:	<b>M-910-010</b>	DS MH:	<b>M-910-011</b>
		Total Length Surveyed (ft):	<b>83.5</b>

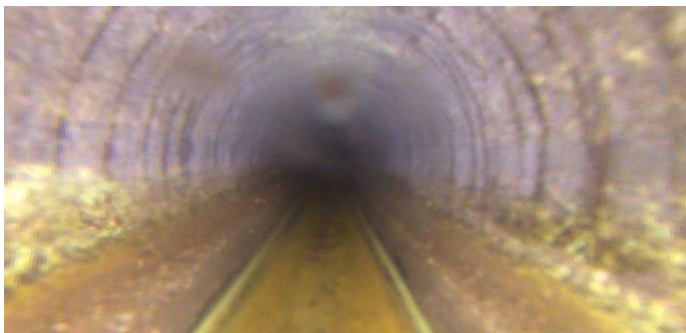
Code: **AMH**  
Description: **Manhole**

Distance (ft): **.0**  
Structural Grade: **0**  
O&M Grade: **0**  
Clock Start/From:  
Clock To:  
1st Value:  
2nd Value:  
Value Percent:  
Continuous Index:  
Within 8" of Joint: **NO**  
Remarks: **M-910-011**

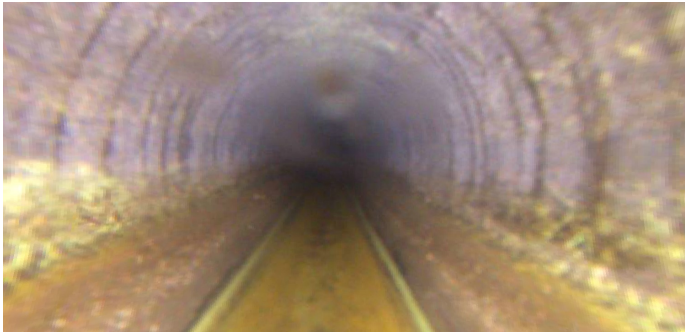
Code:	<b>MWL</b>
Description:	<b>Water Level</b>

Distance (ft):	<b>.0</b>
Structural Grade:	<b>0</b>
O&M Grade:	<b>0</b>
Clock Start/From:	
Clock To:	
1st Value:	
2nd Value:	
Value Percent:	<b>5.000</b>
Continuous Index:	
Within 8" of Joint:	<b>NO</b>
Remarks:

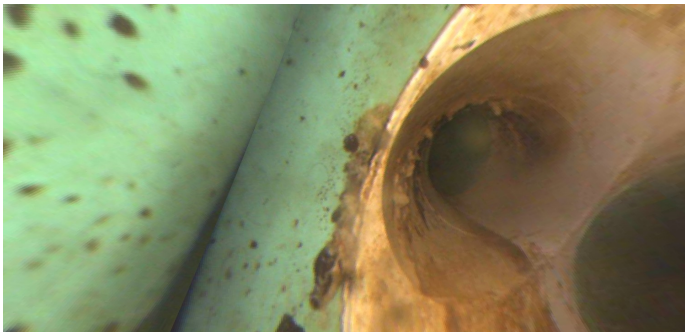
Code:	<b>TF</b>
Description:	<b>Tap Factory</b>

Distance (ft):	<b>50.1</b>
Structural Grade:	<b>0</b>
O&M Grade:	<b>0</b>
Clock Start/From:	<b>2</b>
Clock To:	
1st Value:	<b>4.000</b>
2nd Value:	
Value Percent:	
Continuous Index:	
Within 8" of Joint:	<b>YES</b>
Remarks:

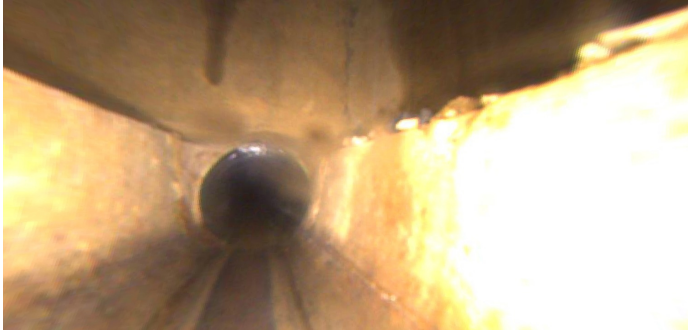
Code:	<b>AMH</b>
Description:	<b>Manhole</b>
Distance (ft):	<b>83.5</b>
Structural Grade:	<b>0</b>
O&M Grade:	<b>0</b>
Clock Start/From:	
Clock To:	
1st Value:	
2nd Value:	
Value Percent:	
Continuous Index:	
Within 8" of Joint:	<b>NO</b>
Remarks:	<b>M-910-010</b>
