Profile/Photo Observation Report

Date:	03/28/2018	Weather:		Coding:	PACP 6.0
Pipe Length (ft):	101.8	Owner:	NA	Pre Clean:	Not Known
P.O.#:		Surveyor:	Selasie Honu	PSR:	P-910-013-012
Customer:		Clean Date:	01/01/1900	Shape:	C

Street:	NORRIS DR	Flow Control:	Not Controlled
City:	Hobart, IN	Year Renewed:	
Location:	Sidewalk	Tape/Media #:	
Purpose:	Maintenance Related	Dia/Height:	8"
Use:	Sanitary	Material:	PVC
Drain Area:	NA	Lining:	
Category:	NA		
Comment:

Location Details:		Direction of Survey:	Upstream
US MH:	M-910-012	DS MH:	M-910-013
		Total Length Surveyed (ft):	98.3

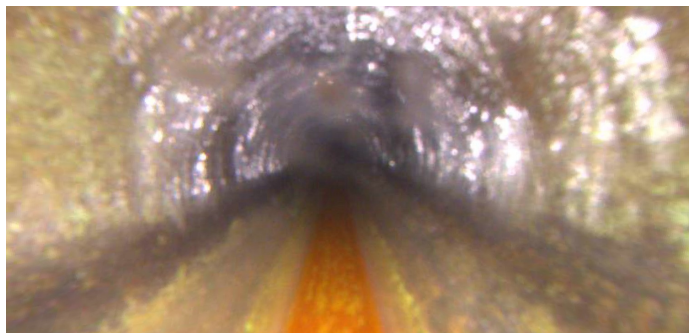
Code: **DAGS**
Description: **Deposits Attached Grease**

Distance (ft): **.0**
Structural Grade: **0**
O&M Grade: **2**
Clock Start/From: **8**
Clock To: **4**
1st Value:
2nd Value:
Value Percent: **5.000**
Continuous Index: **S01**
Within 8" of Joint: **NO**
Remarks:

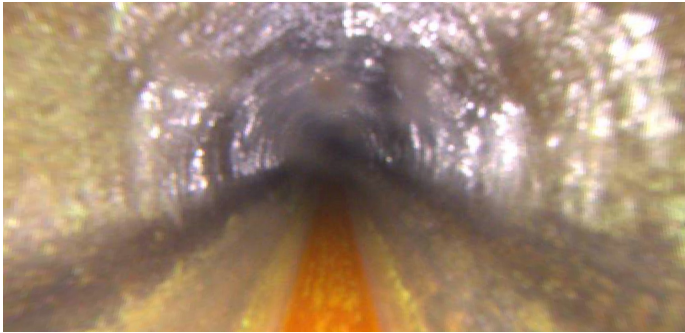
Code:	AMH
Description:	Manhole

Distance (ft):	.0
Structural Grade:	0
O&M Grade:	0
Clock Start/From:	
Clock To:	
1st Value:	
2nd Value:	
Value Percent:	
Continuous Index:	
Within 8" of Joint:	NO
Remarks:	M-910-013

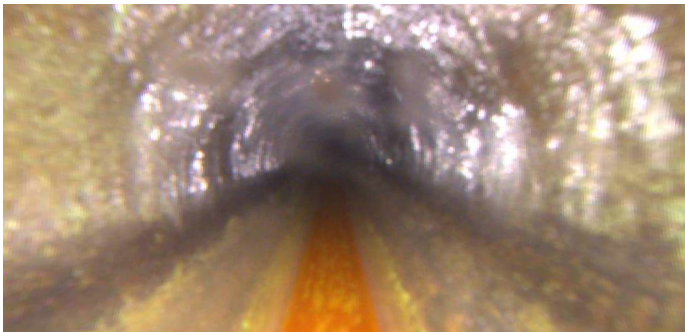
Code:	MWL
Description:	Water Level

Distance (ft):	.0
Structural Grade:	0
O&M Grade:	0
Clock Start/From:	
Clock To:	
1st Value:	
2nd Value:	
Value Percent:	5.000
Continuous Index:	
Within 8" of Joint:	NO
Remarks:

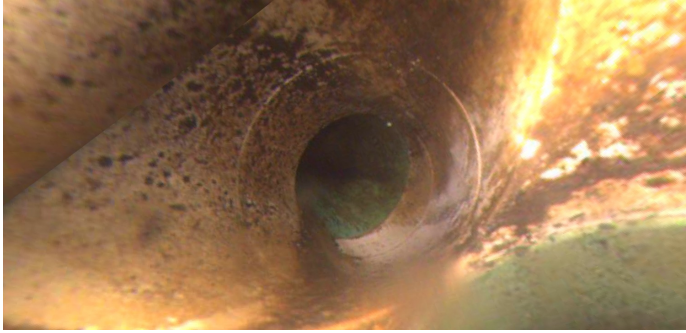
Code: **TF**
Description: **Tap Factory**

Distance (ft): **46.4**
Structural Grade: **0**
O&M Grade: **0**
Clock Start/From: **2**
Clock To:
1st Value: **4.000**
2nd Value:
Value Percent:
Continuous Index:
Within 8" of Joint:
Remarks:

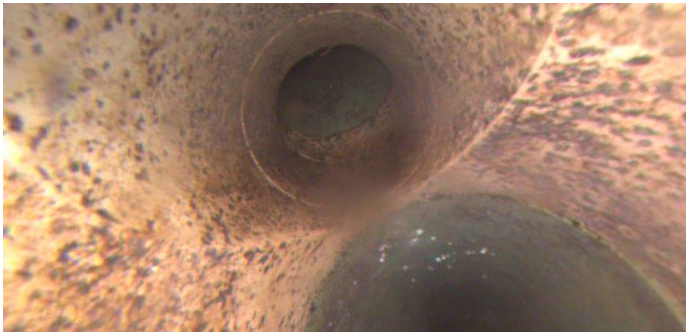
Code: **TF**
Description: **Tap Factory**

Distance (ft): **83.9**
Structural Grade: **0**
O&M Grade: **0**
Clock Start/From: **1**
Clock To:
1st Value: **4.000**
2nd Value:
Value Percent:
Continuous Index:
Within 8" of Joint:
Remarks:

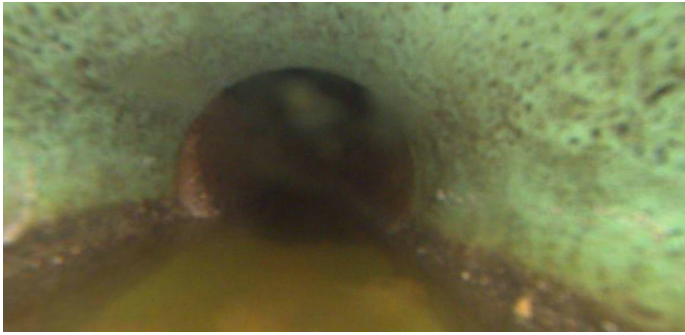
Code: **DAGS**
Description: **Deposits Attached Grease**

Distance (ft): **95.6**
Structural Grade: **0**
O&M Grade: **2**
Clock Start/From: **8**
Clock To: **4**
1st Value:
2nd Value:
Value Percent: **5.000**
Continuous Index: **F01**
Within 8" of Joint: **NO**
Remarks:

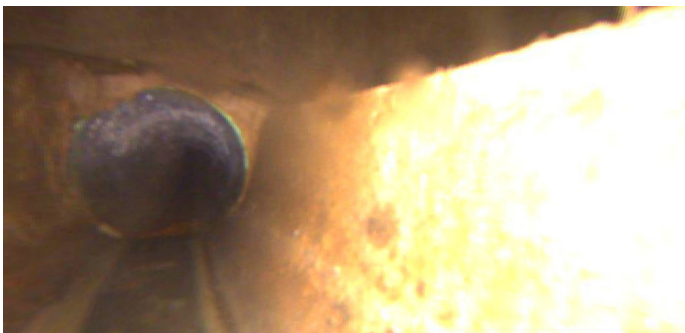
Code: **AMH**
Description: **Manhole**

Distance (ft): **98.3**
Structural Grade: **0**
O&M Grade: **0**
Clock Start/From:
Clock To:
1st Value:
2nd Value:
Value Percent:
Continuous Index:
Within 8" of Joint: **NO**
Remarks: **M-910-012**
